A REQUEST FOR PROPOSAL (RFP) FOR:

Powell Avenue Bridge Deck Rehabilitation

State Project No: 7994-00-52

Bridge ID: P-55-0148

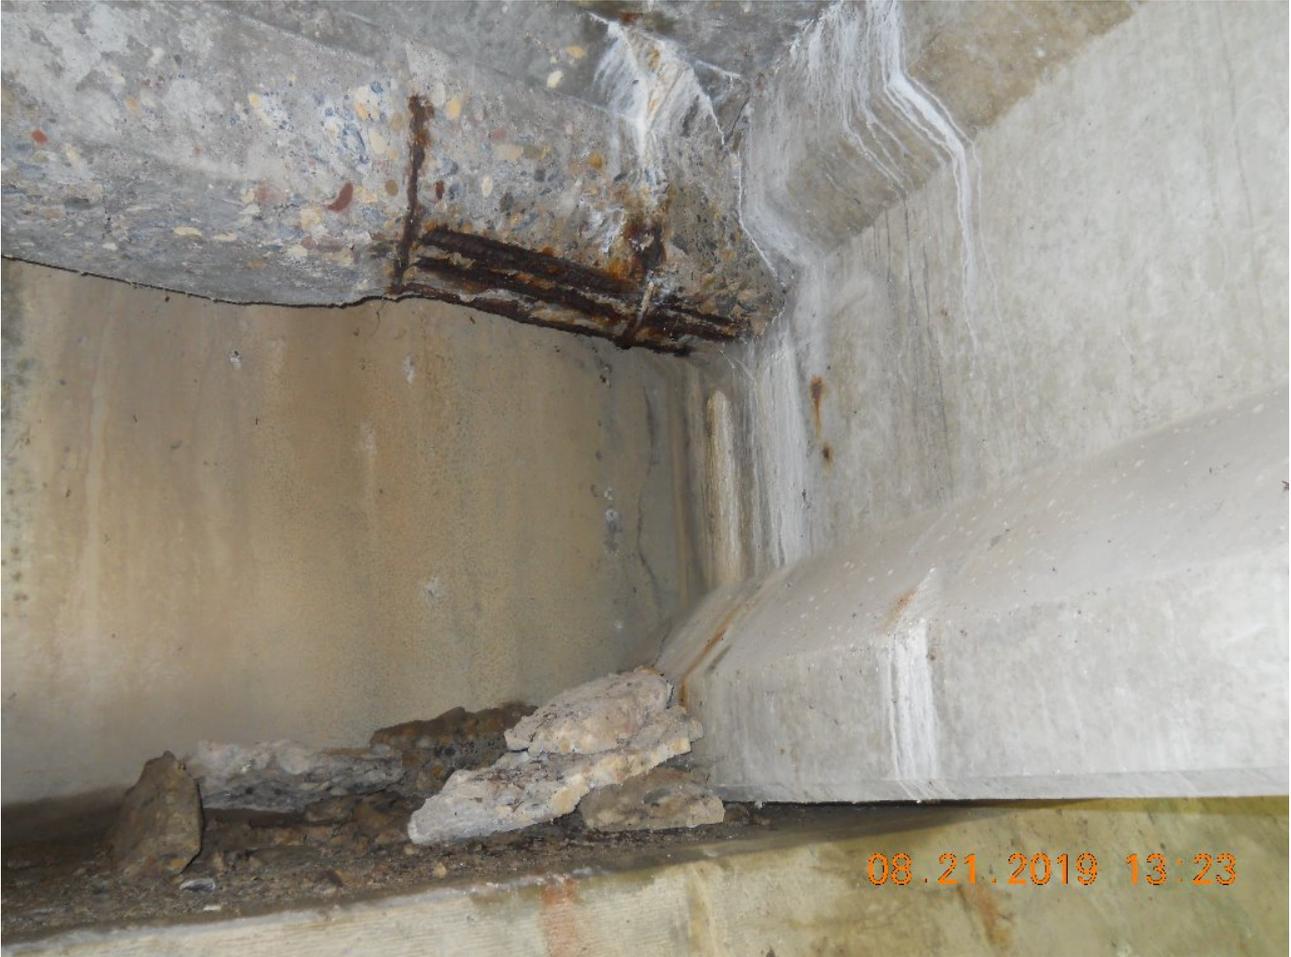
Concrete diaphragm at end of girder

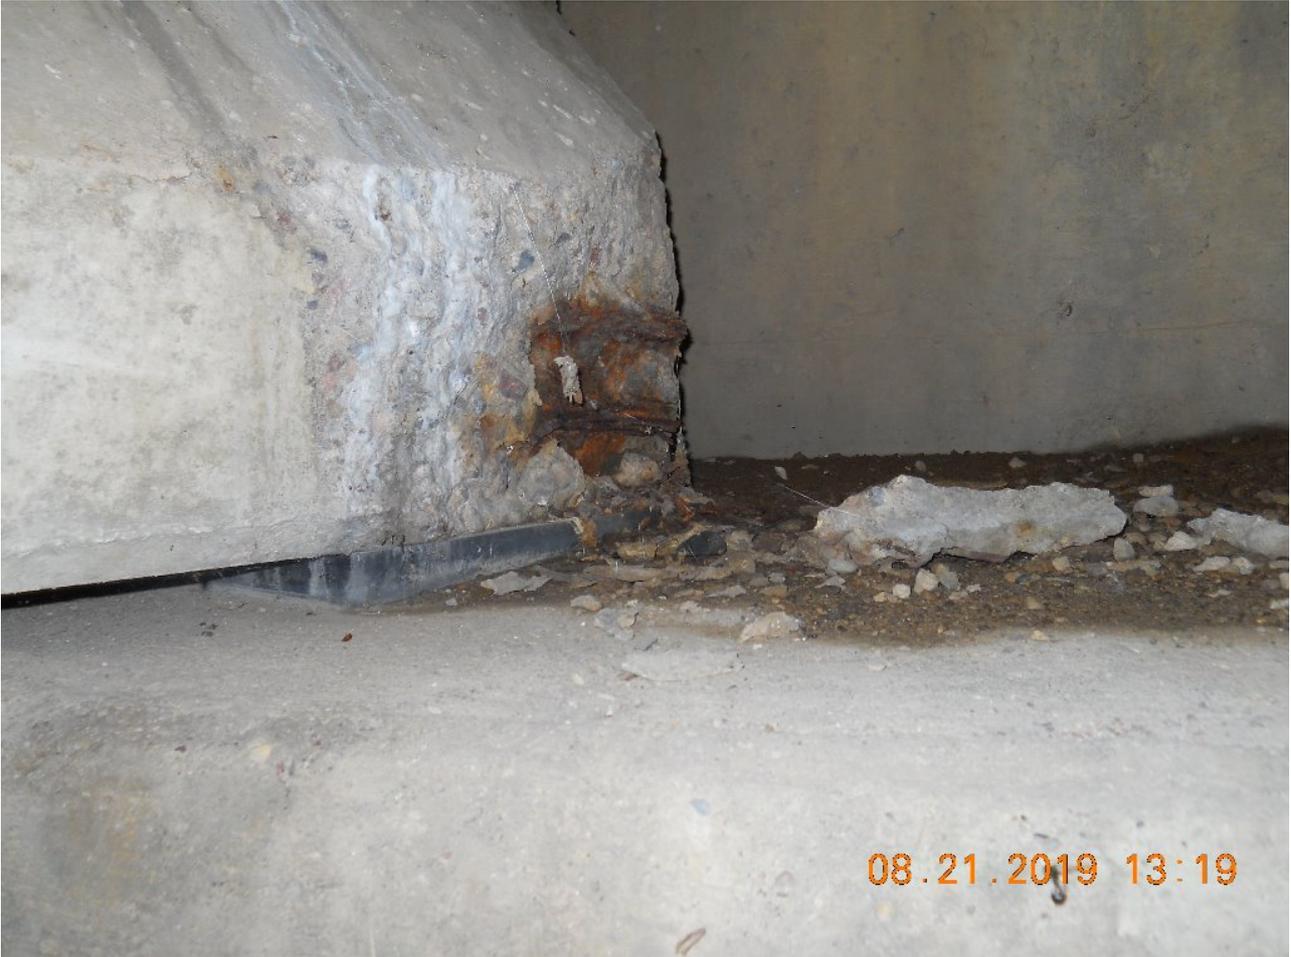
Bearing on east end rusted

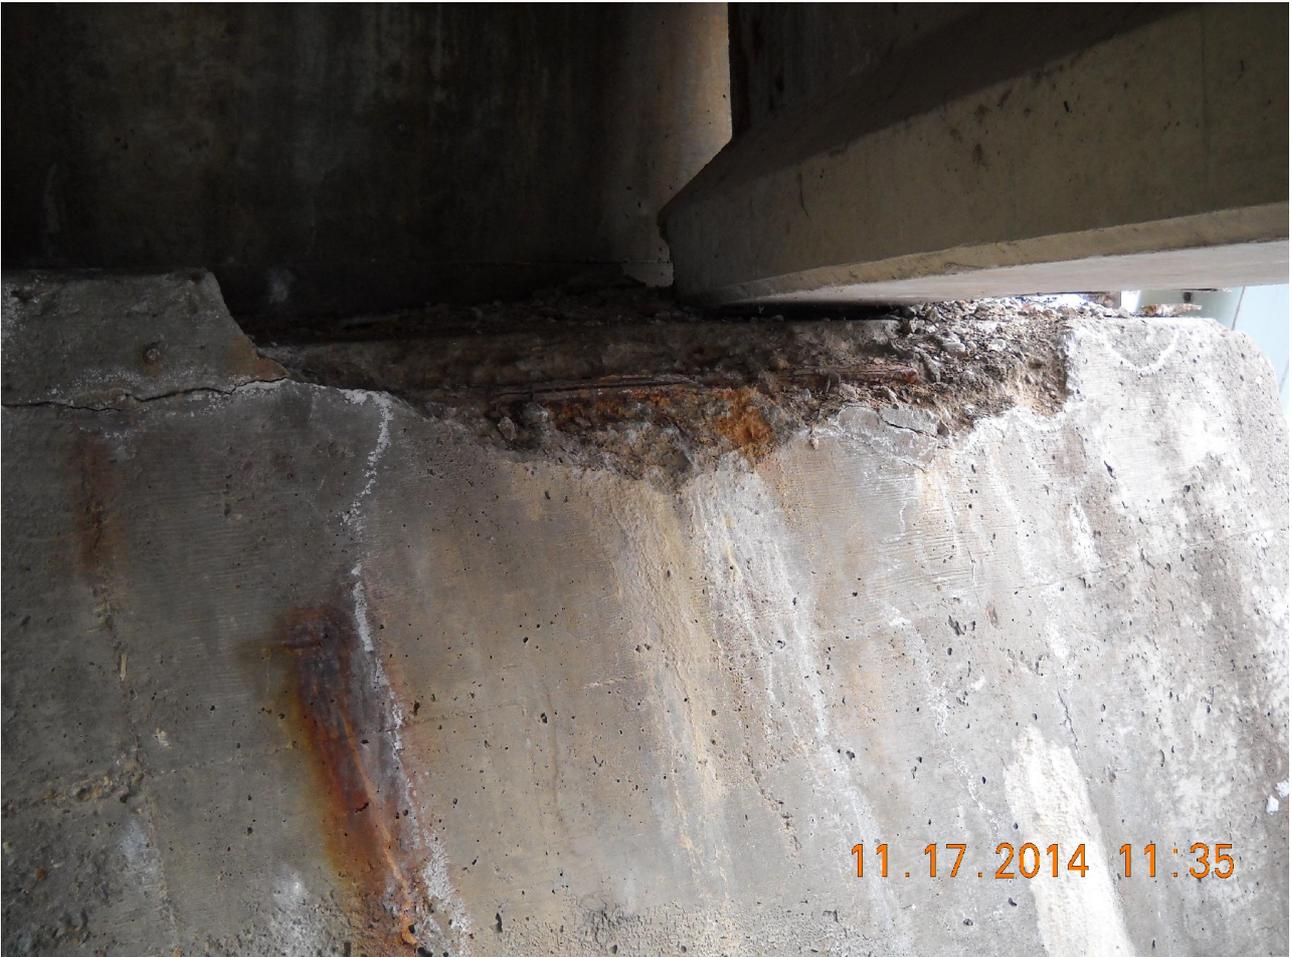
Bearing on east end rusted and sitting on cracked abutment

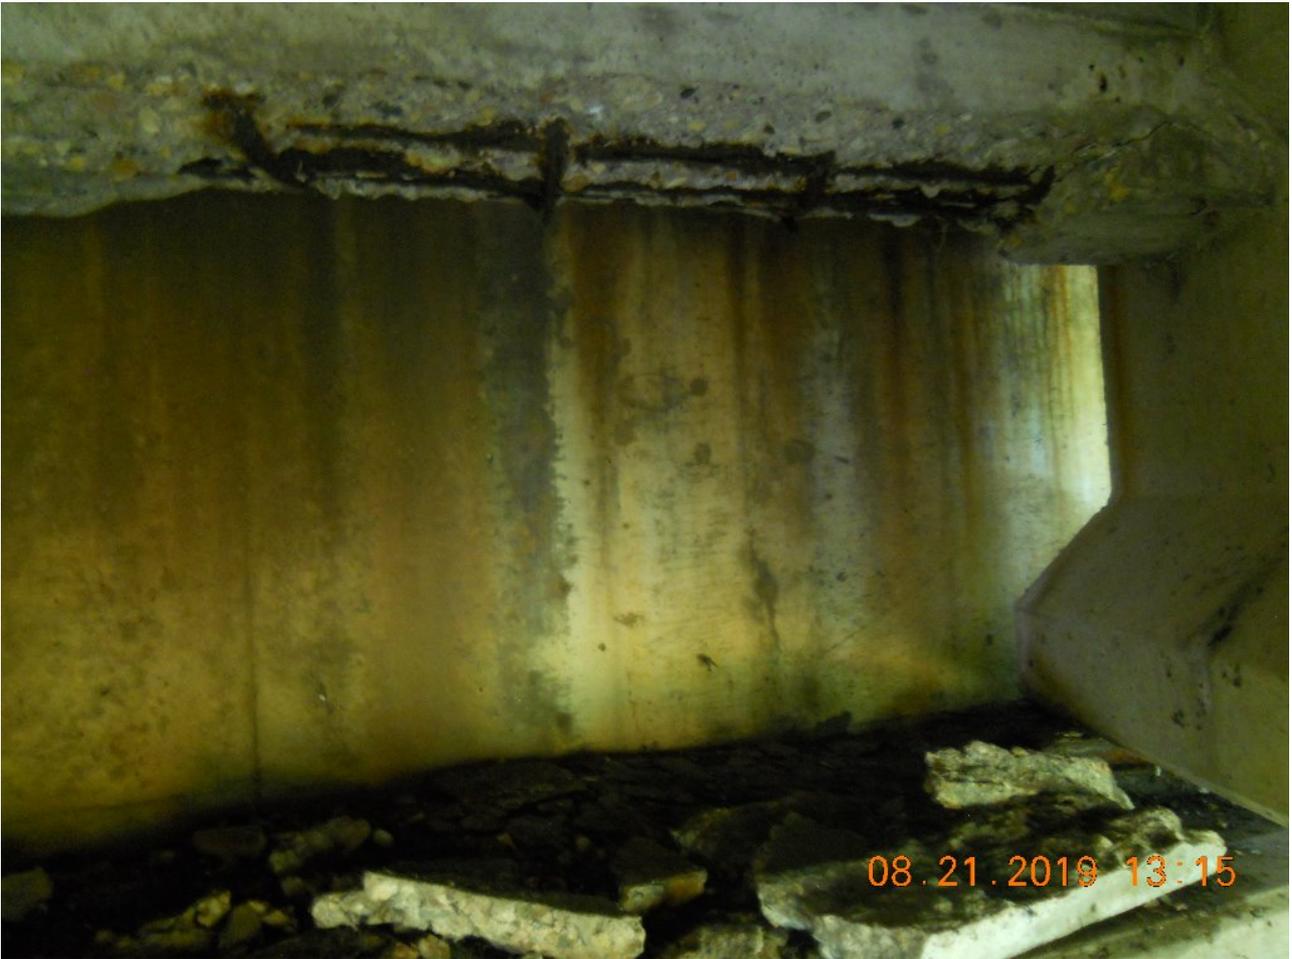
Bottom of Diaphragms at girder ends.

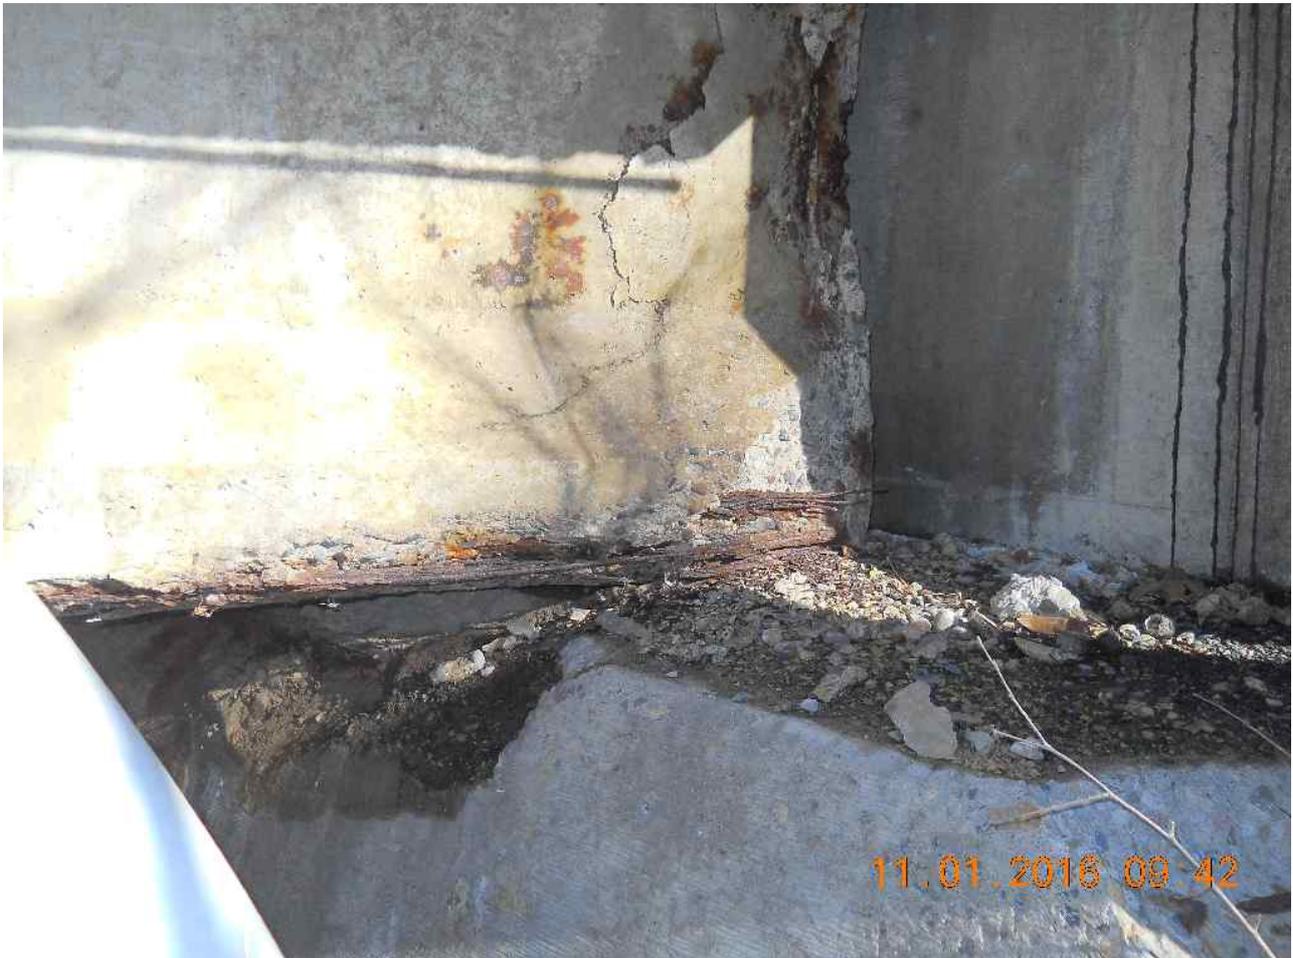
Spalling South beam, East abutment. Due to minimal bending moment at spall locations, structural review not needed

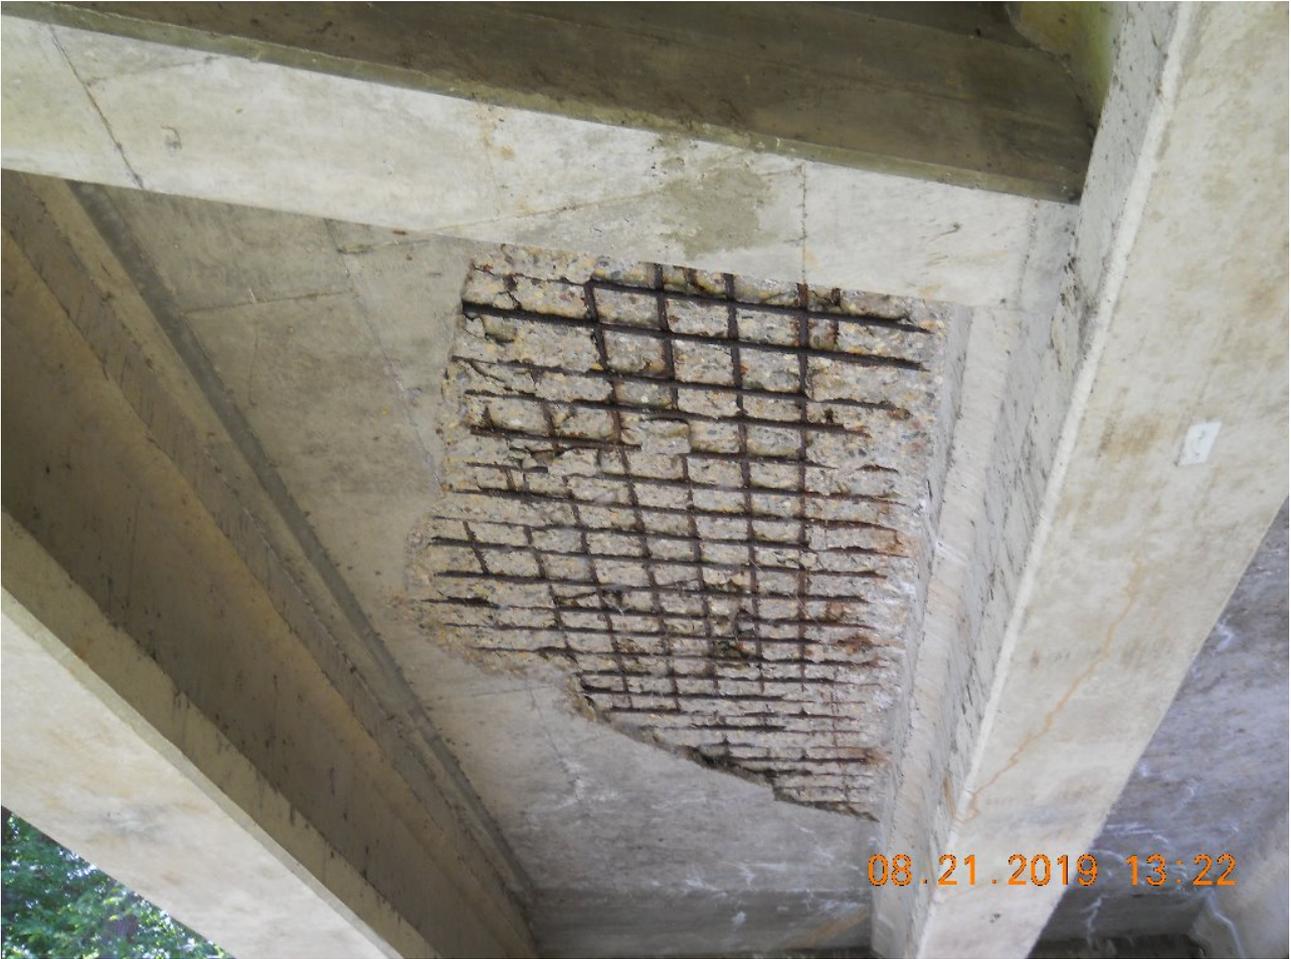
East end, spalled areas. Also large spall on the underside of the deck at the southeast quadrant. Rebar still intact but placed with minimal cover. Structural review not required.

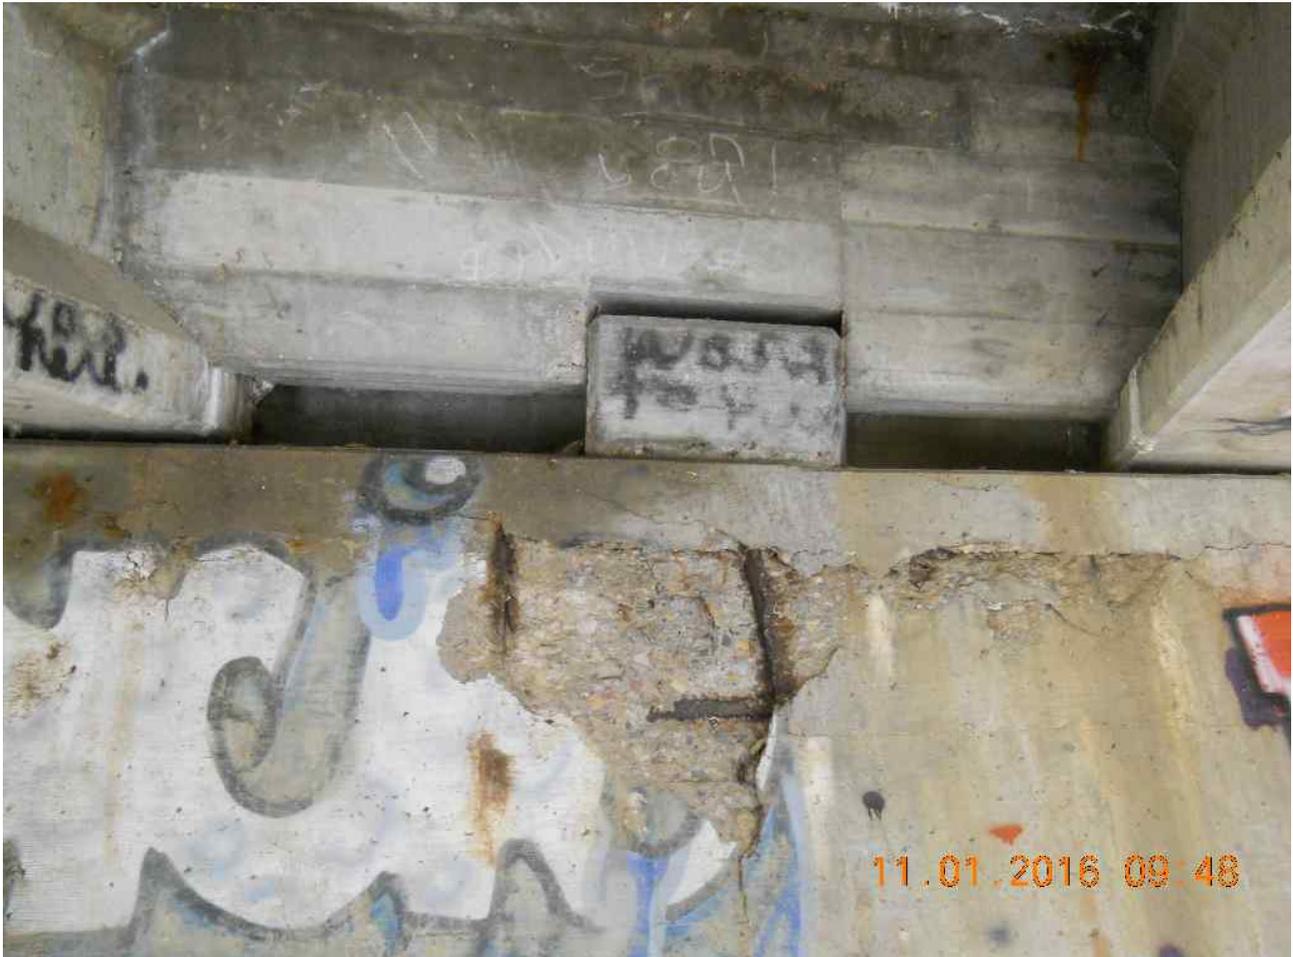
Spalling and cracking on east abutment

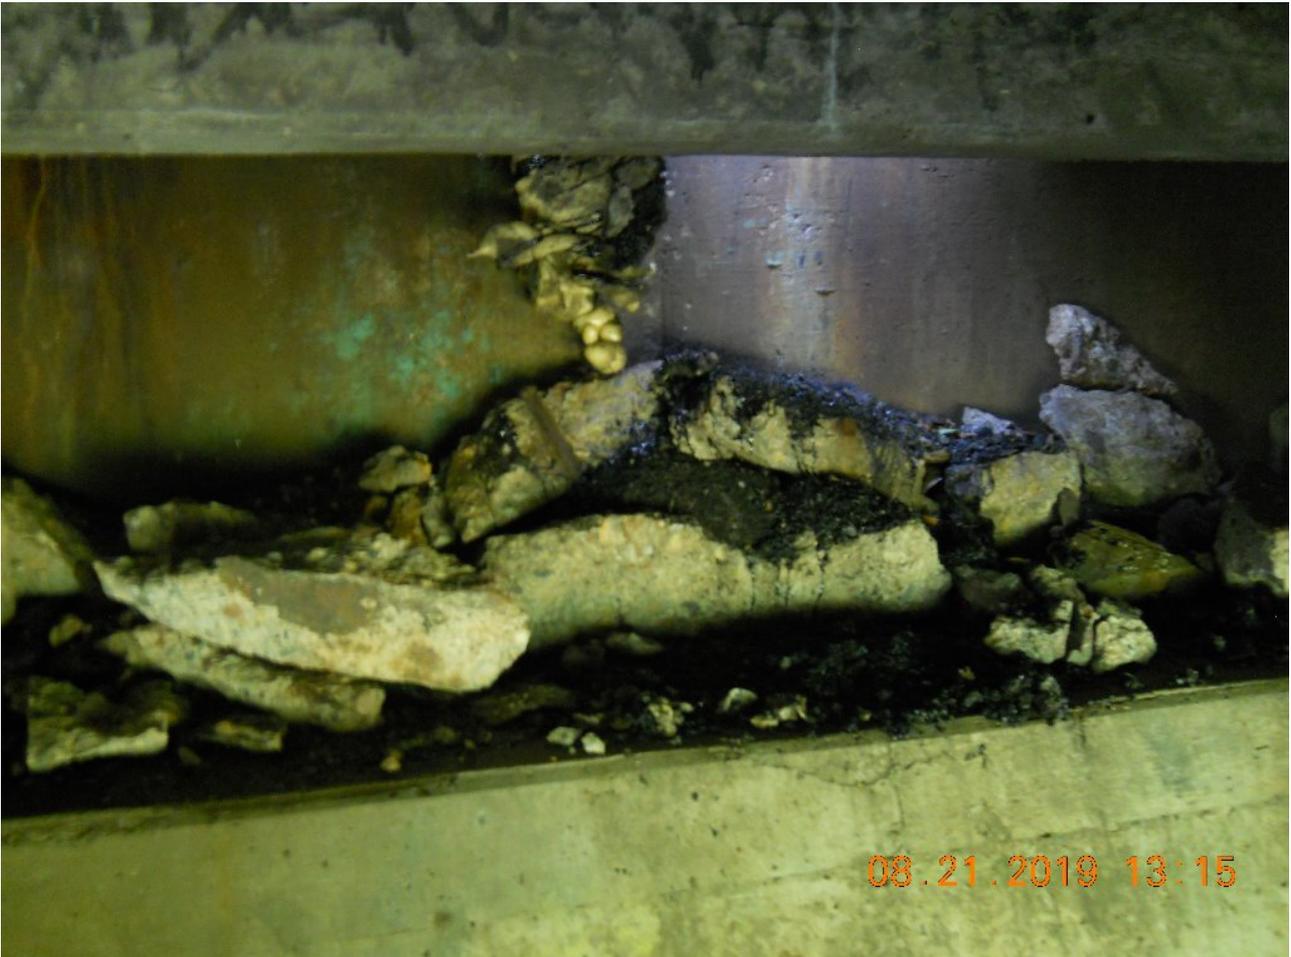
Concrete under steel expansion plates that has spalled off, and is now sitting on abutment.

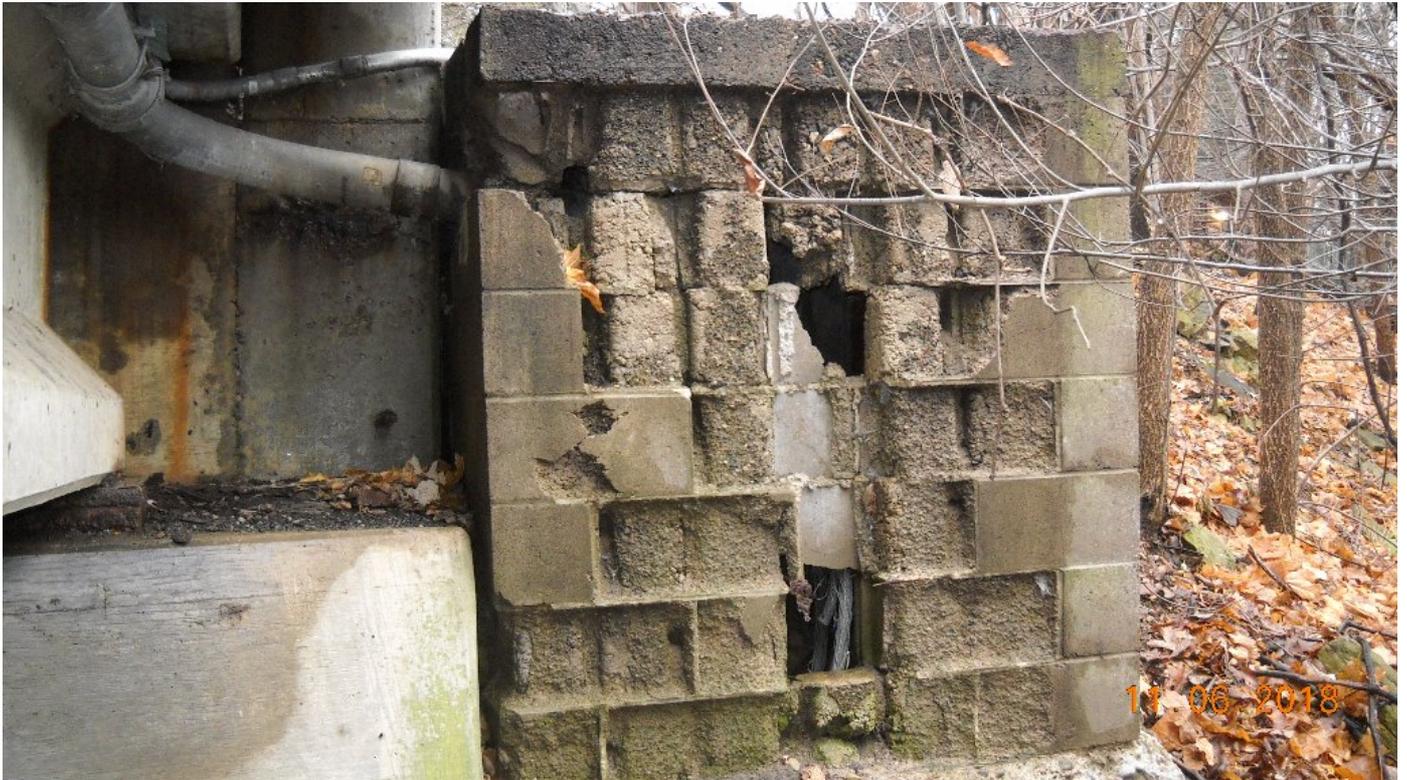
Service box deterioration. Northwest end of structure.

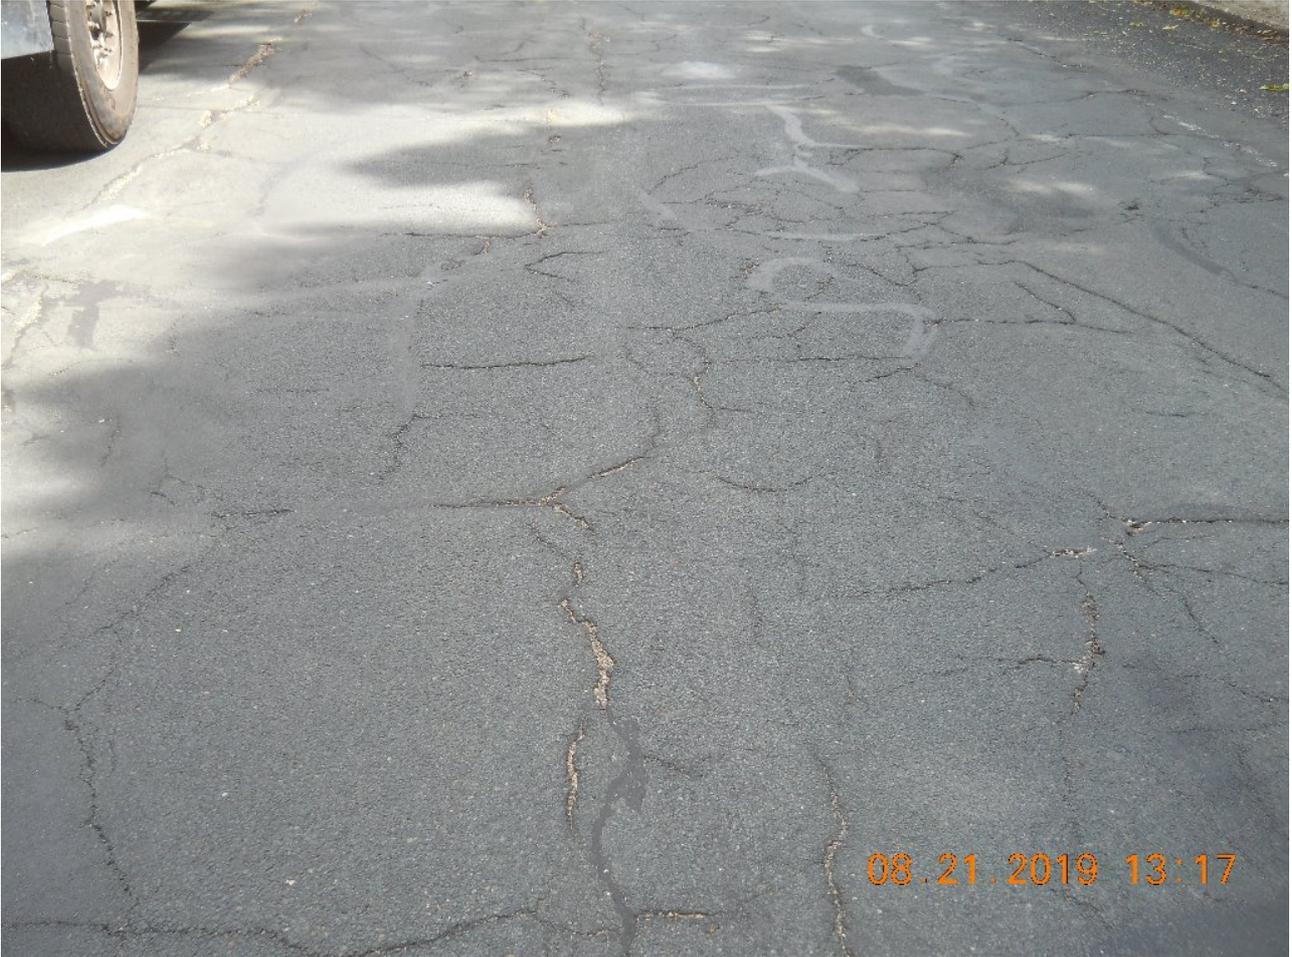
Showing cracking of pavement over membrane throughout

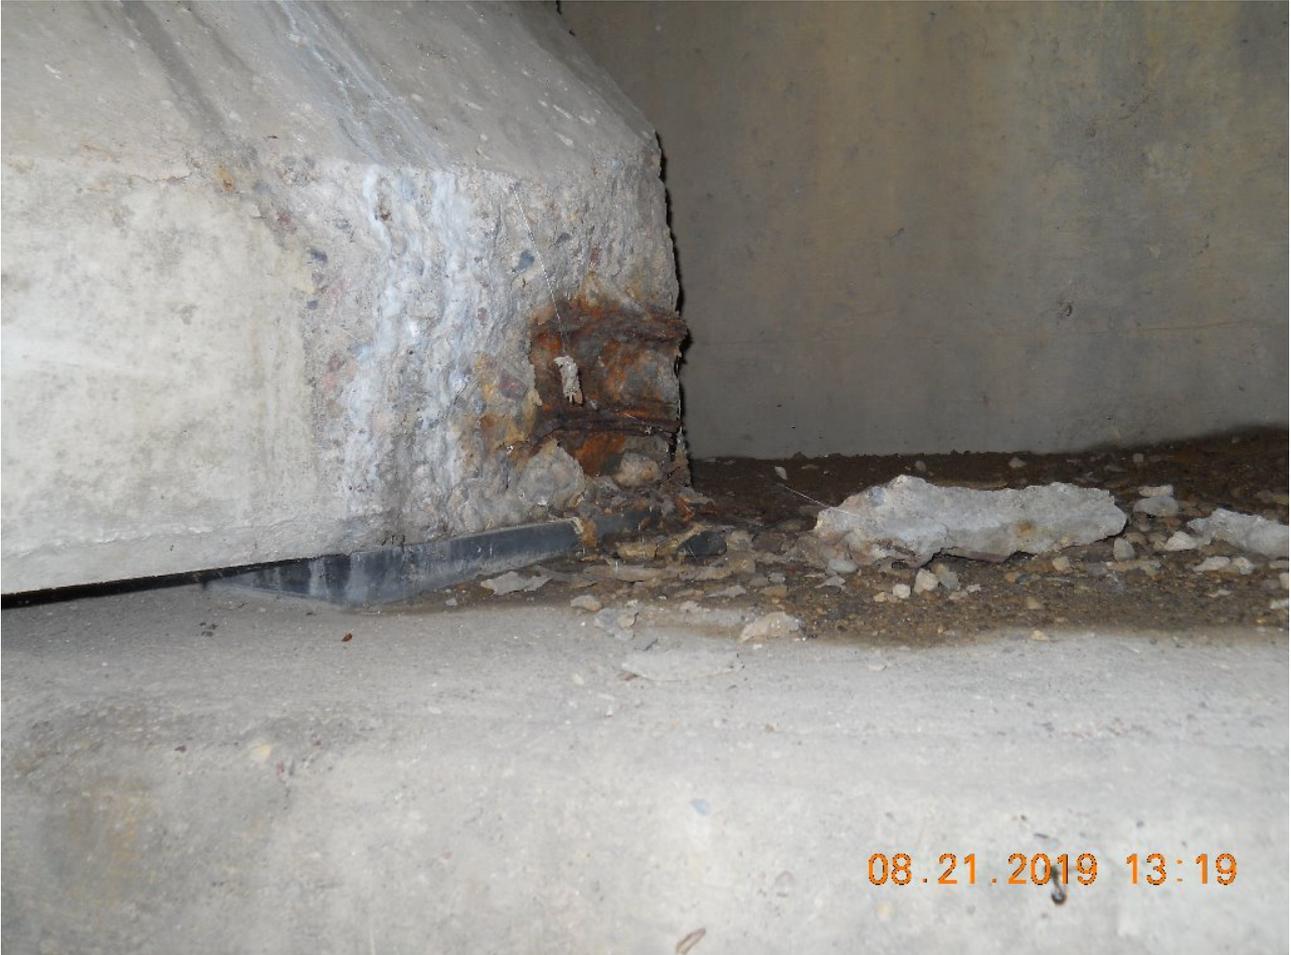
Typical spalling at abutments on girder ends.

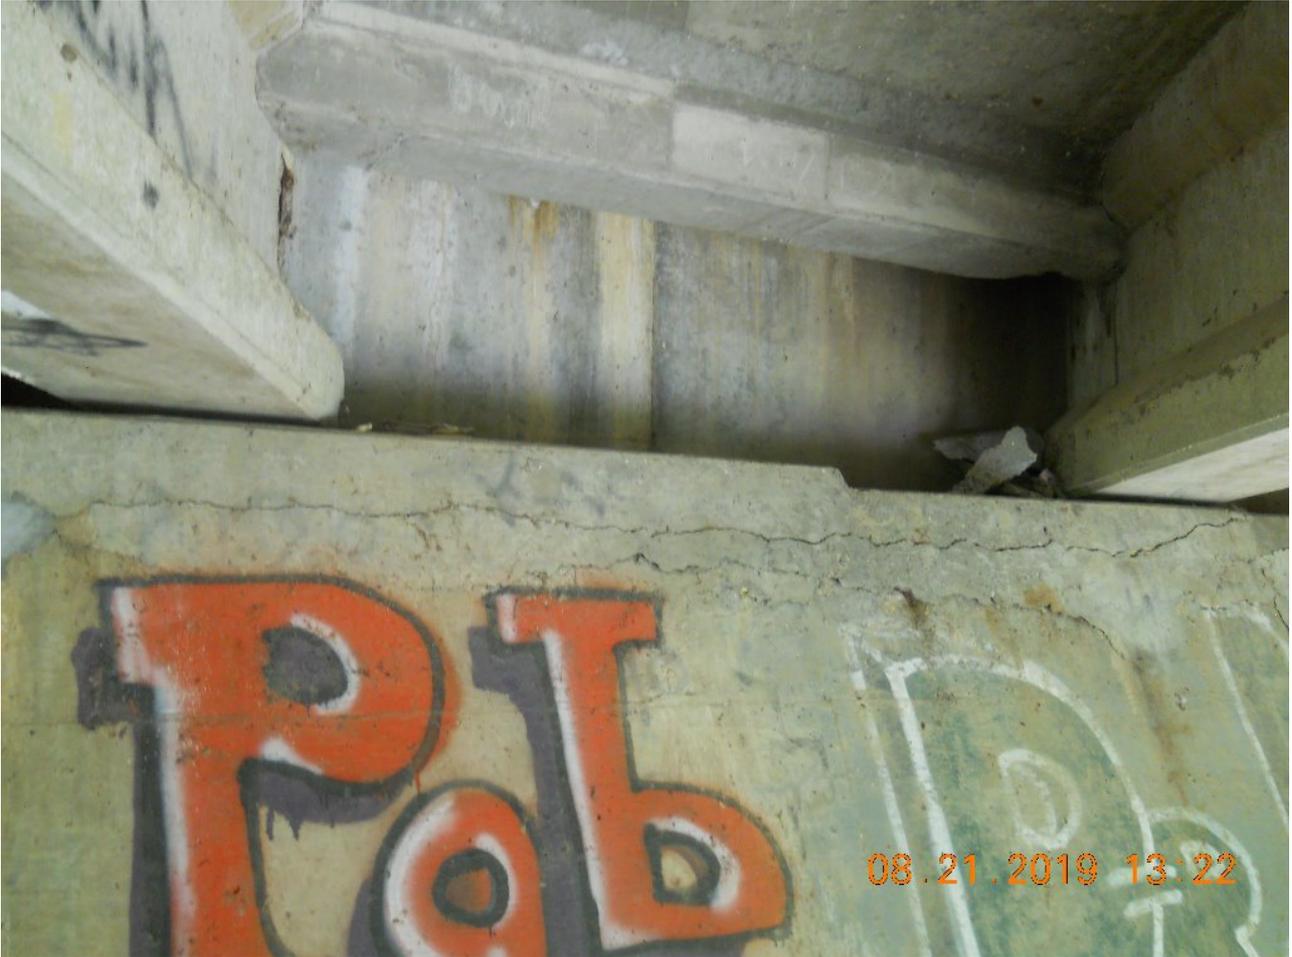
Moderate cracking.

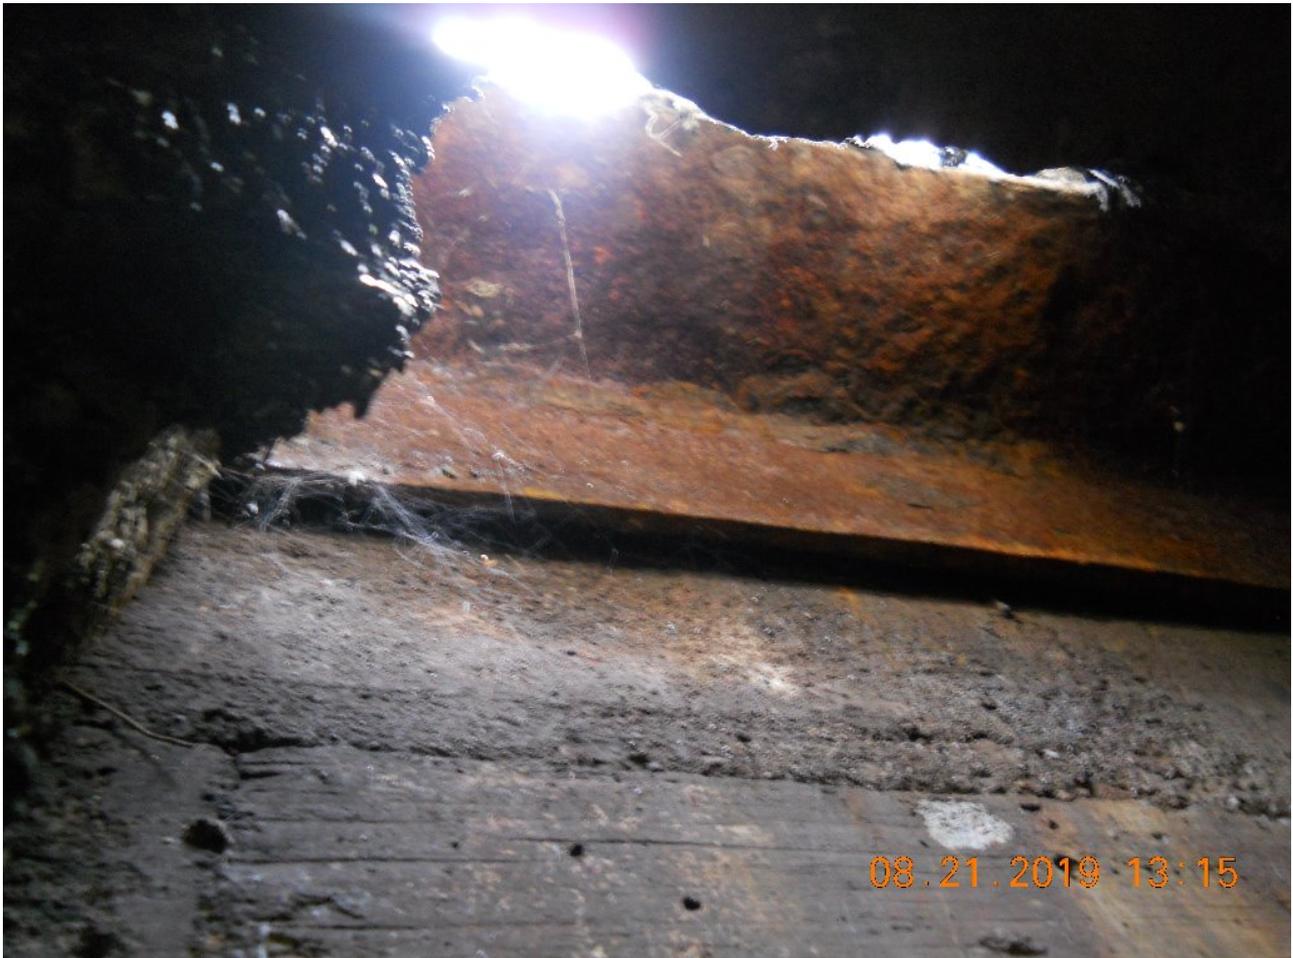
Concrete under steel expansion plates that has spalled off and left a gap at the joint, photo taken from underside of deck.

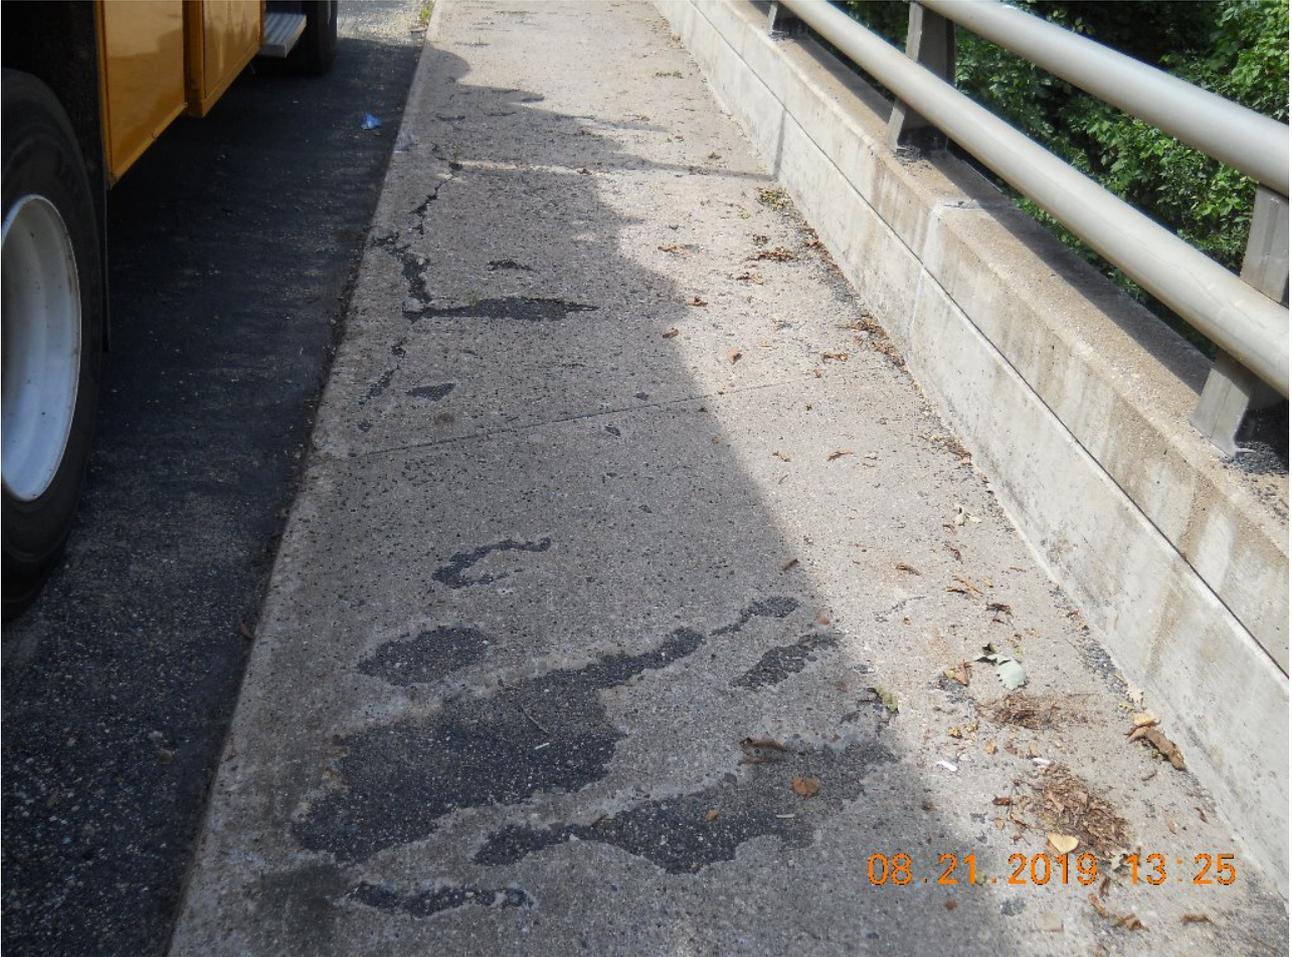
Sidewalk cracking and popouts throughout

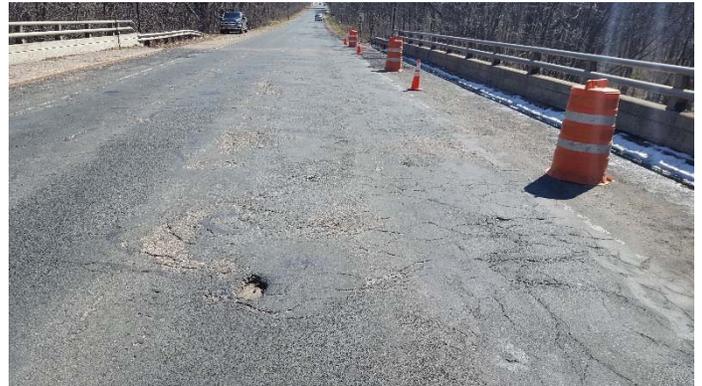
- The asphaltic deck surface is in satisfactory to poor condition. There is a pothole in the center span and the surface is rough and cracking.
- The hole in the east span of the deck appears to be in the location of a previous patch. The previous patch looks like it was done by placing a roadway sign over a hole and then covering it with asphalt.

Looking East at Deck & Pothole in Overlay

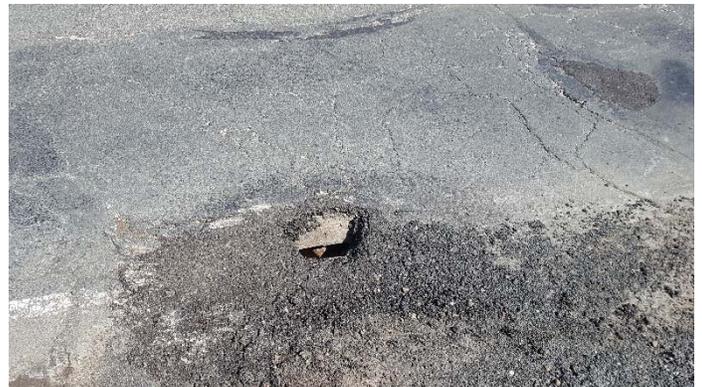
Looking at Hole in Deck

The hole in the deck should be temporarily repaired with a steel plate as described above. The hole should be frequently monitored to make sure there are no issues with the patch.

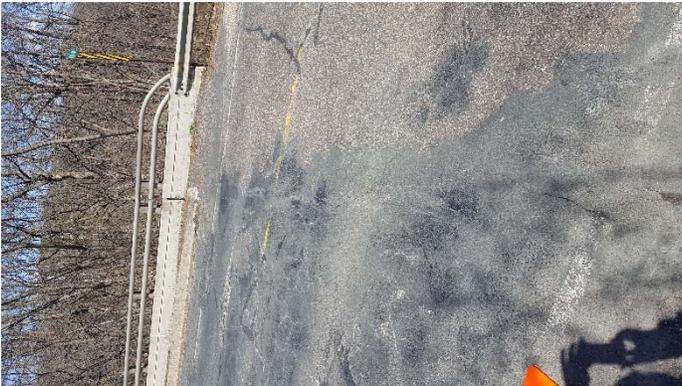
- The exposed steel in the bottom of the deck is showing significant section loss.
- Both joints in the deck at the abutments have failed and are leaking excessively. The deck and abutment backwalls are deteriorating at the joints.

Looking at East Abutment Joint

The existing deck and abutment joints would be replaced. The new deck would match the existing width of the structure. The new abutment joints would be strip seals. The railings on the bridge would also be replaced. The ends of the beams at the abutments would also be repaired. The steel bearings at the west abutment could also be replaced. The bridge would no longer require a Load posting. Future maintenance for the new deck would consist of power washing the new strip seal joints every spring and fall to remove sand and debris that accumulates in the recess. After about 30 years, the bridge would require a concrete overlay. The estimated life of the structure with this alternative is 50 years providing that maintenance is done. The estimated cost is approximately \$750,000.

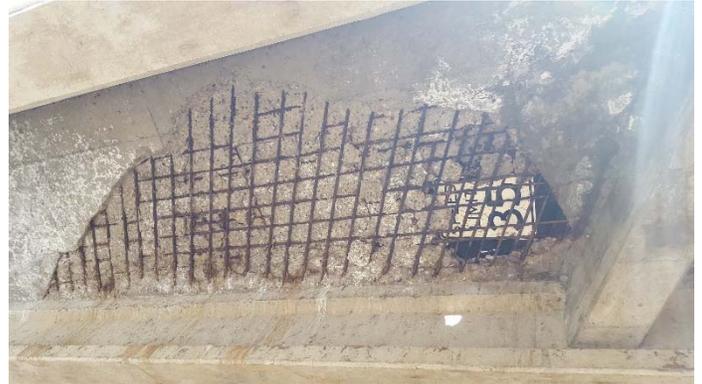
Bottom of Deck at Hole in Deck

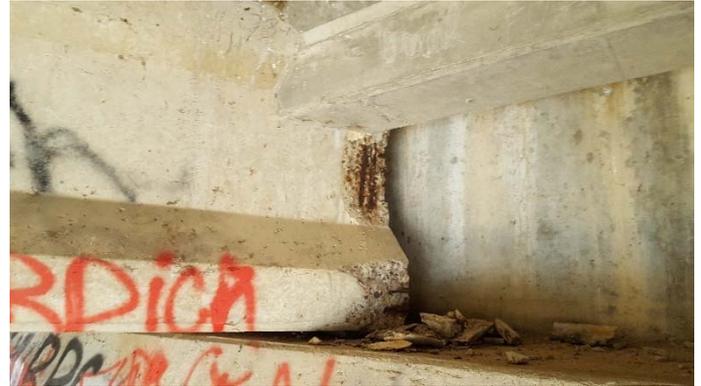
- The ends of the prestressed concrete beams are deteriorating at both abutments.
- The east end of the south exterior beam in the east span has been repaired in the past.

Typical Beam End at East Abutment

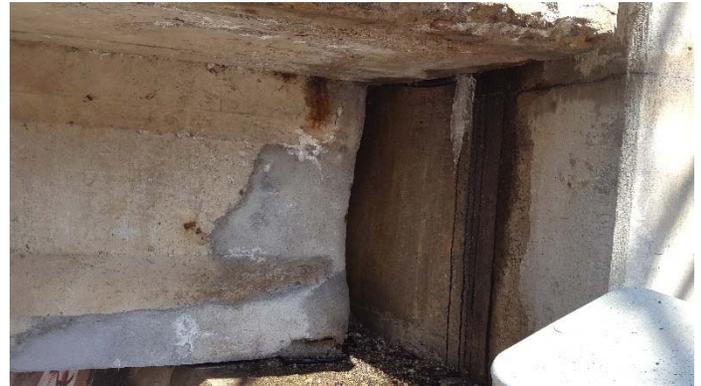
Typical Joint Deterioration at East Abutment

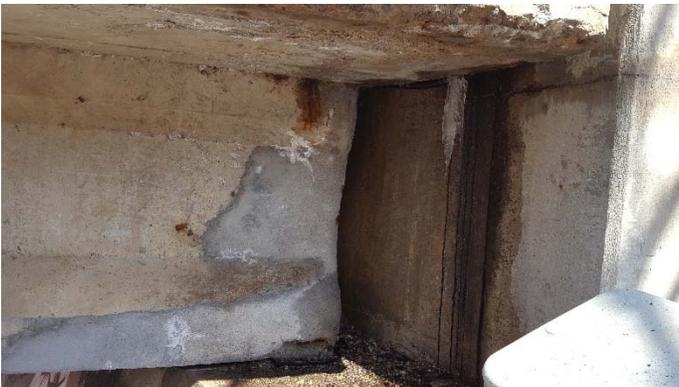
Previous Beam Repair in Southeast Corner

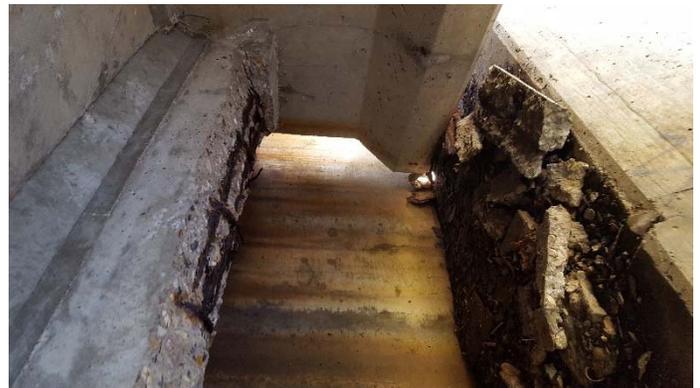
Joint Deterioration Southwest End of West Abutment

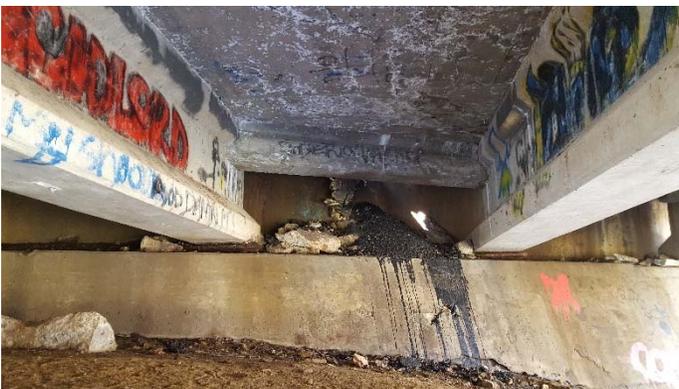
- There is a significant hole developing over the west abutment joint on the north side of the deck.
- Most of the east span is in poor condition. There are large areas of the bottom of the deck that are ready to fall off, which is a safety issue.

Bottom of Hole at West Abutment Joint

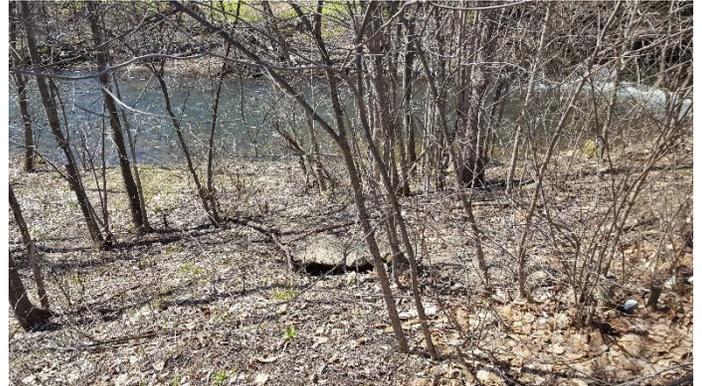
Bank Erosion in Southeast Quadrant
