Inspection Report

**River Falls Hydroelectric Project
FERC Project No. P-10489**

**Junction Falls Dam
River Falls, Wisconsin**

December 2009

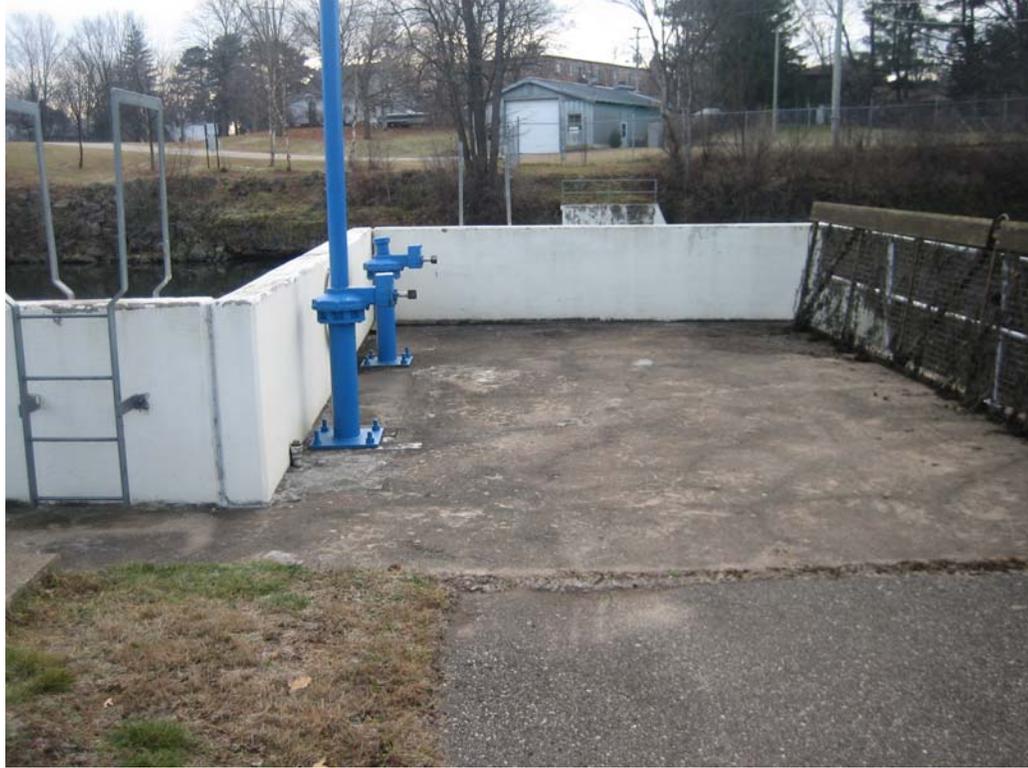
1. Upstream parapet wall and operating deck

The brush and trees growing around the headworks should be removed within one year to facilitate inspection and to eliminate potential seepage paths and concrete damage due to the root systems

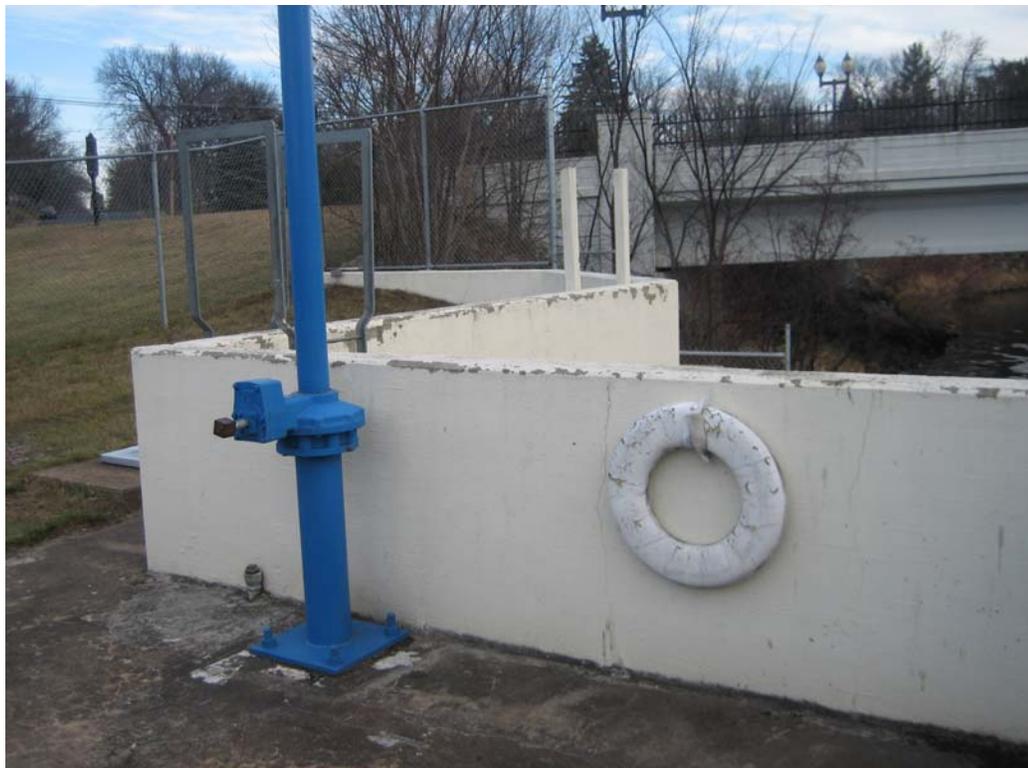
The parapet walls are in good condition with minor cracking (Photos 4, 7 and 8). The paint system has failed in many areas.

4. Typical upstream parapet wall cracking

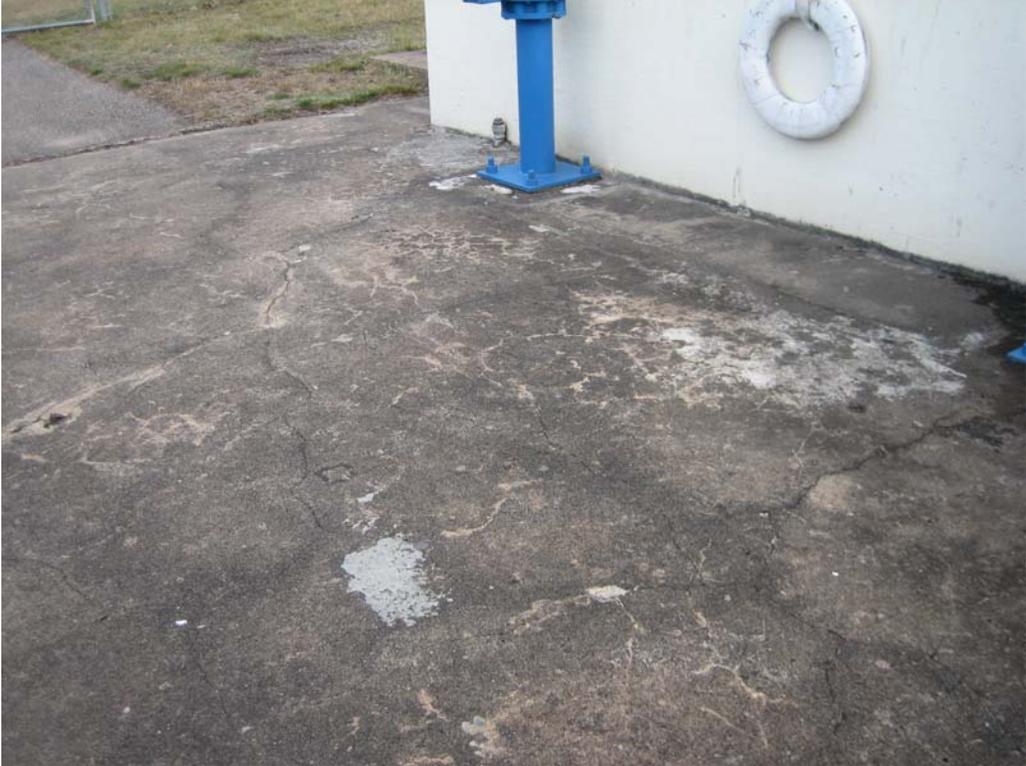
The operating deck is in fair condition with cracking and deterioration (Photo 5).

5. Typical deck cracking

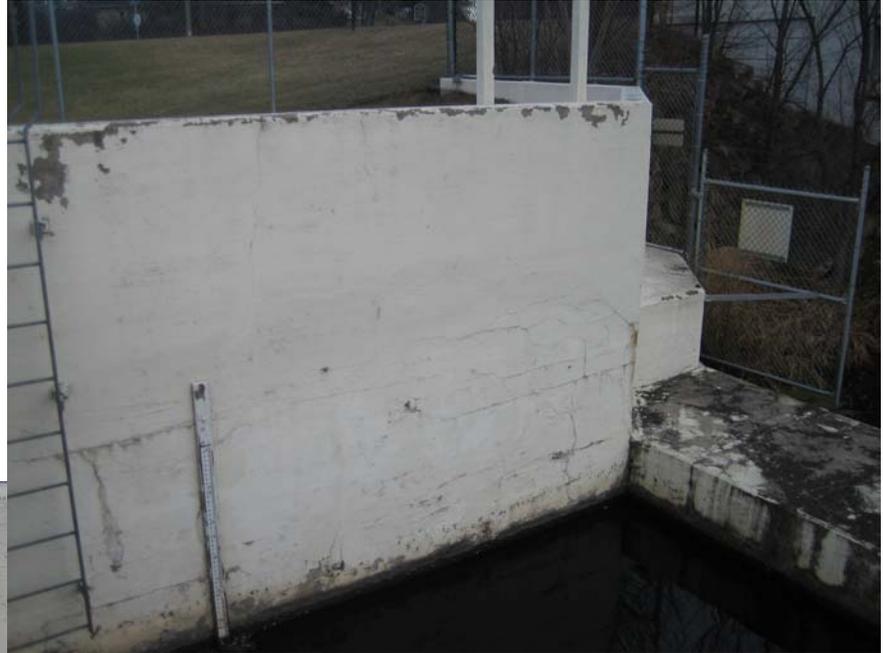
7. Upstream wall cracking

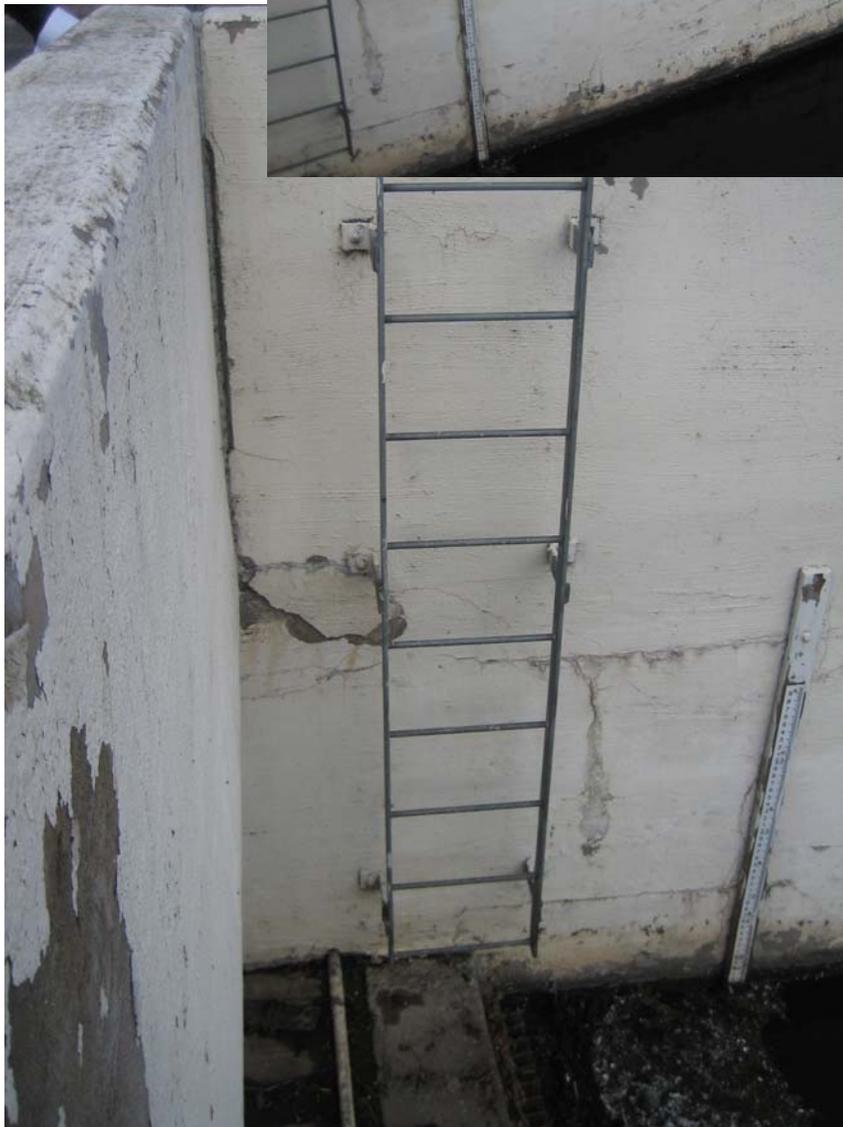
8. Previous spall repair and headwater gauge

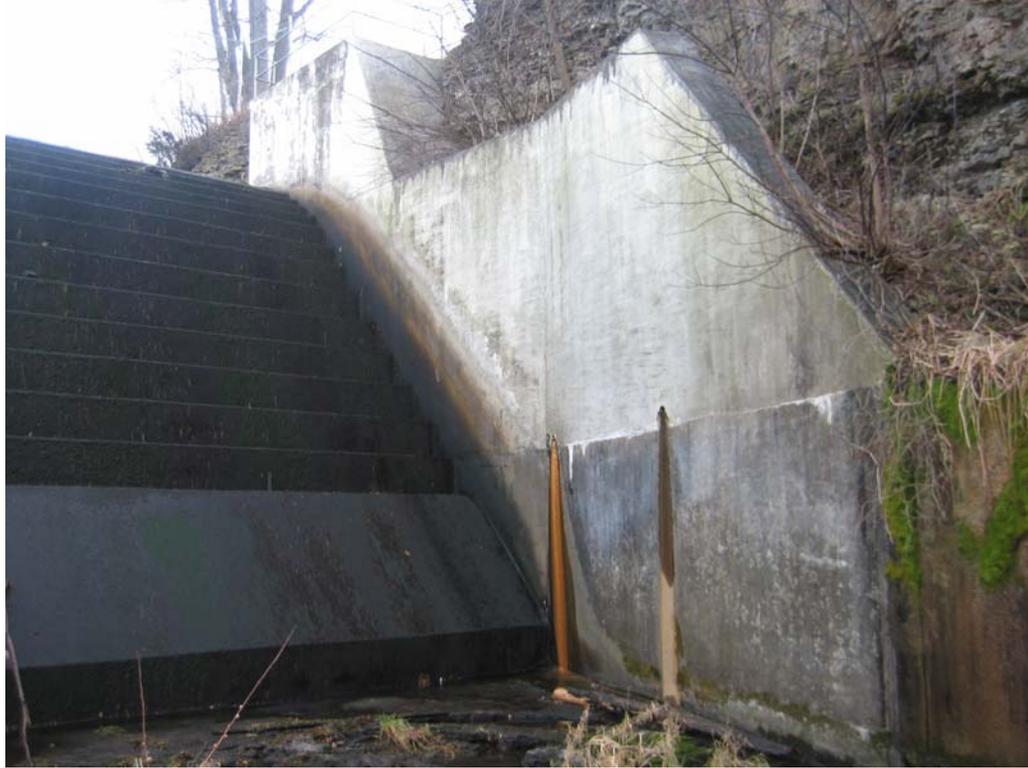
The left abutment is in good condition. The downstream retaining wall is in good condition with minor cracking and efflorescence (Photos 11 and 12). The paint system has failed in many areas. All the weep holes were functioning at the time of the inspection. There is moss growth (Photo 12) on the downstream retaining wall due to seepage through the rock face and vegetation build up on the top of the wall.

There is heavy vegetation growth behind the left abutment and downstream retaining wall (Photos 11 and 12).

11. Spillway, left abutment and left downstream retaining wall

The brush and trees growing around the left abutment and downstream retaining wall should be removed within one year to facilitate inspection and to eliminate potential seepage paths and concrete damage due to the root systems.

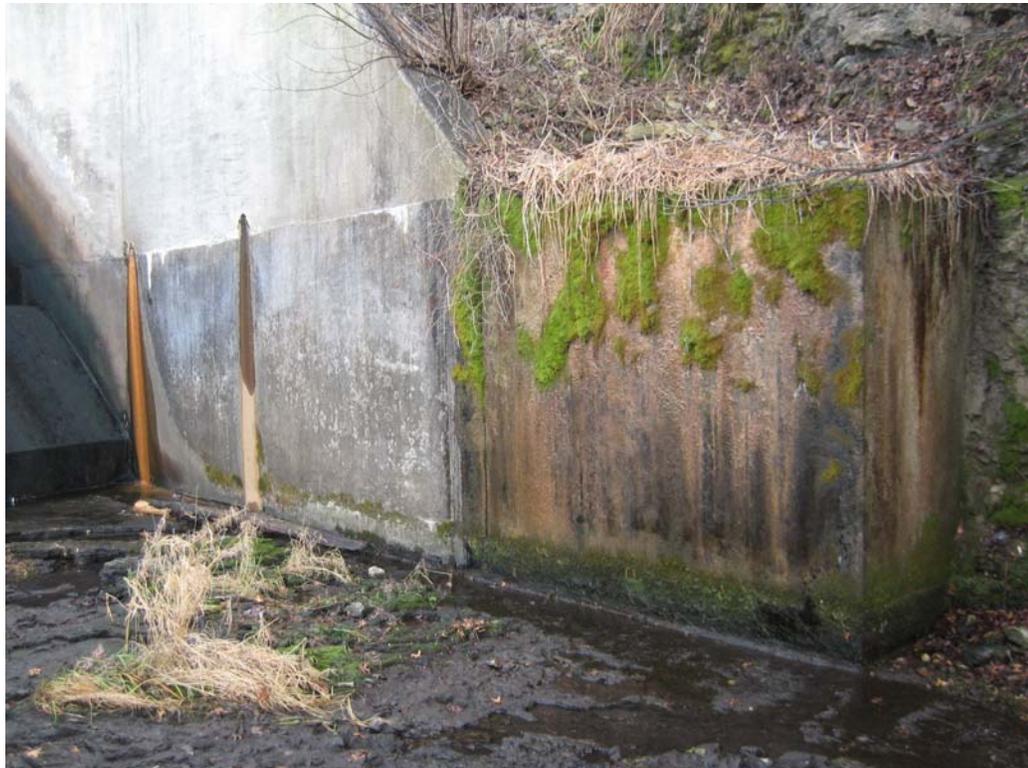
12. Left downstream retaining wall

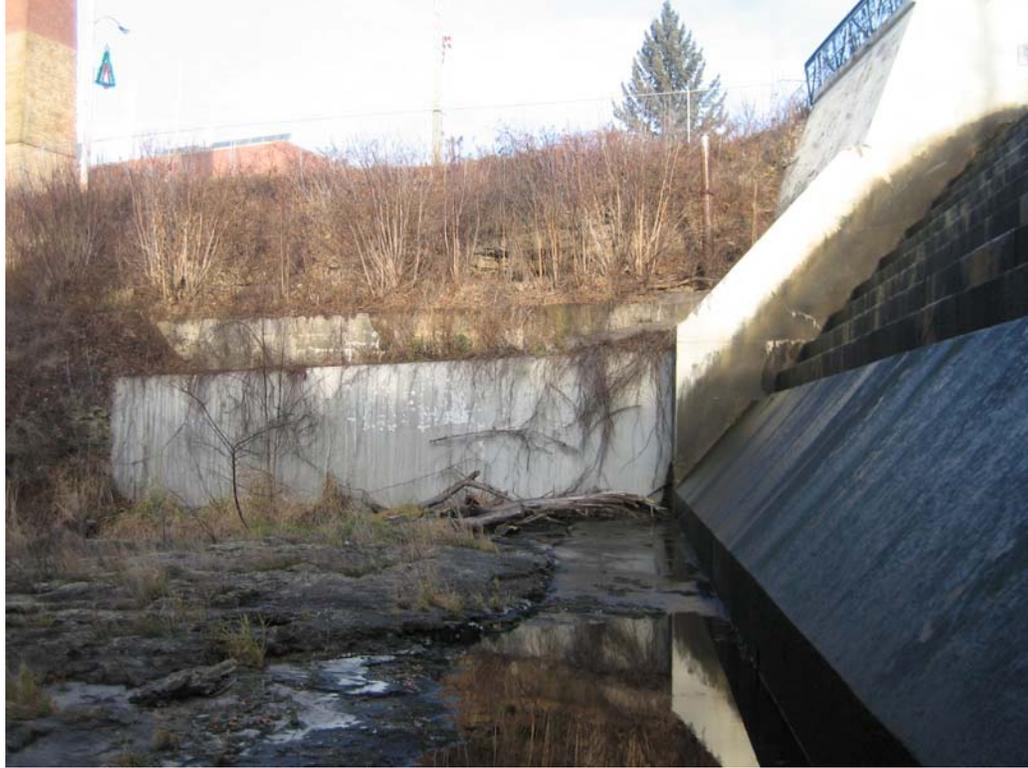
The right abutment is in fair condition with cracking and efflorescence (Photos 13 and 14). The paint system has failed in many areas.

The downstream retaining wall is in good condition. There is heavy vegetation growth in front of and behind the downstream retaining wall (Photo 13).

There is heavy vegetation growth on the right downstream bank (Photos 13 and 15).

13. Right downstream retaining wall and right spillway abutment

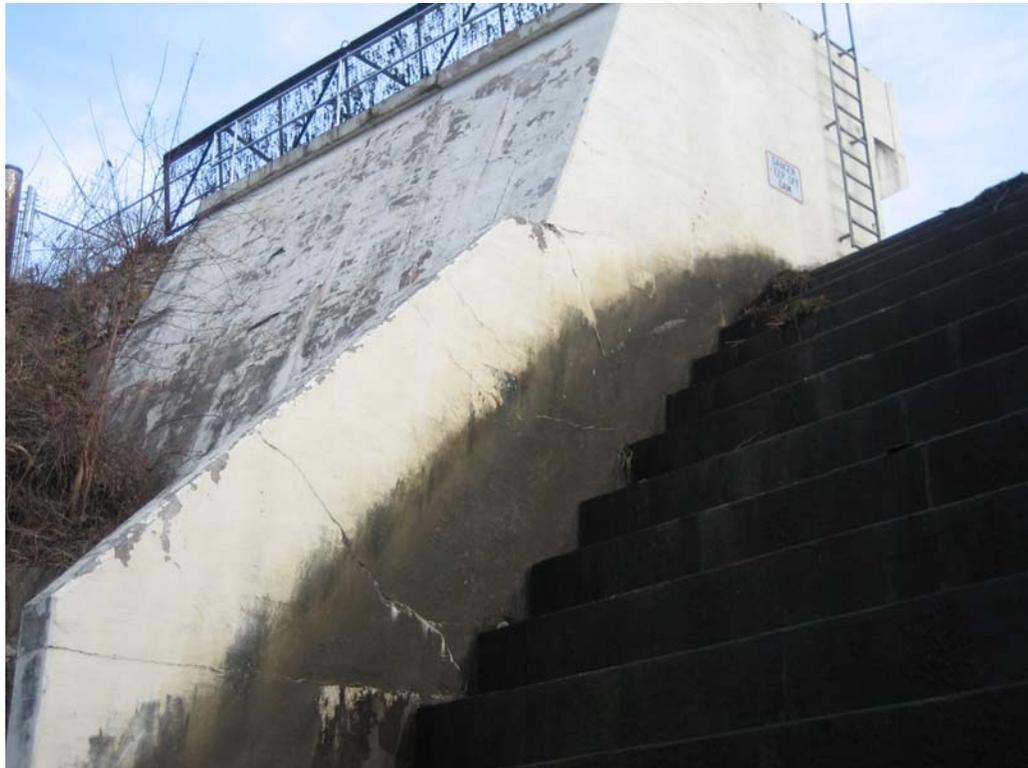
14. Cracking in right spillway abutment

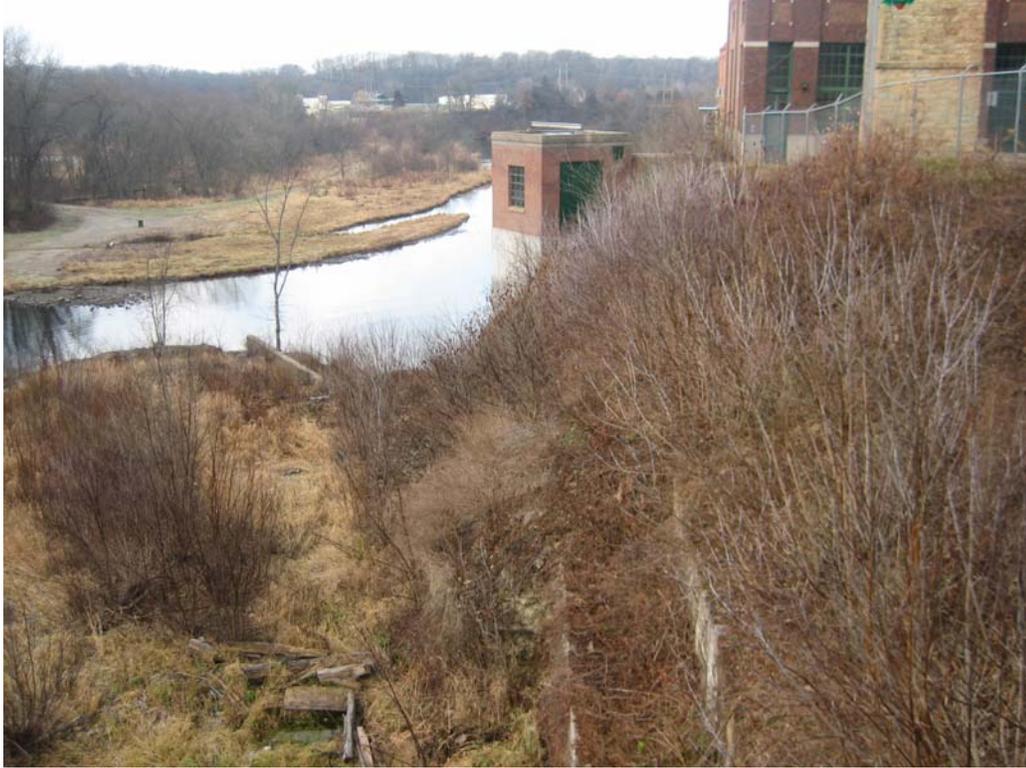
There is heavy vegetation growth around the powerhouse (Photos 15, 18 and 19).

15. Right bank looking downstream

The brush and trees growing around the powerhouse should be removed within one year to facilitate inspection and to eliminate potential seepage paths and concrete damage due to the root systems.

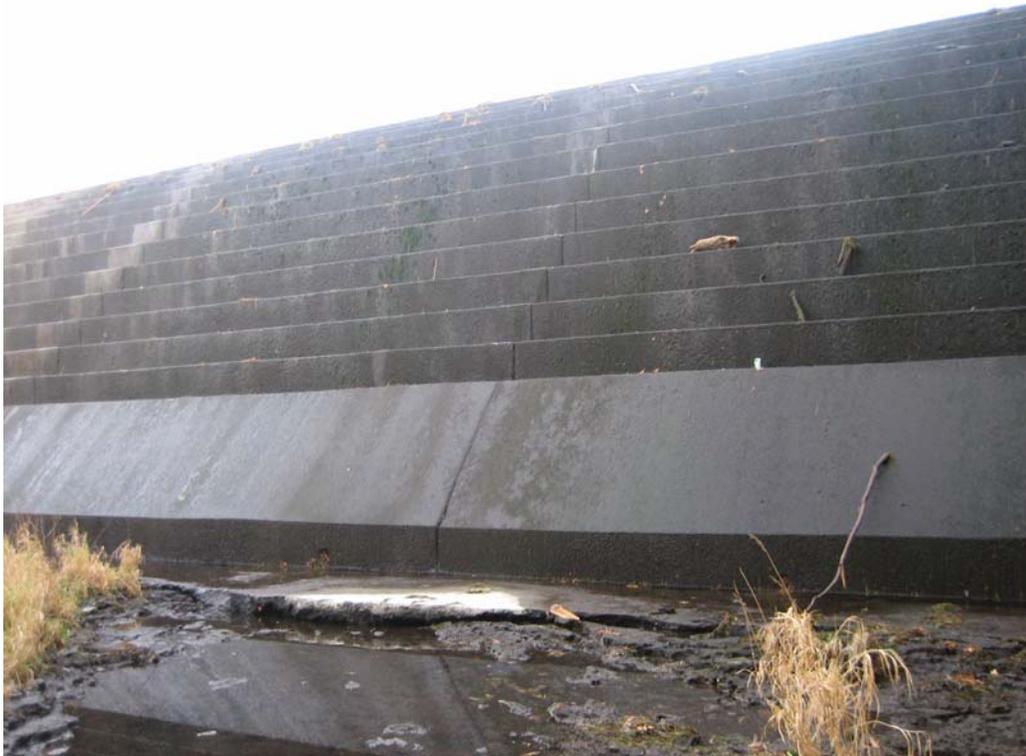
The spillway is in good condition with minor deterioration and missing caulk at the vertical joints. Moss growth limited inspection of all joints. There were no visible signs of structure undermining. Minor flow was observed from the weep holes.

16. Typical spillway and vertical joint

The missing caulk at the vertical joints should be repaired within two years.

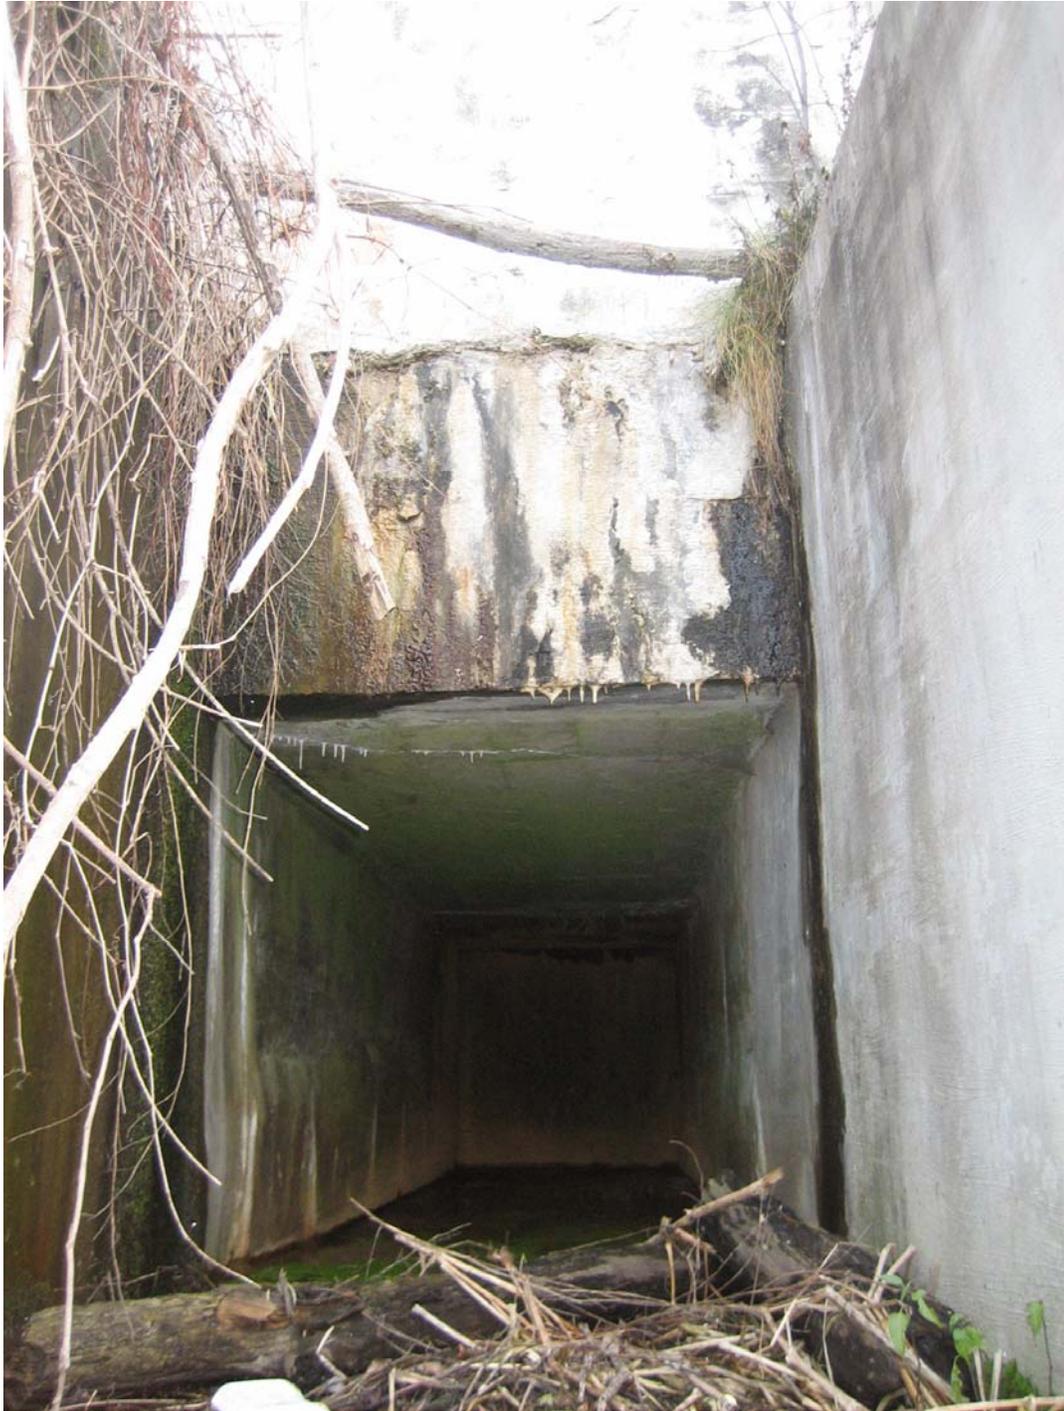
There downstream face of the headworks near the wasteway is in good condition. It appears there is seepage through a joint above the wasteway exit, however, heavy vegetation growth near the joint makes an assessment difficult. Vegetation was hanging over the right downstream retaining wall and dripping water. Seepage around the sluice gate is unknown due to the standing water on the sill that may be caused by the dripping water (Photo 17).

17. Downstream face of wasteway

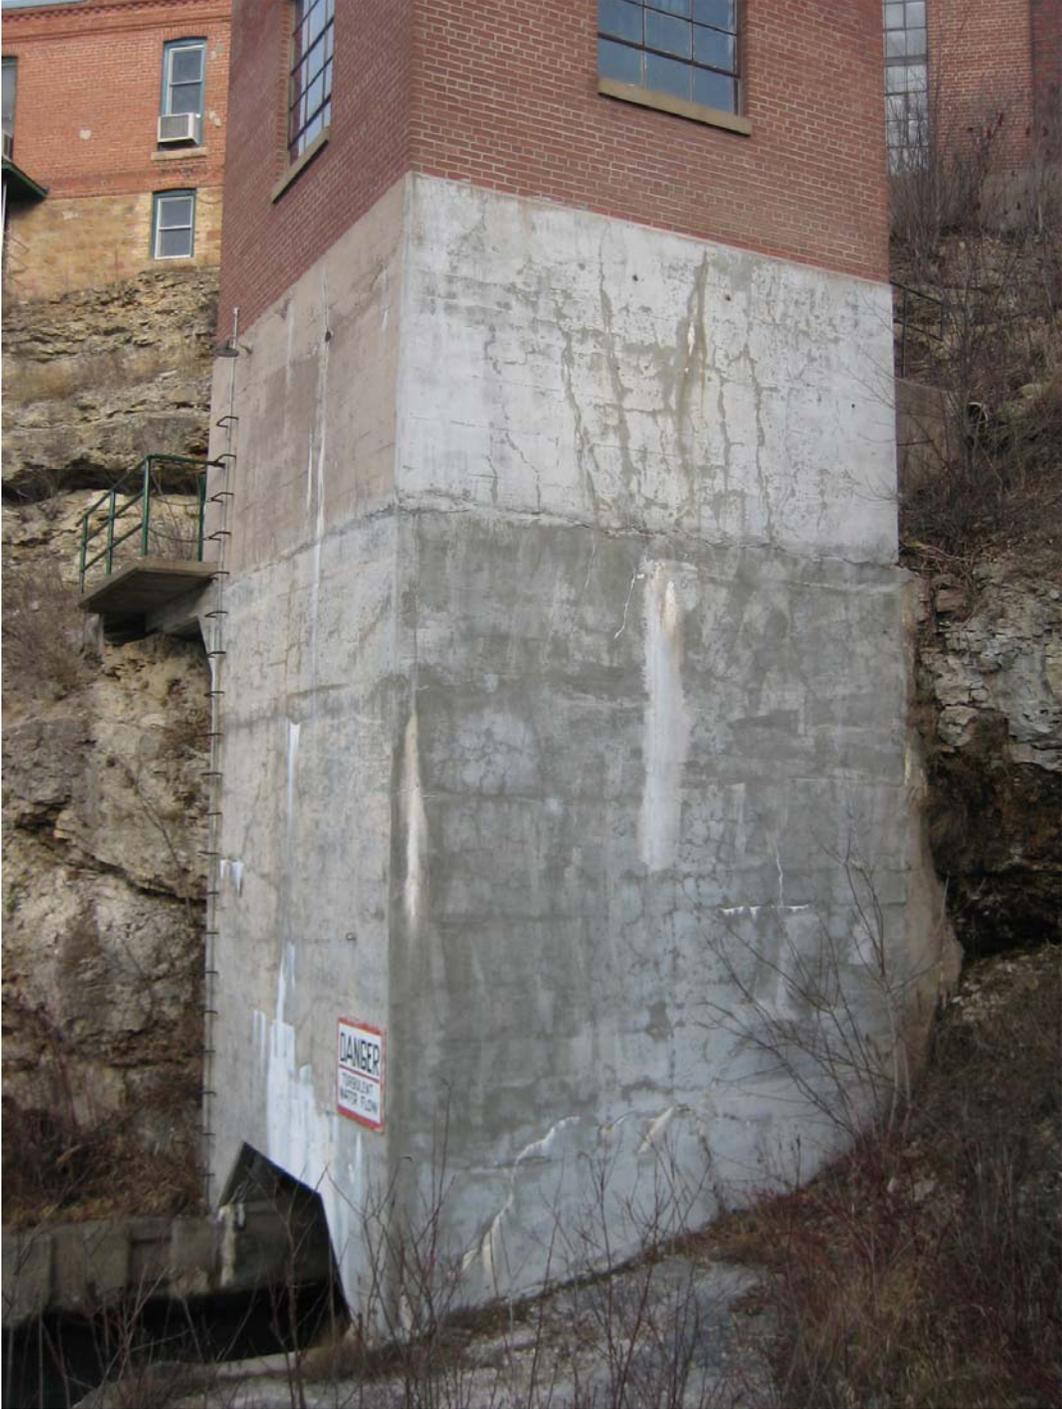
The powerhouse superstructure is generally in good condition. The concrete substructure is in fair condition with cracking, deterioration and efflorescence (Photos 18, 20 to 23). The deterioration is located near the waterline (Photos 21 to 23).

18. Powerhouse

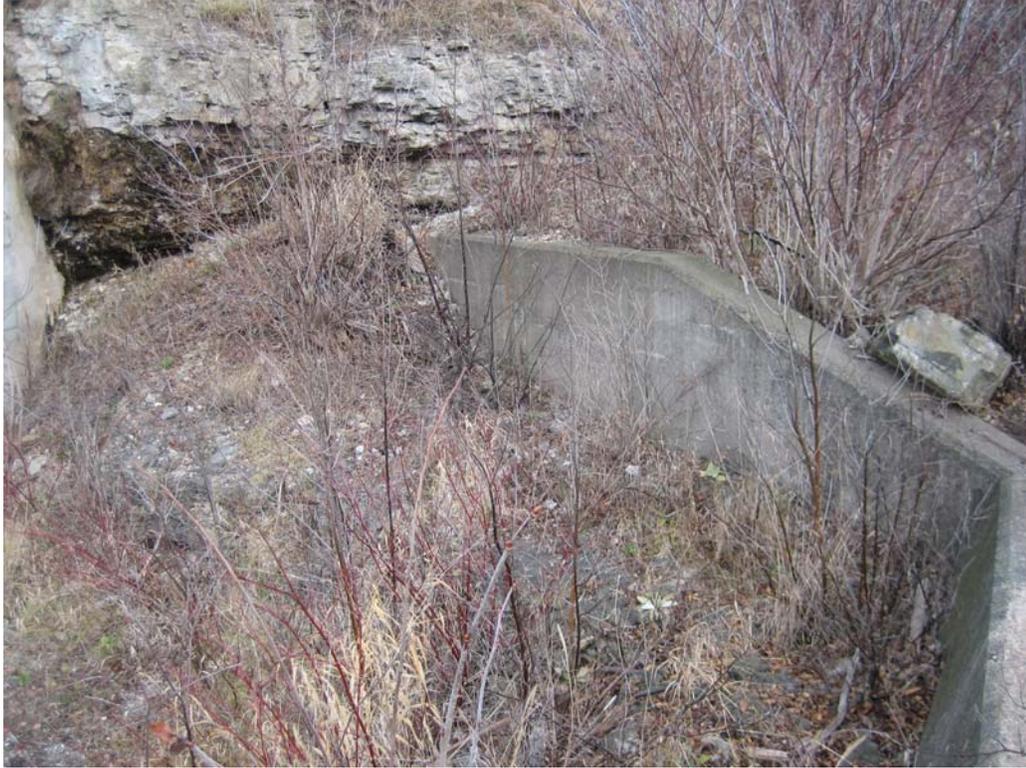
The downstream training wall is in good condition (Photo 19).

19. Downstream powerhouse training wall

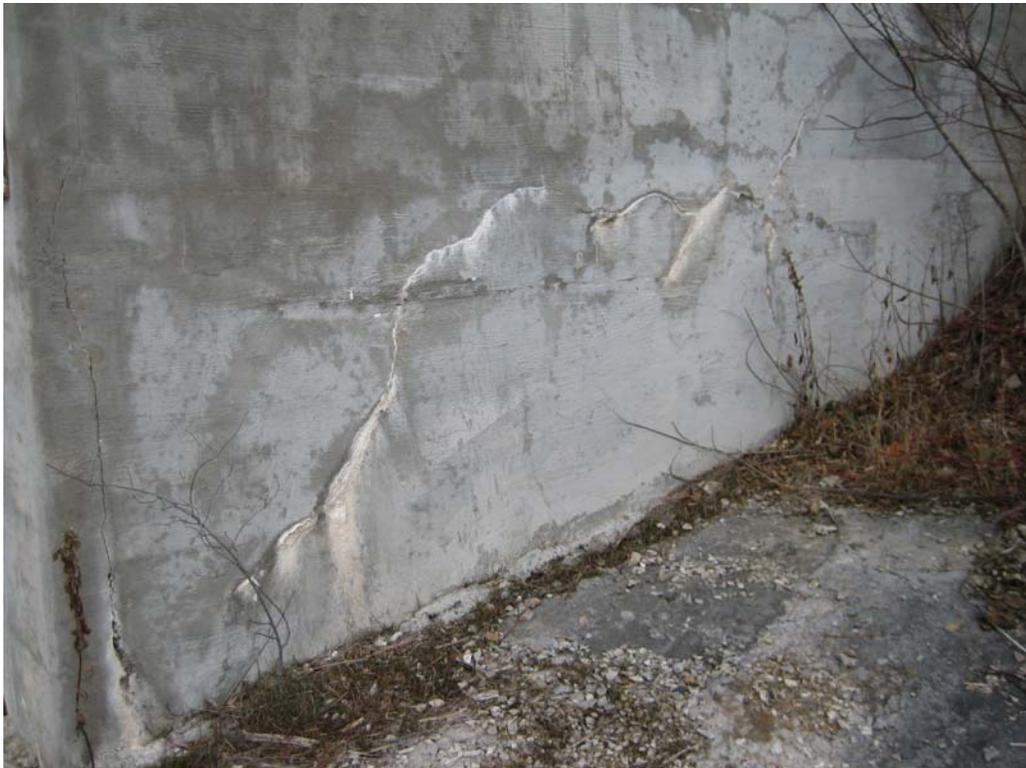
20. Crack in powerhouse wall (see photo 18)

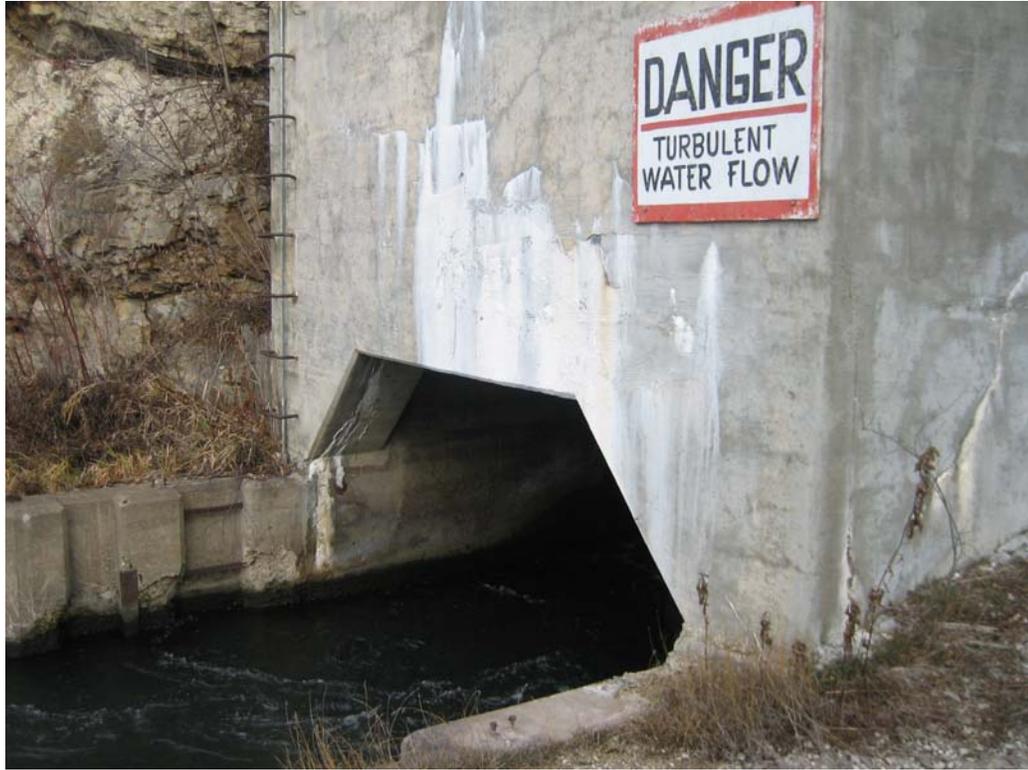
21. Tailrace

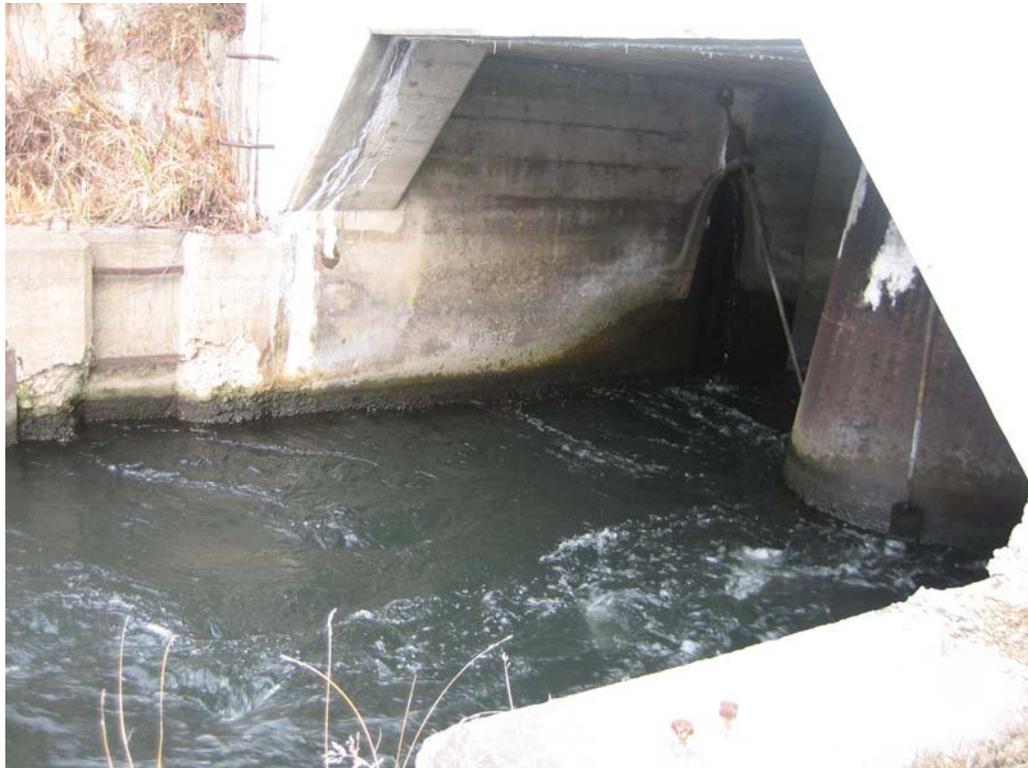
22. Tailrace interior

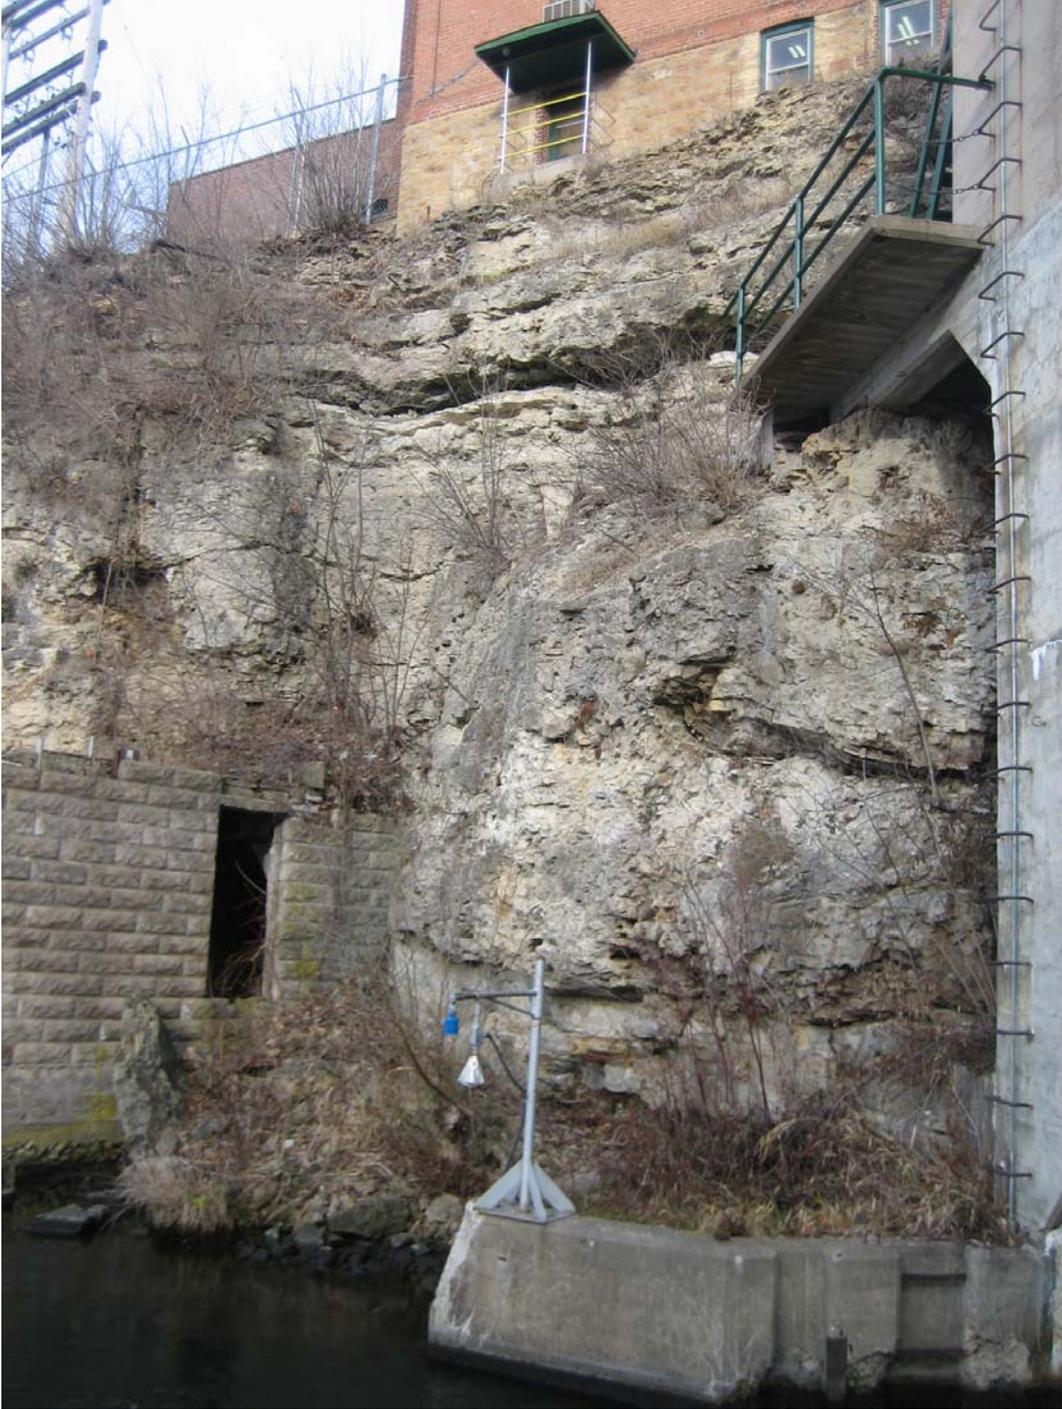
23. Tailrace and rock face
