TECHNICAL MEMORANDUM

To: Kinni Corridor Collaborative
From: Sean Morrison and Marty Melchior, Inter-Fluve
Date: December 18, 2020
Re: Drone based Drawdown Analysis

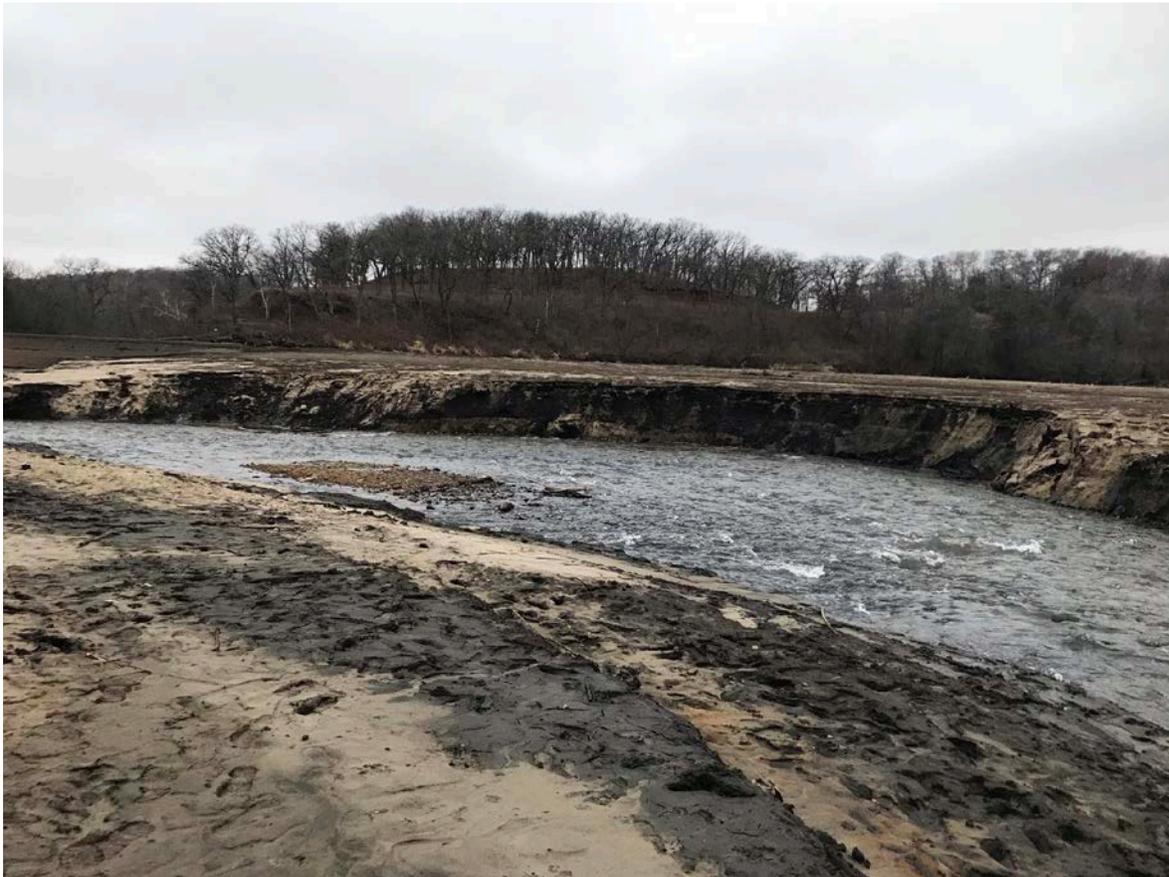
On the ground photos collected on 11/25 showed near vertical banks which were approximately 15 ft high near the dam and gravels on the channel bottom (Figure 3). Gravels on the channel bottom may indicate that the channel has reached its pre-dam elevation and initial incision of the channel is nearing completion. However, the gravels may also be unassociated with the pre-dam channel and represent a coarse layer deposited in the impoundment or a coarsening layer caused by the winnowing (removal) of fine-grained sediment. The near vertical banks are unstable and will continue to erode and calve into the channel even under relatively low flow conditions. Immediately downstream of the Powell Falls Dam, several mid-channel bars have developed following the drawdown (Figure 4). These bars are likely composed primarily of the fine-sand sized sediment eroded during the drawdown as the new channel was excavated. Finer grained sediment was transported further downstream as suggested by the increased turbidity during the drawdown. The deposition immediately downstream of the dam is temporary and larger floods are expected to transport the sediment further downstream and may lead to the burial of gravel riffle substrates, which are the most abundant and beneficial habitats located downstream of the Powell Falls dam (Inter-Fluve 2020a).

Figure 3: Photo of the channel collected on 11/25.

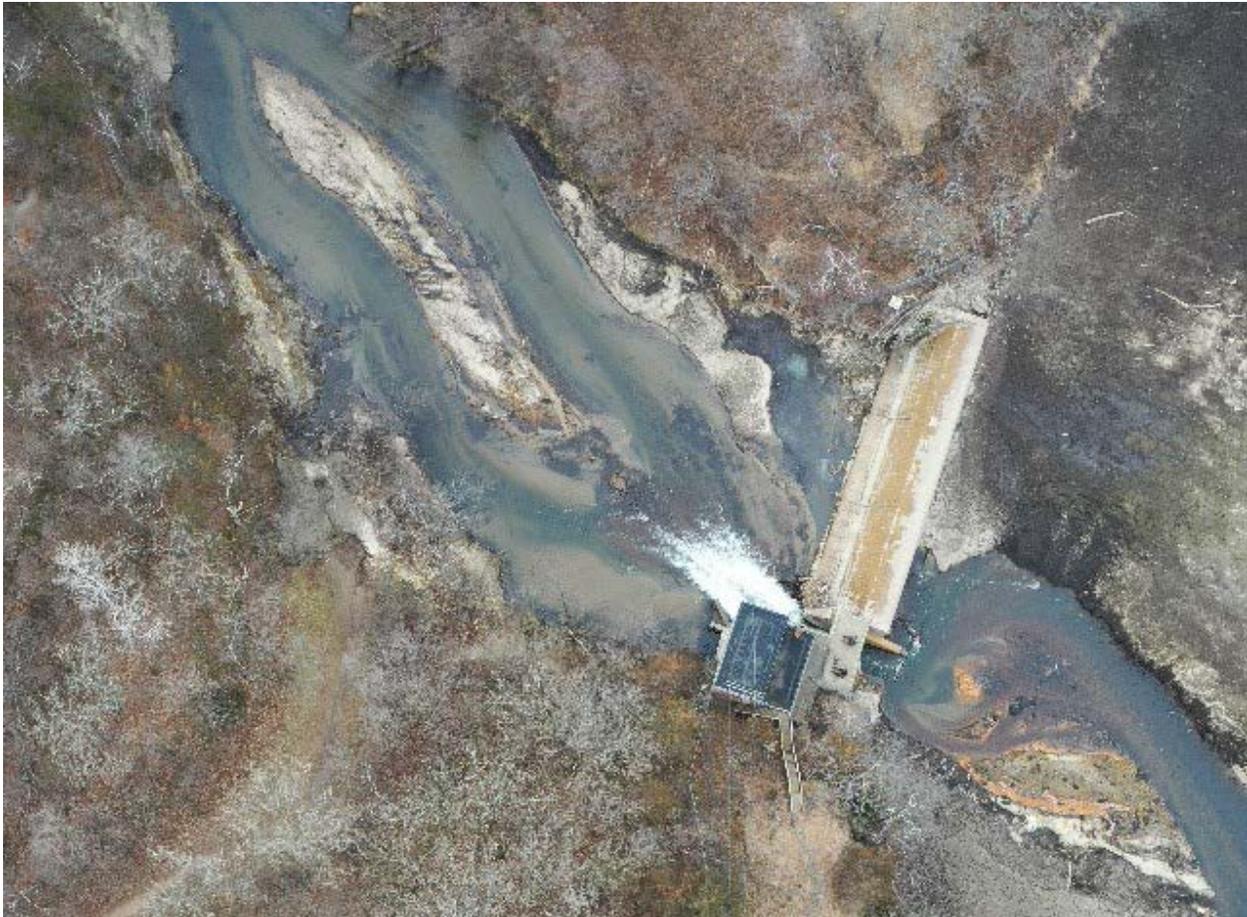
Figure 4: Drone image collected on 12/11 above the Powell Falls dam showing bar development immediately downstream.
