**RE: River Falls Hydroelectric Project, FERC Project No. 10489  
Updated Study Report**

Attachment: Updated Study Report for the River Falls Hydroelectric Project (P-10489)

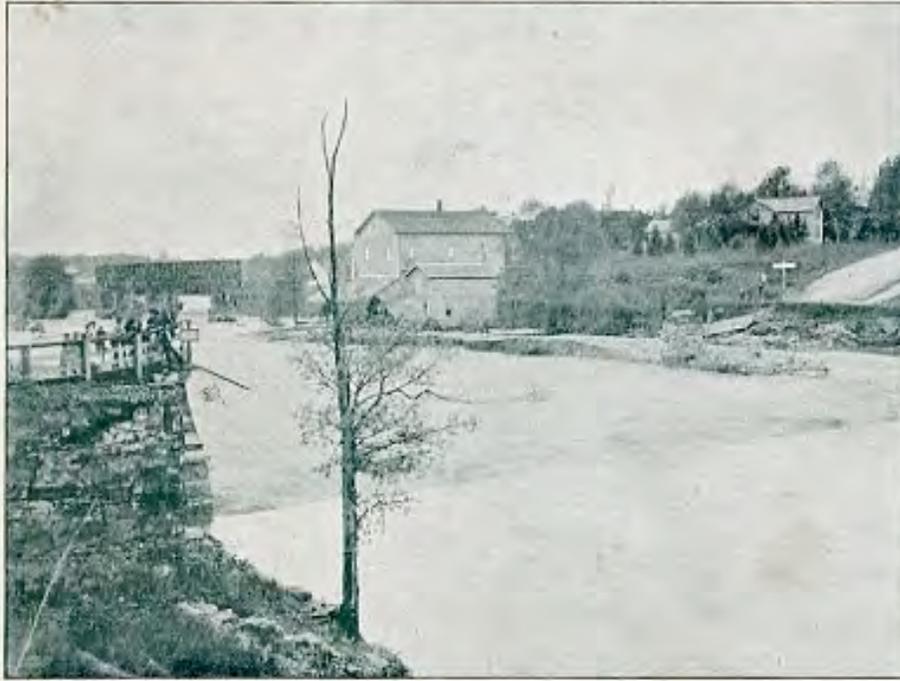
The Flood of 1894,  
Site of Maple St. Bridge  
River Falls, Wis.

Figure 2-3. Photograph of the Former Site of the Maple Street Bridge during the 1894 Flood, (Reference 22)

Figure 2-4 show photos taken of the 1894 and 1934 floods, respectively, that were available on the website for the University Archives and Area Research Center, (Reference 22).

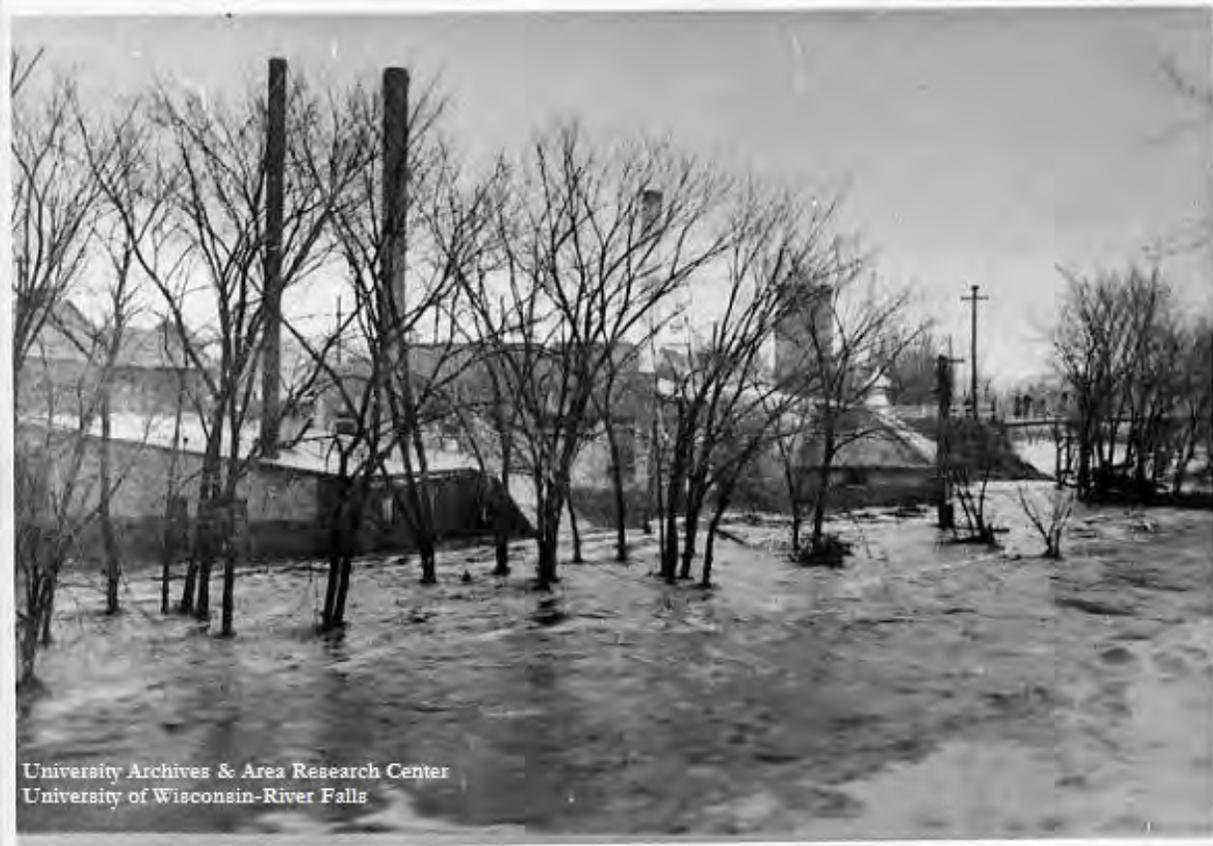
Figure 2-4. Photograph of an Unknown Location in Downtown River Falls during the 1934 Flood, (Reference 22)

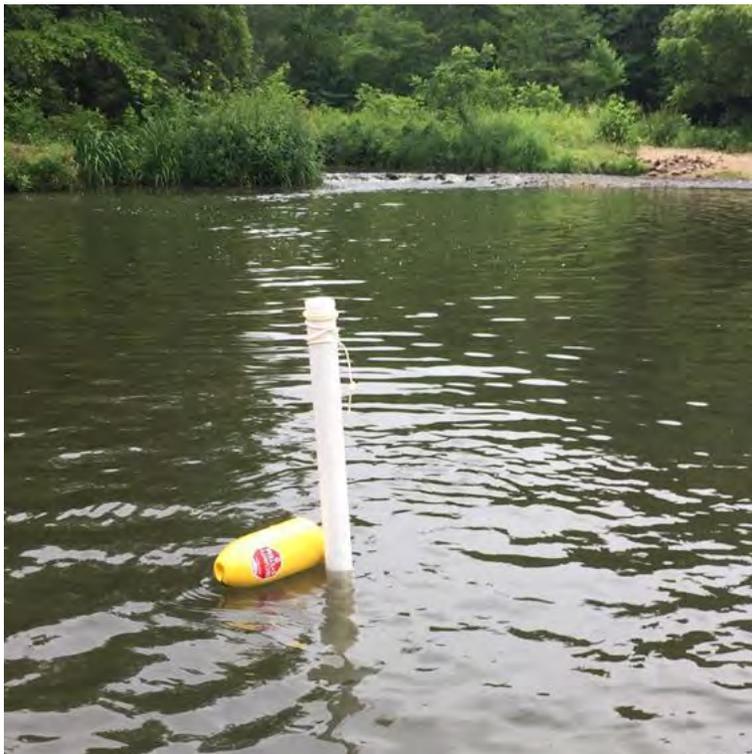
Each sensor was attached to a slotted PVC pipe, anchored with one or more cinder blocks, and positioned approximately in the middle of the water column. Buoys were attached to the pipes to assist in retrieving the unit should it become detached from the anchor block. Figure 2 shows a typical installation.

Figure 2: Monitor installation downstream of Junction Falls Dam

The installations shown in Figure 2 were in place throughout the 2019 season. However, over the course of the summer of 2020, the PVC pipes at all but the Lake George location were eliminated as they seemed to attract public interference. The sensors were then attached to the cinder blocks themselves with no above-water visibility, positioned to maintain a mid-water-column vertical location.

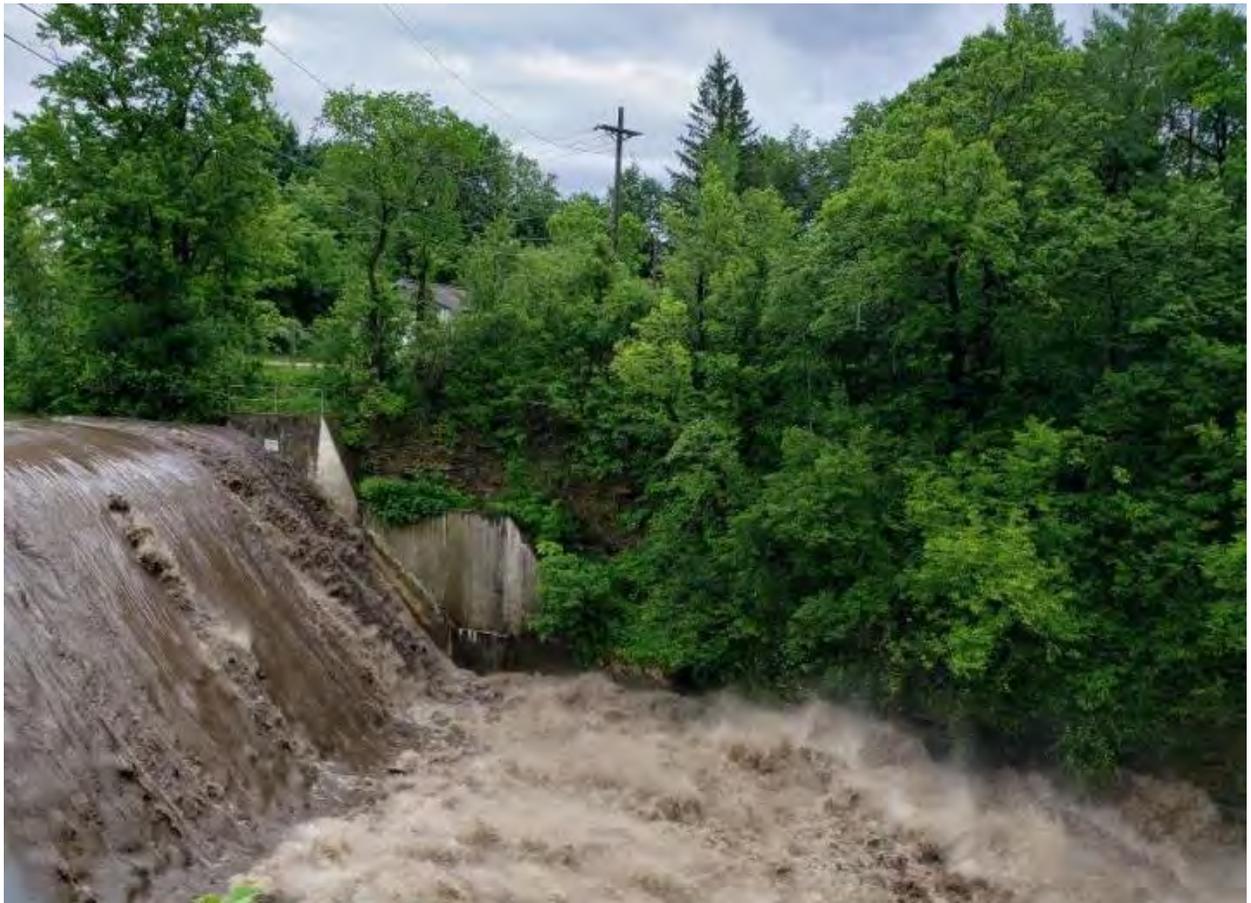
Figure 3. June 29, 2020 Flood at Junction Falls

Figure 3 shows the June 29, 2020 flood at the Junction Falls spillway (photo provided by River Falls Municipal Utilities).

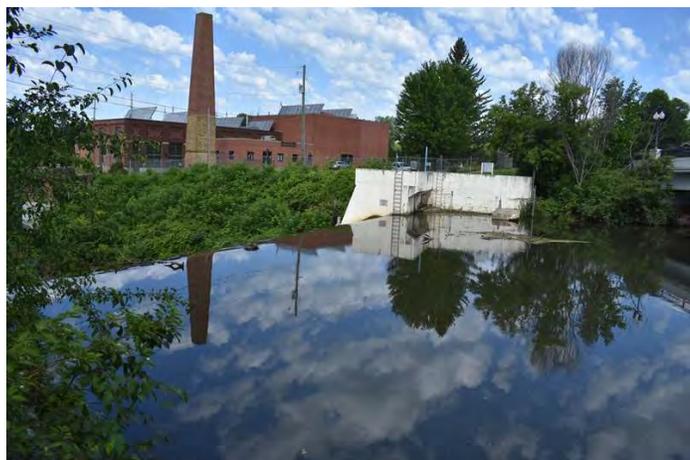
**Photograph 1. View of Junction Falls Dam and the adjoining powerhouse, facing northwest.**

Around Lake George, as well as the adjacent upper reach of the Kinnickinnic River to the north and Lake Louise to the south, public use areas including biking/walking trails, benches, and water-access infrastructure have been developed for use by residents of the City of River Falls. Paved bike trails run along both sides of Lake George. While most of the parcels around the lake are maintained as a public recreation opportunity, parcels along the upper reach of the Kinnickinnic River are owned by private individuals and contain both businesses and residences. The City of River Falls surrounds the lake, including the city's downtown to the east/northeast of the lake and neighborhoods to the west. The Junction Falls powerhouse is located immediately west of Junction Falls Dam (Photograph 1).

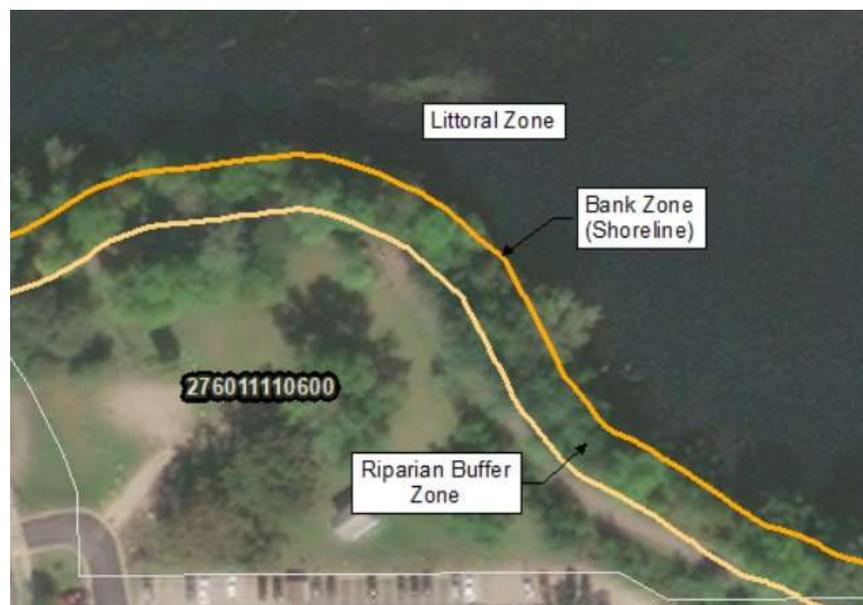
- 1) Littoral Zone: defined as the in-water area of the lake starting at the present water line and extending approximately 50 feet into the lake.
- 2) Bank Zone: the area between the top of the bank lip and the bank toe, which includes the ordinary high-water mark (OHWM).
- 3) Riparian Buffer Zone: begins at the top edge of the bank zone and extends inland 35 feet. Note that the actual riparian area or flood zone may extend further than 35 feet, but a 35-foot wide assessment area has been designated for standardization purposes (WI DNR 2020).

Figure 3. Assessment Zones for Lake George SHA

An example of these zones shown over aerial imagery for a single parcel along Lake George is provided in Figure 3.

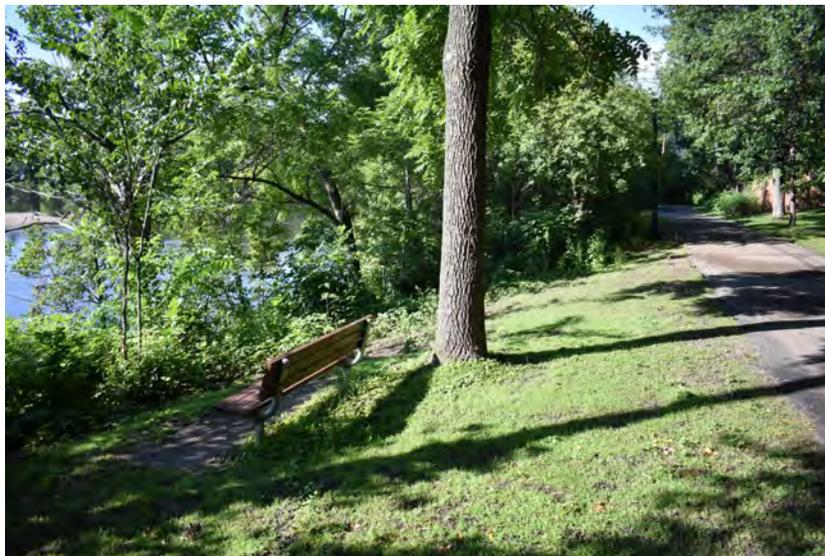
**Photograph 2. Typical forms of vegetated cover, manicured lawn, and impervious surface found in the Riparian Buffer Zone.**

Approximately one quarter of the riparian buffer zone exhibited significant disturbance or anthropogenic modifications. Typical disturbed areas include maintained lawns along Lake George intended for public use and paved trails used by bicyclists and pedestrians (Photograph 2).

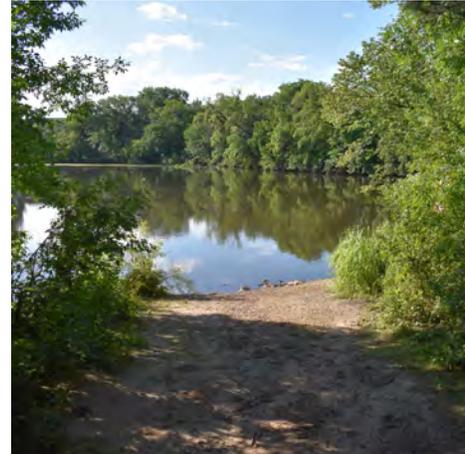
**Photograph 3. Boat ramp on west side of Lake George.**

Though primarily lacking development more extensive than trail systems, the Lake George and upper Kinnickinnic River riparian buffer zone contains sporadic structures as presented in Table 4 and Figure 9. None of the five buildings recorded in the 35-foot buffer were located along the Lake George shoreline. Rather, four buildings are located on the eastern side of the upper Kinnickinnic River, and the other building recorded was a portion of the Junction Falls Development’s powerhouse which is found downstream (south) of the dam. Additional buildings are located in the parcels assessed but are found outside (i.e., further inland) of the designated riparian buffer zone. The boat ramp located on the western shoreline of Lake George is a gravel takeout with rip rap at the base (Photograph 3).

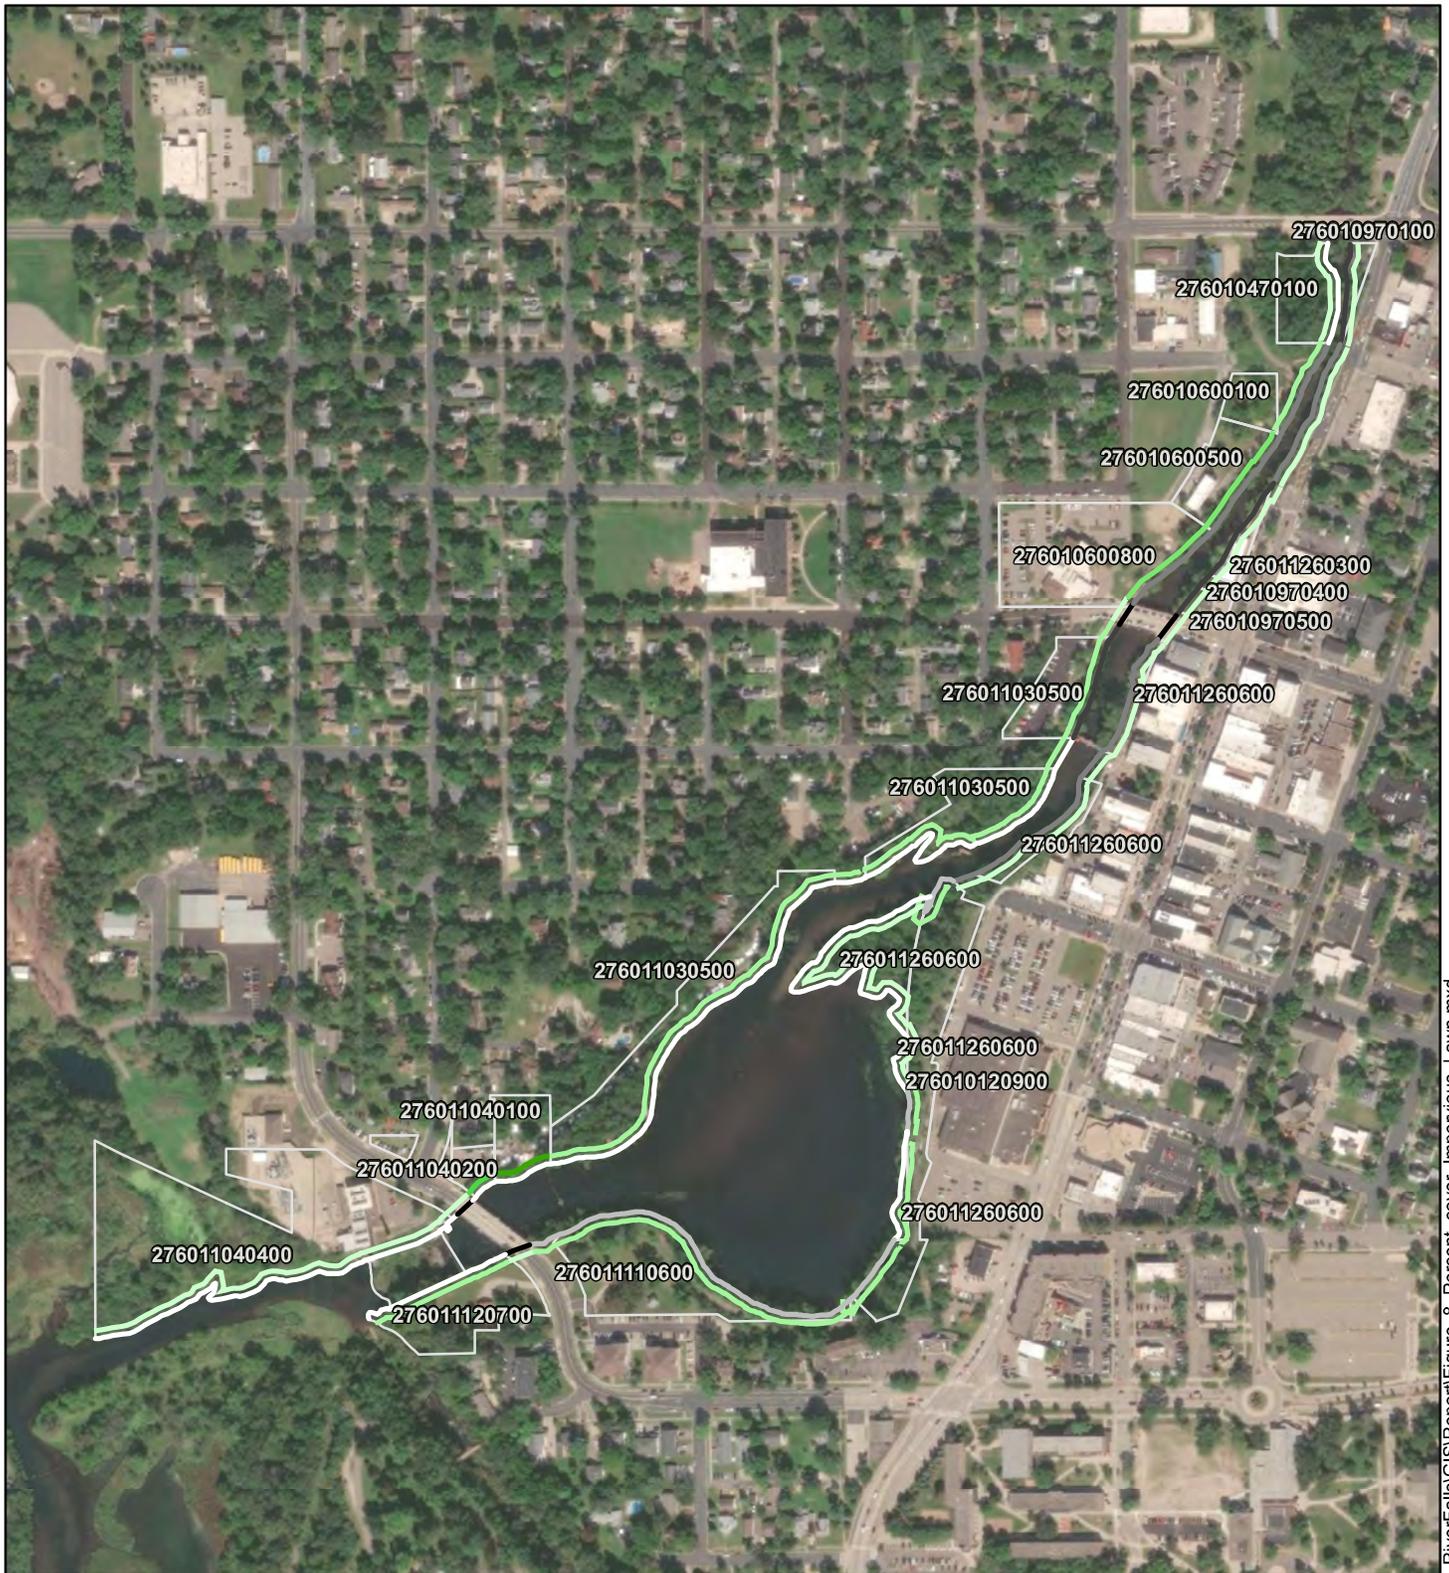
**Figure 7. Percent Cover - All Disturbed Conditions (Impervious Surface, Lawn, and Exposed Soil/Sand)**

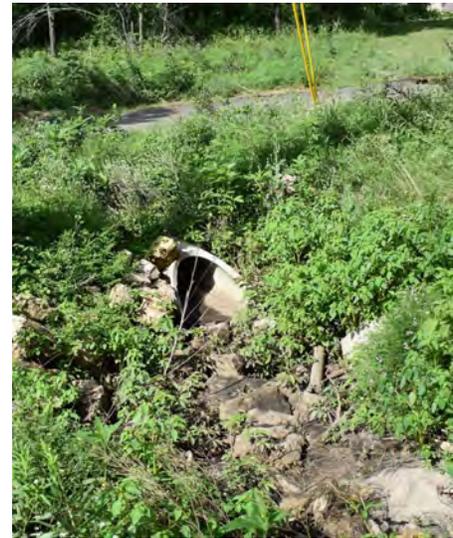
**Photograph 4. Typical point source in riparian buffer zone.**

Runoff concerns and other inputs of water to the impoundment and river were considered for both the riparian buffer zone and the rest of the parcel outside of the buffer zone (i.e., further inland). Typical runoff concerns recorded were trails or roads leading to the lake and lawns or exposed soil sloping towards the lake (Table 5). Point sources, defined as specific identifiable sources of water or pollution input into the lake (e.g., storm water outflows), were found consistently around the lake. Due to the often hidden or obscured nature of point sources observed, it is possible that more exist along the lake and river edge that have been covered by debris, vegetation, or soil erosion (Photograph 4).

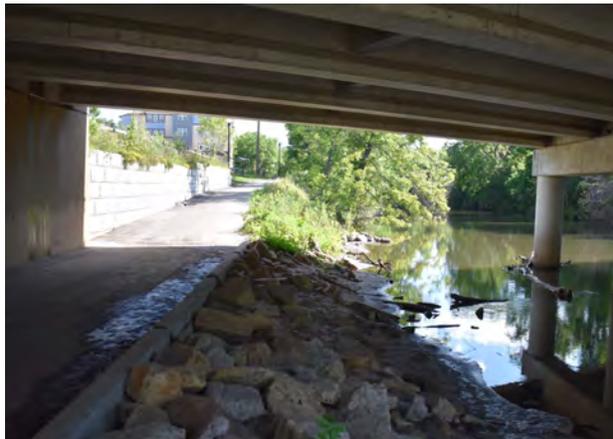
**Photograph 5. Top left – Paved path sloping to lake showing collected water.**

Other examples of types of runoff concerns are provided in Photographs 5 through 7. Channelized water flow was minimal and on average less than 2 feet wide when found in the Project Area. Trails or designated paths leading to the lake were either portions of the walking path installed by the City or pedestrian-made dirt trails leading to fishing spots or lookouts along the Lake George bank.

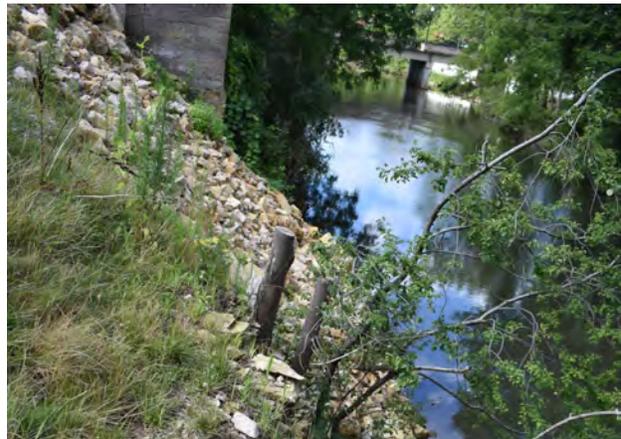
**Photograph 6. Top right – steep slope with maintained lawn and rip rap behind.**

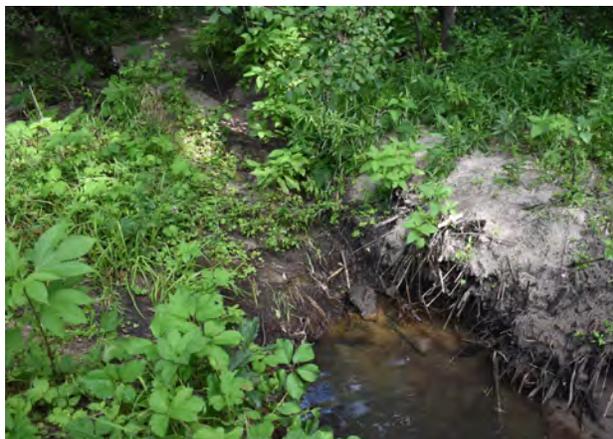
**Photograph 7. Bottom left – signs of minor channelized (ephemeral) water flow coming from uphill.**

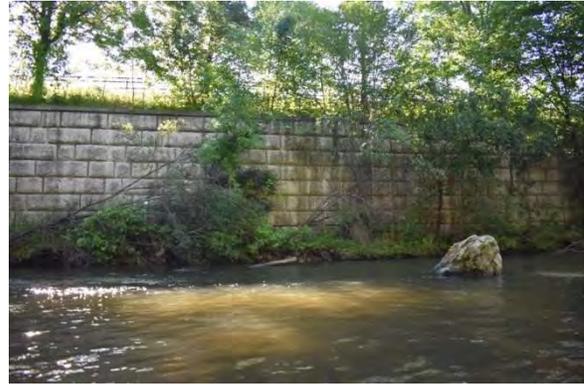
**Photograph 8. Retaining wall along upper Kinnickinnic River.**

Within the bank zone, which is the portion of shoreline between the upper bank lip and lower bank toe that typically contains the OHWM, anthropogenic modifications consisted of vertical retaining wall along two stretches and rip rap (Table 6). A retaining wall has been installed along the western bank of the dam and powerhouse (Parcel No. 276011040400) as well as a stretch of the eastern bank of the upper Kinnickinnic River (Photograph 8). Rip rap was found commonly associated with bridges, retaining walls, or steep portions of shoreline along the upper reach of the river. A short stretch of shoreline containing natural vegetation on the east bank of the river showed signs of erosion.

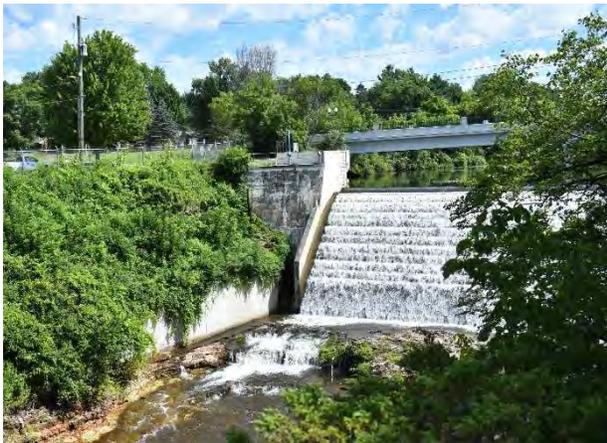
Photograph 9. Junction Falls Dam.

Two large road bridges (West Maple Street and Winter Street) are located between parcels and not noted in the list above, but these bridges are present in the littoral zone of the overall Project Area. Photographs 9 through 12 present examples of the human structures found in the littoral zone.

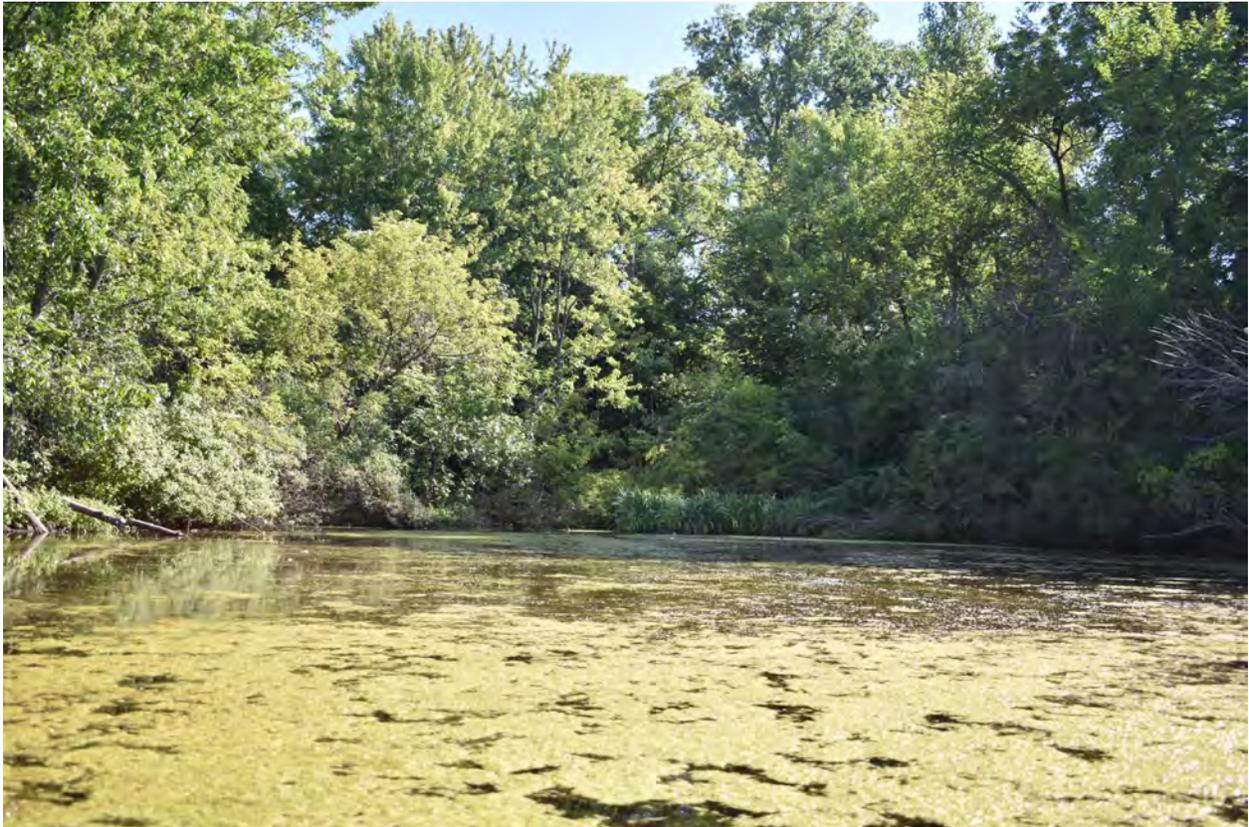
**Photograph 13. Green algae bloom on Lake George.**

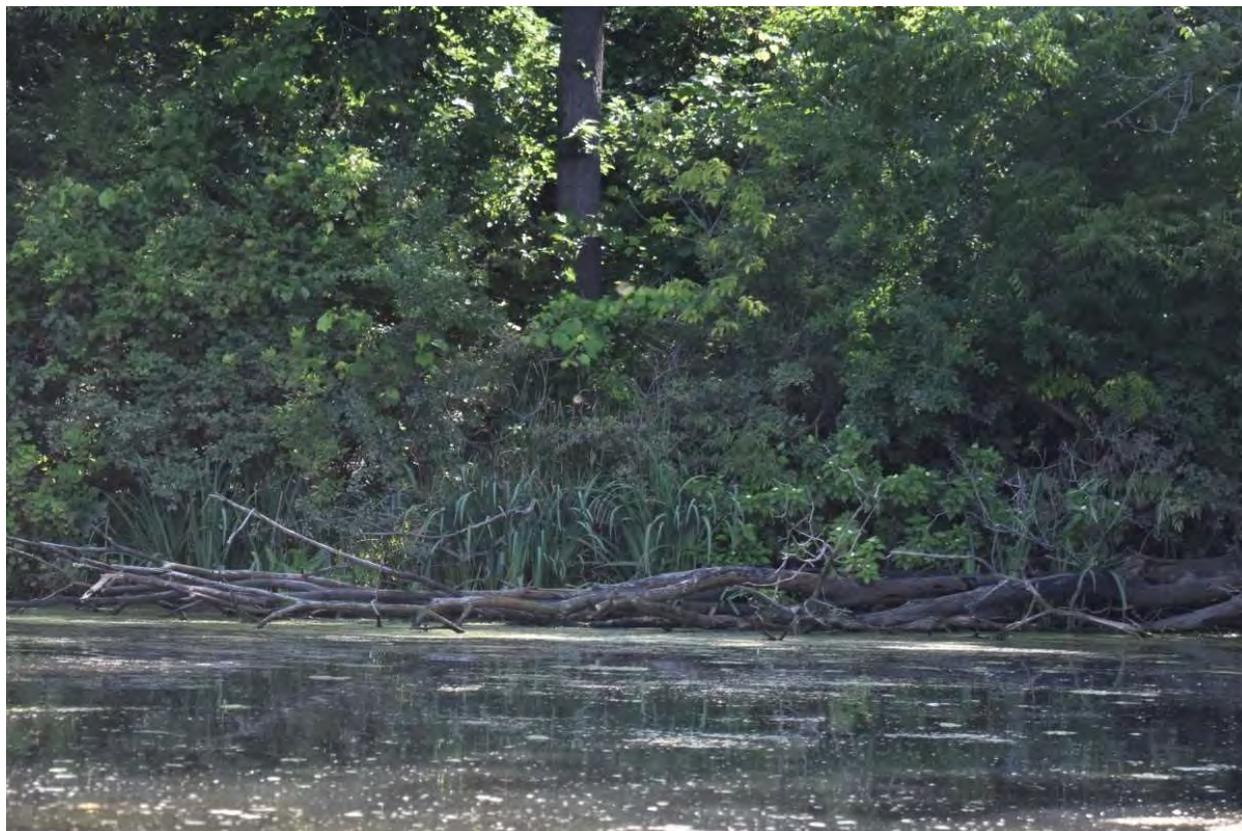
Photograph 14 shows the typical form of woody debris found on the edge of Lake George. The largest congregation of woody debris occurred along the southern to southeastern shoreline of Lake George, likely because of patterns of water flow and deposition.

**Photograph 14. Example of woody debris on the Lake George shoreline.**

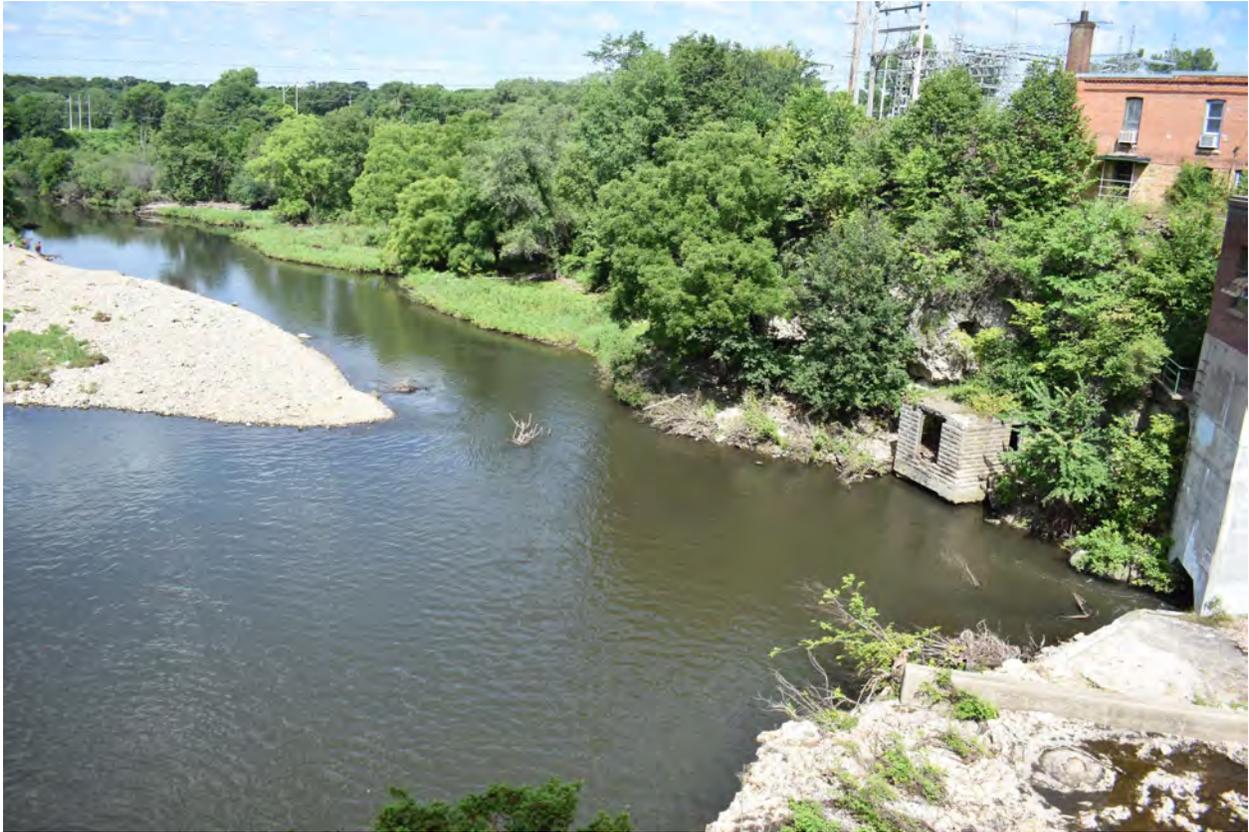
South of Junction Falls Dam, the shoreline changes rapidly from exposed bedrock waterfalls that have been modified by the installation of the dam, adjoining retaining wall, and powerhouse to a short “river reach” that leads to Lake Louise to the south. Lake Louise is the impoundment that has been created by installation of the Powell Falls Dam further south. This short stretch of channel between impoundments (Photograph 15) is likely to have become wider and shallower than pre-disturbance conditions, as is typical of river reaches where sediment transport has been impeded downstream and an impoundment has developed (Schmutz and Moog 2018). Swaths of reed canary grass (*Phalaris arundinacea*) dominate much of the northern shoreline of

this reach. Channelized water drainages have developed that connect the river to wetlands that have established immediately to the north. It is possible that these wetlands developed in response to installation of the two dams.

**Photograph 15. Stretch of river south of Junction Falls Dam.**

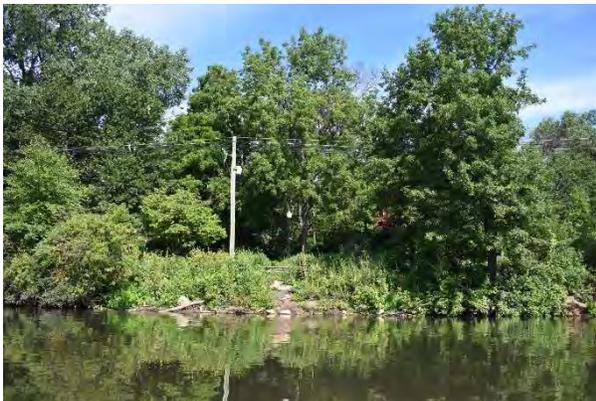
**Photograph 16. View of southeast portion of Lake George shoreline.**

Lake George is the second distinct portion of the Project Area and the focal point of this SHA study. The original river channel flowed near to the existing northwest shoreline (along Parcel No. 276011030500). When the dam was built, the impoundment was created to the south and east of the original channel in lower elevation floodplains or forests. Currently, the shoreline around the lake is mostly consistent in character (Photographs 16 and 17).

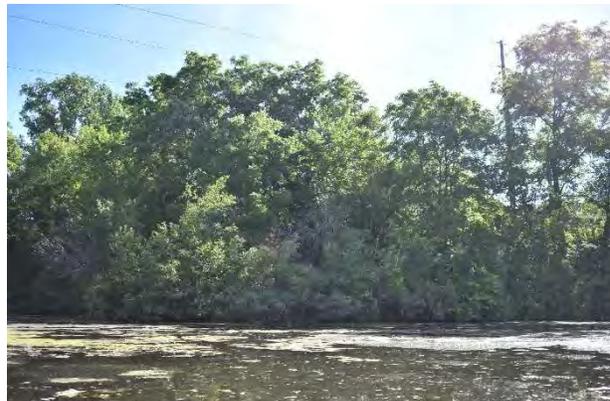
**Photograph 17. View of northwest portion of Lake George shoreline.**

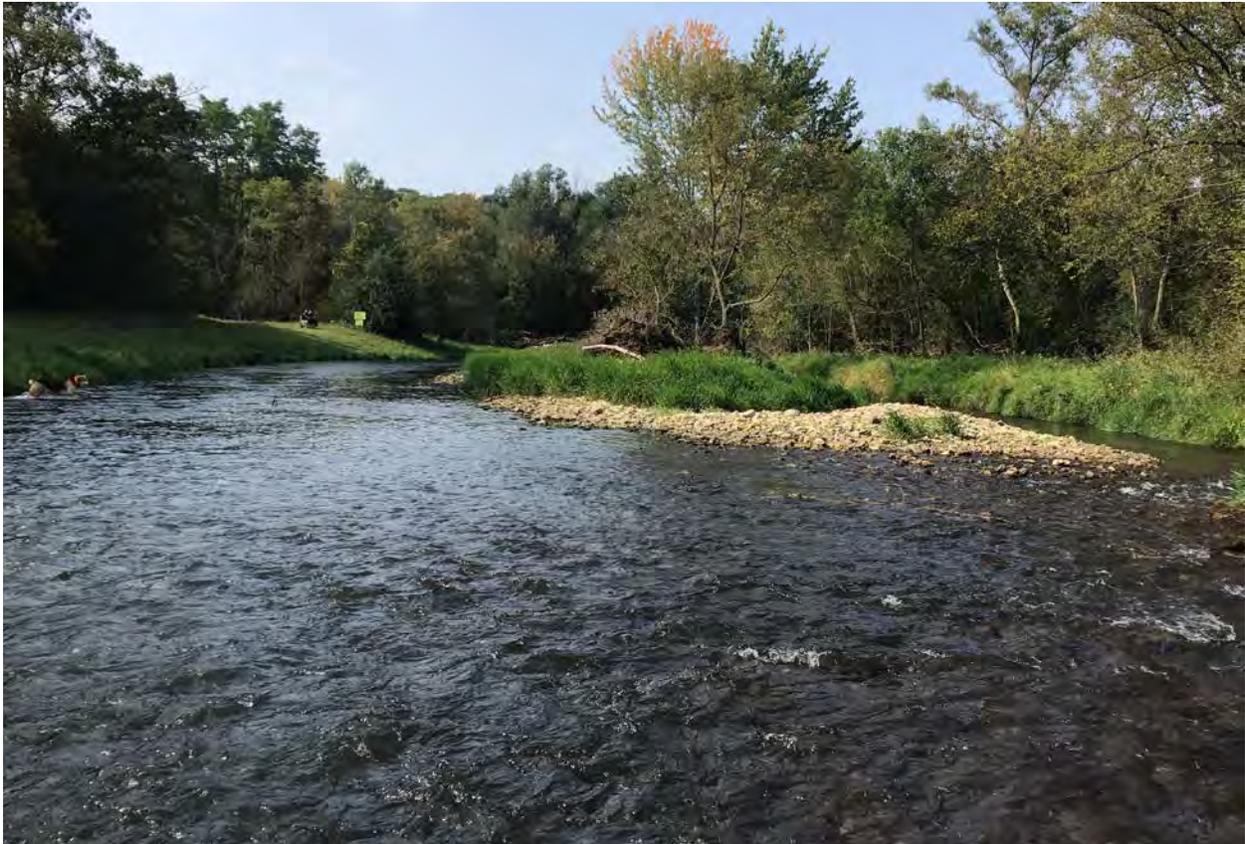
**Figure 2: Typical photo collected at station 490+00 in representative subreach 1.**

Representative subreach 1 was from station 484+00 to 500+00. Banks in representative reach 1 were typically vegetated. From Station 489+80 to Station 500+00 (approximately 120 feet), the left bank was bare and likely actively eroding. Exposed bank sediments were composed of sandy loam. Streambanks were generally stable and active erosion was interpreted as a result of the natural lateral migration of the river channel in response to flood events. For approximately 450 feet on river left, the river ran adjacent to a maintained trail and near a historic lime kiln. This portion of the bank was stabilized with riprap below the ordinary high water. A 300-foot long, 40-foot wide vegetated island was present within the reach. The island was vegetated with reed canary grass and a cluster of four 3-to-6-inch diameter deciduous trees. Bankfull widths averaged 66 feet (+/- 4.5 feet), wetted width averaged 59 feet (+/- 3.4 feet), and bankfull thalweg depth averaged 4 feet (+/- 0.5 feet). Riffles were typically composed of poorly sorted sand to cobble with cobbles typically embedded by smaller material and had bankfull depths which averaged 2 feet. Depth of refusal on riffles was generally between 2 and 3 feet. Pools were typically composed of well sorted sand or gravel with residual depths of 2 feet (+/- 0.5 feet). Valley width was estimated to be 400 feet. Overbank

sedimentation was common, with sediments composed of well sorted fine sand and typically deposited as sand sheets in low lying floodplain forest and were thickest in areas associated with the Rocky Branch. There was on average one large wood piece per 100 feet. This subreach contained a low density of habitat features with few large wood pieces and overhanging vegetation. Undercut banks were absent. Pools were typically shallow. The main habitat feature within this subreach was coarse riffle substrate and boulders associated with the riprap bank.

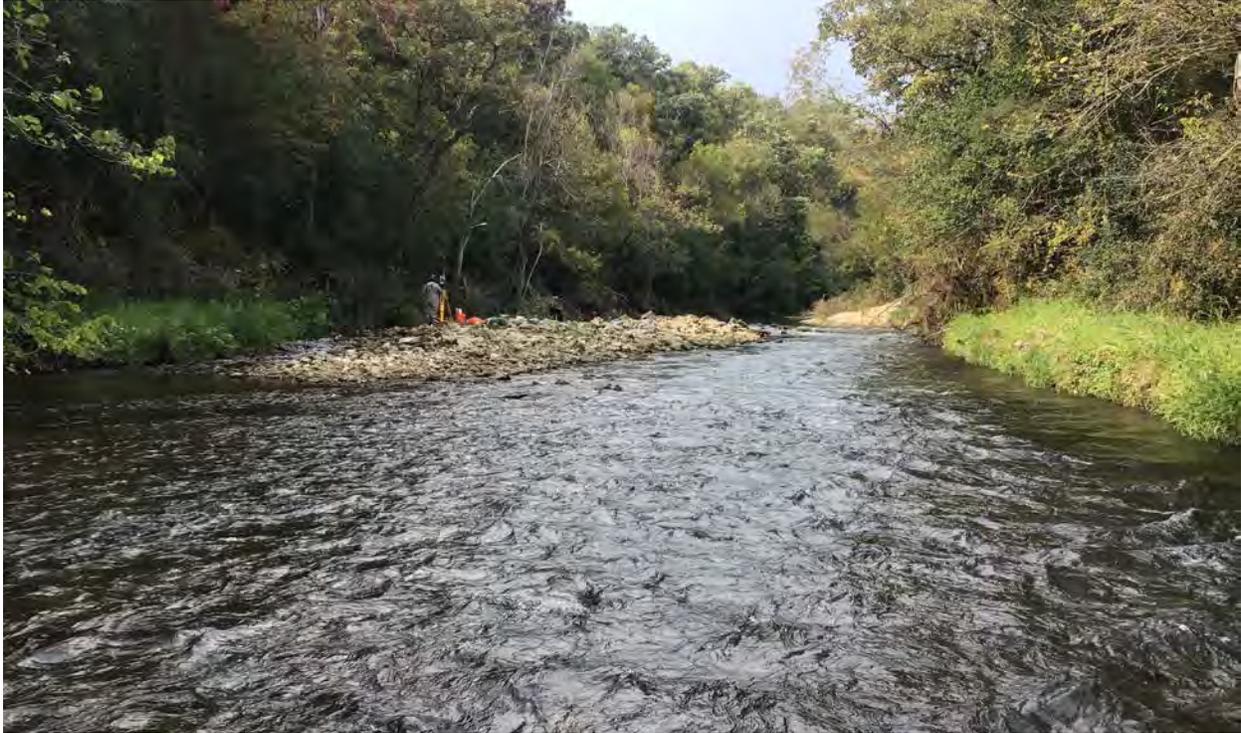
Figure 3: Typical photo collected at station 445+00 in representative subreach 2.

Representative subreach 2 was from station 434+00 to 444+00. Banks in representative subreach 2 were approximately 80% vegetated with alternating banks exposed. Where exposed, bank sediments consisted of poorly sorted sand and gravel. Streambanks were generally stable and active erosion was interpreted as a result of the natural lateral migration of the river channel in response to flood events. Bankfull widths averaged 67 feet (+/- 6.2 feet), wetted width averaged 63 feet (+/- 7.0 feet), and bankfull thalweg depth averaged 4 feet (+/- 1.3 feet). Riffles were typically composed of poorly sorted sand to cobble with cobbles typically embedded by smaller material and had bankfull depths which averaged 2.5 feet. Depth of refusal on riffles was generally between 1 and 2 feet. Pools were typically composed of well sorted sand or gravel with residual depths of 2 feet (+/- 1 foot). Valley width was estimated to be 450 feet. Overbank sedimentation was common with sediments composed of well sorted fine sand. A mid-channel bar was present near the upstream terminus of the reach and was composed of poorly sorted sand to boulders. There was on average 0.4 large wood pieces per 100 feet in this reach. This subreach contained a low density of habitat features with few large wood pieces, boulders, and overhanging vegetation. Undercut banks were absent. Pools were typically shallow. The main habitat feature within this subreach was coarse riffle substrate.

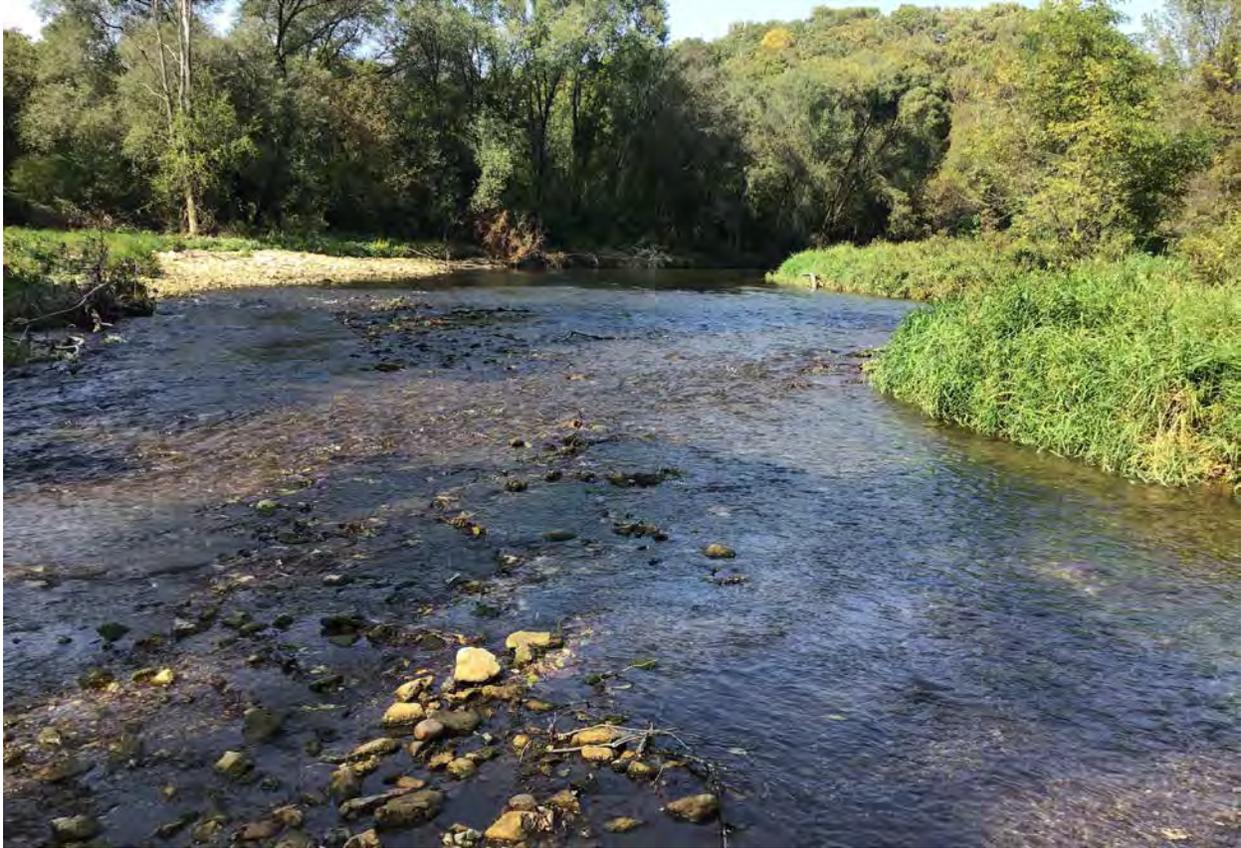
**Figure 4: Typical photo collected at station 315+00 in representative subreach 3.**

Representative subreach 3 was from station 305+00 to 316+00. Banks in representative reach 3 were approximately 60% vegetated with alternating banks exposed. Where exposed, bank sediments consisted of sandy loam overlaying poorly sorted sand and gravel or bedrock. Streambanks were generally stable and active erosion was interpreted as a result of the natural lateral migration of the river channel in response to flood events. Bankfull widths averaged 61 feet (+/- 10.1 feet), wetted width averaged 42 feet (+/- 16.7 feet), and bankfull thalweg depth averaged 4 feet (+/- 1.5 feet). Riffles were typically composed of poorly sorted sand to cobble with cobbles typically embedded by smaller material and had bankfull depths which averaged 2 feet. Depth of refusal on riffles were generally between 2 and 3 feet. Pools were typically composed of well sorted sand with residual depths of 2 feet (+/- 1 feet). Valley width was estimated to be 550 feet. Overbank sedimentation was common with sediments composed of well sorted fine sand and typically deposited as sand sheets on the inside of meander bends. Several mid-channel bars were presented and were composed of poorly sorted sand to cobbles with higher portions vegetated. There was on average 1.5 large wood pieces per 100 feet in this subreach. This subreach contained a low density of habitat features with few large wood pieces, boulders, and overhanging vegetation. Undercut banks were absent. Pools were typically shallow. The main habitat feature within this subreach was coarse riffle substrate.

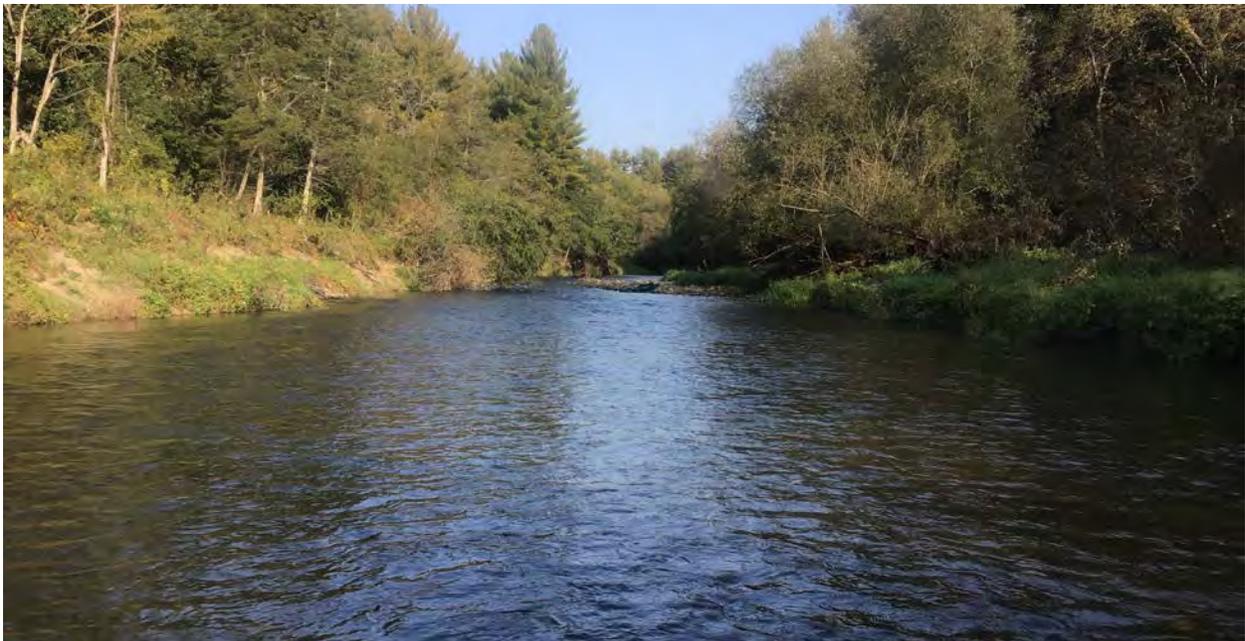
Figure 5: Typical photo collected at station 229+00 in representative subreach 4.

Representative subreach 4 was from station 220+00 to 233+00. Banks in representative subreach 4 were 85% vegetated. Where exposed, bank sediments consisted of sandy loam overlaying poorly sorted sand and gravel. Streambanks were generally stable and active erosion was interpreted as a result of the natural lateral migration of the river channel in response to flood events. Bankfull widths averaged 67 feet (+/- 5.4 feet), wetted width averaged 60 feet (+/- 4.6 feet), and bankfull thalweg depth averaged 4 feet (+/- 0.2 feet). Riffles were typically composed of poorly sorted sand to cobble with cobbles typically embedded by smaller material and had bankfull depths which averaged 2.5 feet. Depth of refusal on riffles was generally between 3 and 4 feet. Pools were typically composed of well sorted sand with residual depths of 1 foot (+/- 0.5 feet). Bars were transitional between alternate and points bars and were composed of poorly sorted sand to cobbles with higher portions vegetated. Valley width was estimated to be 250 feet. There were on average 0.3 large wood pieces per 100 feet in this subreach. This subreach contained a low density of habitat features with few large wood pieces, boulders, and overhanging vegetation. Undercut banks were absent. Pools were typically shallow. The main habitat feature within this subreach was coarse riffle substrate.

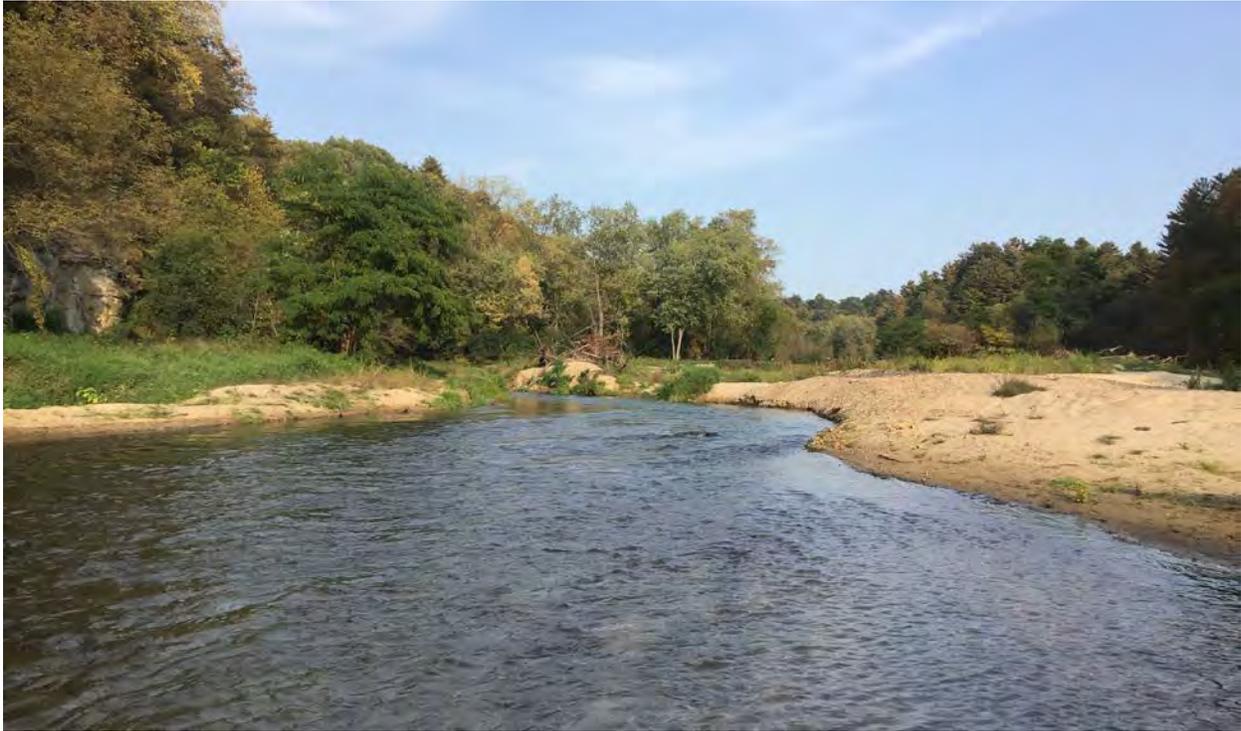
Figure 6: Typical photo collected at station 106+00 in representative subreach 5.

Representative subreach 5 was from station 100+00 to 108+00. Banks in representative subreach 5 were 60% vegetated. Where exposed, bank sediments consisted of sandy loam. Streambanks were generally stable and active erosion was interpreted as a result of the natural lateral migration of the river channel in response to flood events. Bankfull widths averaged 100 feet (+/- 58.3 feet), wetted width averaged 71 feet (+/- 28.2 feet), and bankfull thalweg depth averaged 5 feet (+/- 0.8 feet). Riffles were typically composed of poorly sorted sand to cobble with cobbles typically embedded by smaller material and had bankfull depths which averaged 2.5 feet. Depth of refusal on riffles was generally greater than 5 feet. Pools were typically composed of well sorted sand with residual depths of 2 feet (+/- 1 feet). Point bars were composed of poorly sorted sand to gravels with higher

portions vegetated. Valley width was estimated to be 300 feet. There were on average 1.8 large wood piece per 100 feet in this subreach. This subreach contained a low density of habitat features with few large wood pieces, boulders, and overhanging vegetation. Undercut banks were absent. Pools were typically shallow. The main habitat feature within this subreach was coarse riffle substrate.

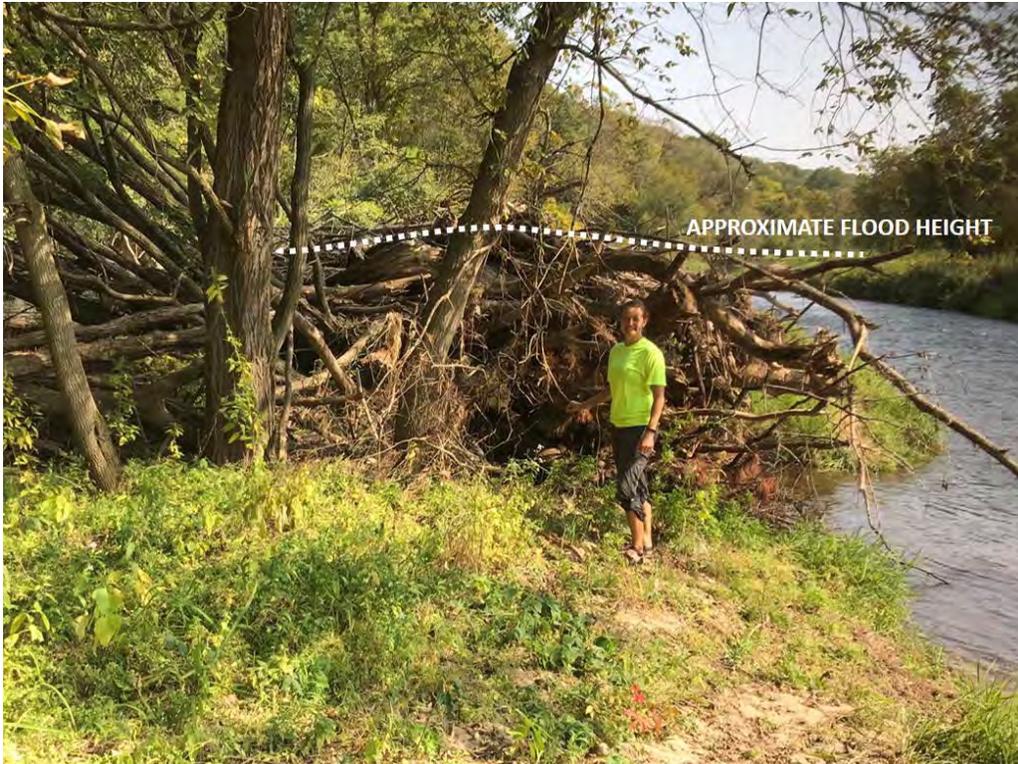
Figure 7: Flood debris wracked behind several trees. Photo collected at station 334+00.
