**RE: River Falls Hydroelectric Project, FERC Project No. 10489  
Updated Study Report**

Attachment: Updated Study Report for the River Falls Hydroelectric Project (P-10489)

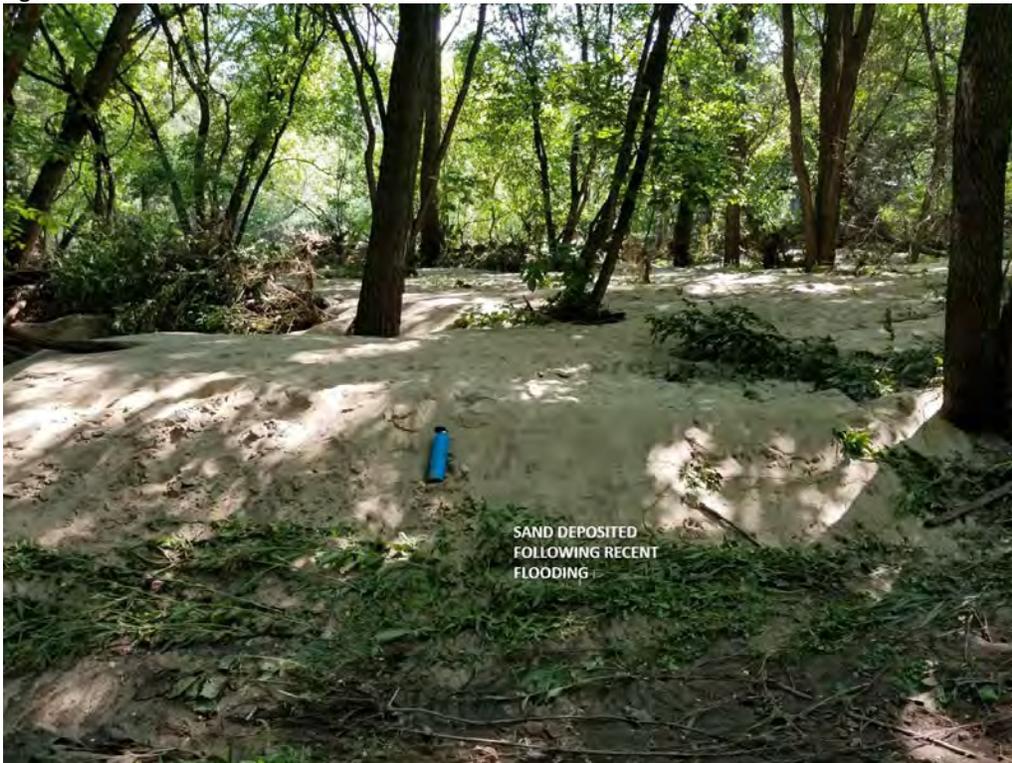
Figure 8: Sand deposited near the Rocky Branch confluence following recent floods. Photo collected at station 483+00.

USGS gage at County Road F indicates that the gage height was over 10 feet higher than the normal gage height. Overbank sedimentation of fine sand was noted in all reaches and varied in thickness from less than 1 inch to 4 feet (Figure 8). The thickest deposits were typically associated with tributary confluences, particularly the Rocky Branch, or associated with gullies. These deposits were typically 1-2 feet thick but were up to 4 feet thick at the leading edge of sand sheets. Thinner deposits (typically less than 6 inches thick) were observed throughout the remainder of the floodplain.

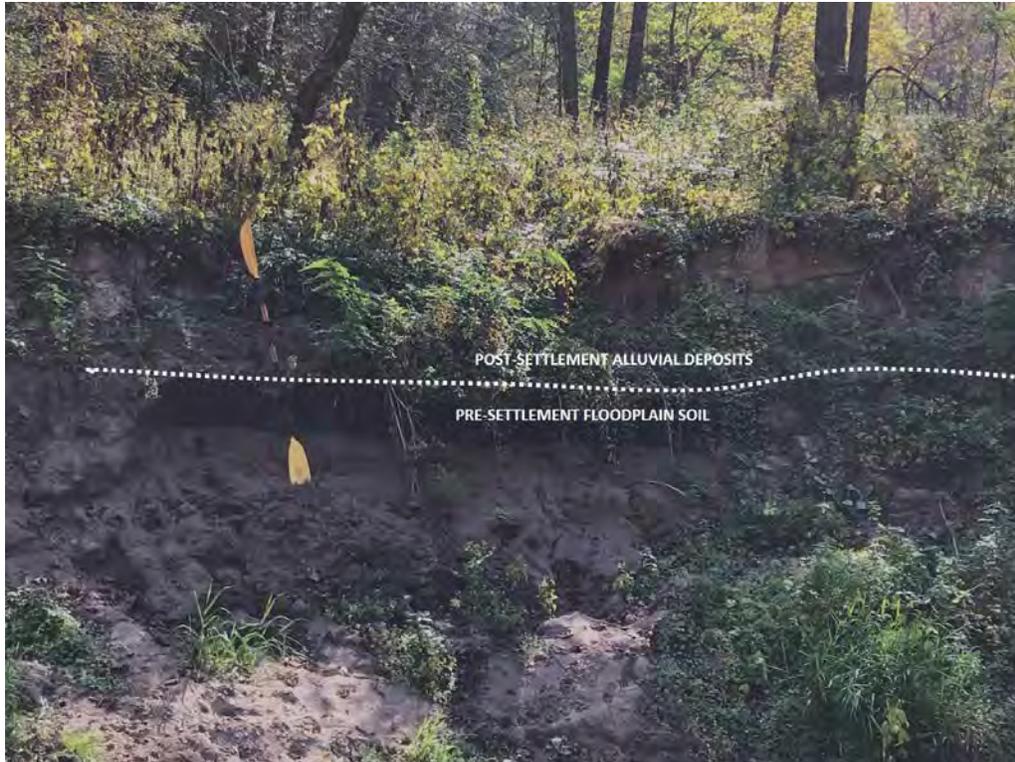
**Figure 9: Photo of cutbank showing pre-settlement soil horizon and post-settlement alluvial deposits. Photo collected at station 168+00.**

Legacy sand deposits overlaying soil horizons were also noted, and were commonly associated with tributary gullies in Reach 4 (Figure 9). The surface of these areas was forested, so the deposition of the sand must be older than the trees currently growing on the surface. It was interpreted that the deposition of the sand on top of the soil horizon is a result of land clearing by Euro-American settlers which destabilized upland surfaces and caused sediment to wash into the Kinnickinnic Gorge where it was deposited on the floodplain. This is similar to observations in other Driftless Area streams (Dauwalter et al. 2019). The result of this historic deposition is a floodplain that has aggraded in areas and is now elevated above the natural floodplain. The river is still actively moving these legacy sediments downstream in addition to contemporary sediment inputs, and overtime will construct a new, lower floodplain.

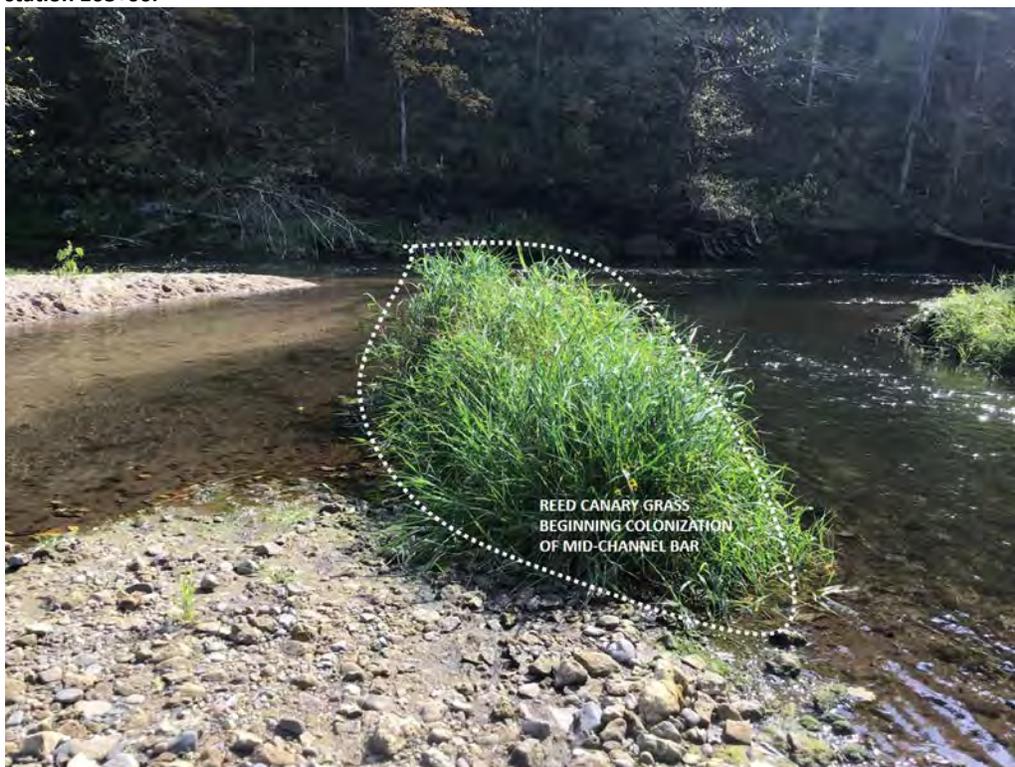
**Figure 10: Mid-channel bar showing colonization of reed canary grass and the stabilization of the bar. Photo collected at station 313+00.**

Sand accumulation, the embedment of gravel substrate, and subsequent establishment of reed canary grass resulted in increased channel erosion in select locations. Embedment of gravel and cobble riffle substrate and overbank sedimentation was common in all reaches. In addition, buried soil horizons were observed in Reach 4. These observations are typical of a river unable to effectively transport existing sediment within the river channel and floodplain, but may also be a temporary result of large flood events. Increased sediment input from upstream, upland, and bank erosion may further fill existing pools thus limiting deep water habitat and increase embedment of coarse riffle substrate. Embedment of coarse river substrate is of special concern since it can negatively impact spawning habitat and macroinvertebrate densities. Subsequent surveys could determine annual versus event-based inputs. It should be noted, both bed complexity and in channel large wood will increase over time as smaller (5-yr flood events or less) floods redistribute both bed material and large wood.

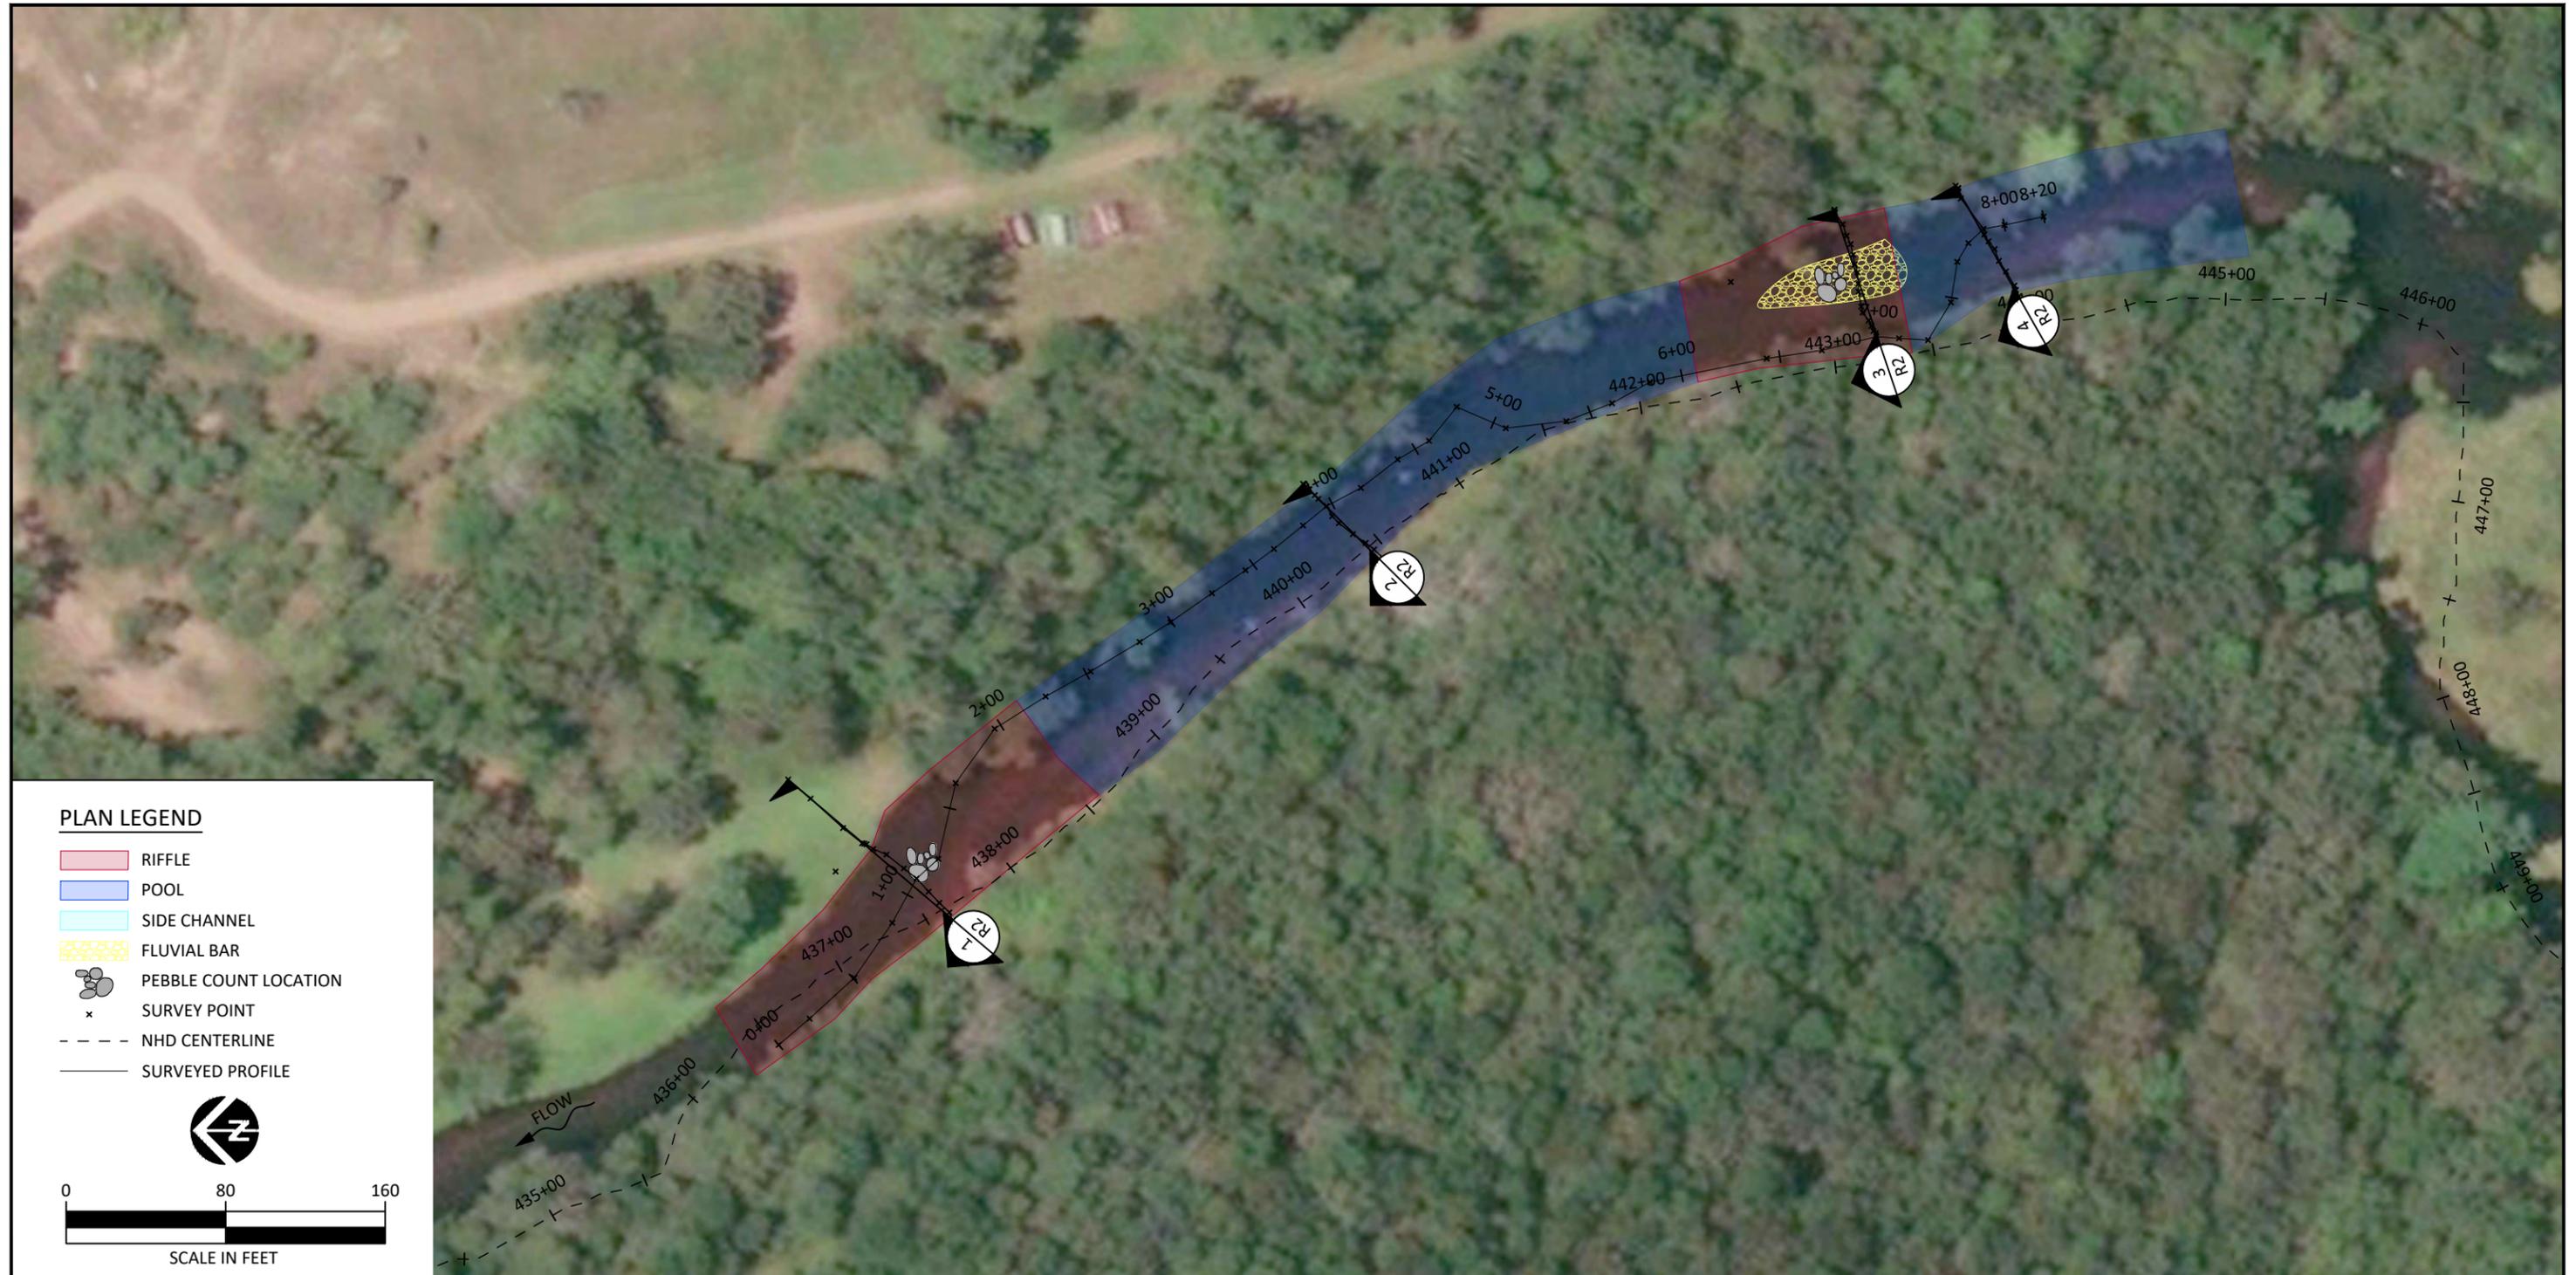
3 OF 10

**LONGITUDINAL PROFILE**  
UNREFERENCED VERTICAL SCALE

NOTE: FIELD WORK CONDUCTED BY SEAN MORRISON, GARRET SHEAR (INTER-FLUVE) AND ROSS HARRIS (GRSC) ON THE KINNICKINNICK RIVER BETWEEN 9/21/2020 AND 9/24/2020.

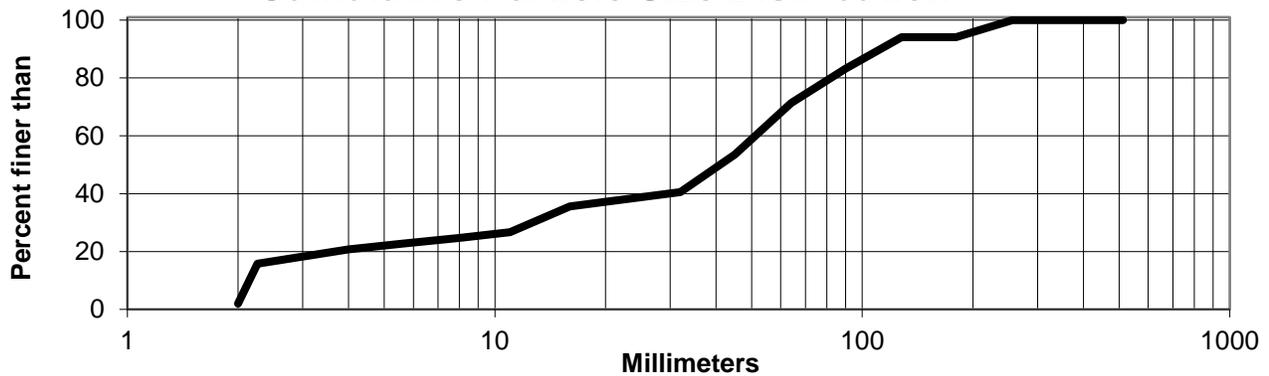
**Cumulative Particle Size Distribution**

Pebble Count Name: Reach 1 Bar  
 Sampling Method: Random Walk  
 Geomorphic Position: Bar  
 Stratigraphic Position: Surface

Sediment size (mm)	Particle Count	Total Percent	Cumulative Percent
2	0	0.00	0.00
2.26	10	10.00	10.00
4	0	0.00	10.00
5.6	0	0.00	10.00
8	0	0.00	10.00
11	0	0.00	10.00
16	0	0.00	10.00
32	23	23.00	33.00
45	24	24.00	57.00
64	22	22.00	79.00
90	18	18.00	97.00
128	2	2.00	99.00
180	1	1.00	100.00
256	0	0.00	100.00
512	0	0.00	100.00
Total:	100	100

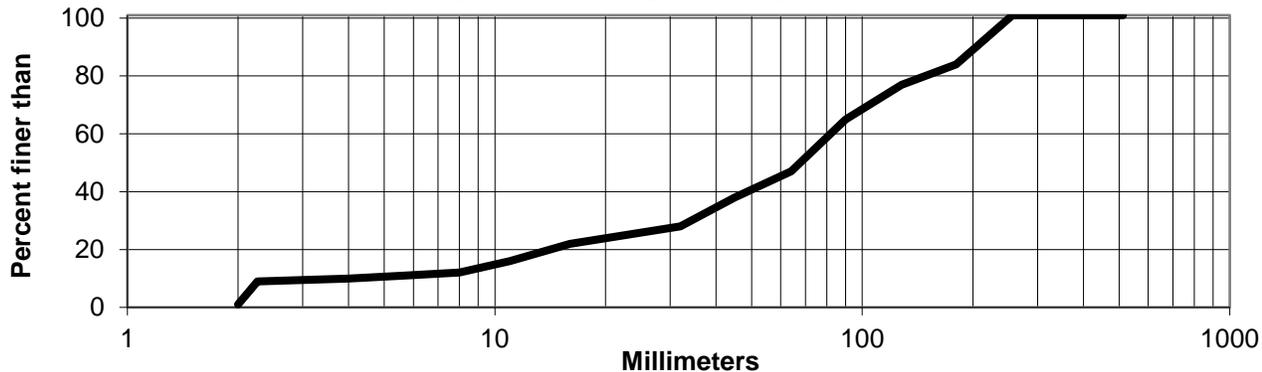
**Cumulative Particle Size Distribution**

Pebble Count Name: Reach 2 Riffle  
 Sampling Method: Random Walk  
 Geomorphic Position: Riffle  
 Stratigraphic Position: Surface

Sediment size (mm)	Particle Count	Total Percent	Cumulative Percent
2	2	2.00	2.00
2.26	12	12.00	14.00
4	1	1.00	15.00
5.6	1	1.00	16.00
8	3	3.00	19.00
11	4	4.00	23.00
16	9	9.00	32.00
32	17	17.00	49.00
45	17	17.00	66.00
64	18	18.00	84.00
90	9	9.00	93.00
128	4	4.00	97.00
180	2	2.00	99.00
256	1	1.00	100.00
512	0	0.00	100.00
Total:	100	100

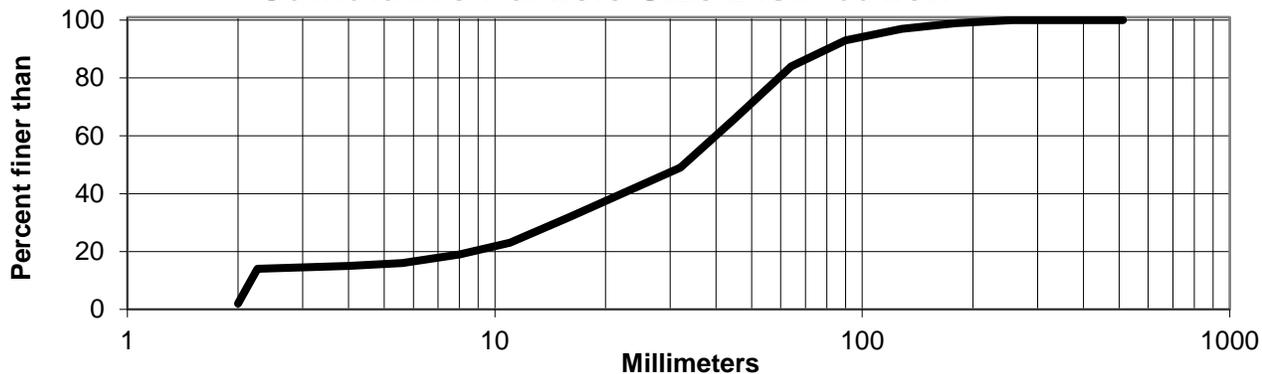
**Cumulative Particle Size Distribution**

Pebble Count Name: Reach 3 Riffle  
 Sampling Method: Random Walk  
 Geomorphic Position: Riffle  
 Stratigraphic Position: Surface

Sediment size (mm)	Particle Count	Total Percent	Cumulative Percent
2	17	17.00	17.00
2.26	6	6.00	23.00
4	1	1.00	24.00
5.6	3	3.00	27.00
8	3	3.00	30.00
11	3	3.00	33.00
16	4	4.00	37.00
32	4	4.00	41.00
45	3	3.00	44.00
64	4	4.00	48.00
90	18	18.00	66.00
128	16	16.00	82.00
180	13	13.00	95.00
256	5	5.00	100.00
512	0	0.00	100.00
Total:	100	100

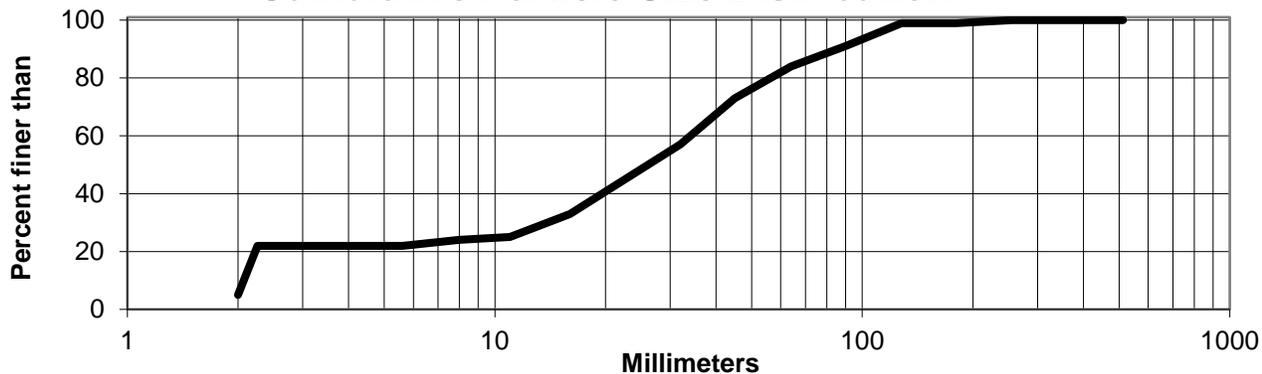
**Cumulative Particle Size Distribution**

Pebble Count Name: Reach 4 Riffle  
 Sampling Method: Random Walk  
 Geomorphic Position: Riffle  
 Stratigraphic Position: Surface

Sediment size (mm)	Particle Count	Total Percent	Cumulative Percent
2	3	3.00	3.00
2.26	3	3.00	6.00
4	1	1.00	7.00
5.6	3	3.00	10.00
8	3	3.00	13.00
11	3	3.00	16.00
16	4	4.00	20.00
32	11	11.00	31.00
45	20	20.00	51.00
64	12	12.00	63.00
90	14	14.00	77.00
128	16	16.00	93.00
180	6	6.00	99.00
256	1	1.00	100.00
512	0	0.00	100.00
Total:	100	100

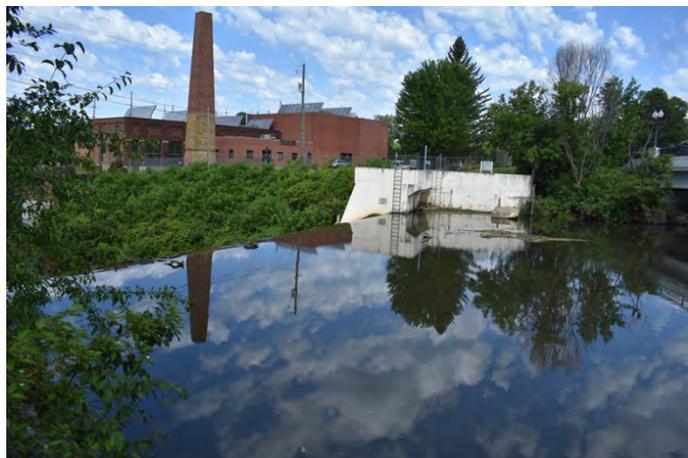
**Photograph 1. View of Junction Falls Dam and the adjoining powerhouse, facing northwest.**

Lake George occupies approximately 16 acres, most of which is east of the original river channel (Inter-Fluve 2017). Lake Louise is of similar size to Lake George, with additional seasonally-inundated wetlands along its northern shoreline. Around Lake George and Lake Louise, as well as the adjacent upper reach of the Kinnickinnic River to the north and lower reach to the south, public use areas including biking/walking trails, benches, and water-access infrastructure have been developed for use by residents of the City of River Falls. While most of the parcels (i.e., properties) around the impoundments are maintained as a public recreation opportunity, parcels along the upper reach of the Kinnickinnic River are owned by private individuals and contain both businesses and residences. The River Falls Wastewater Treatment Facility is located along the western shoreline of Lake Louise. The Junction Falls powerhouse is located immediately west of Junction Falls Dam (Photograph 1).

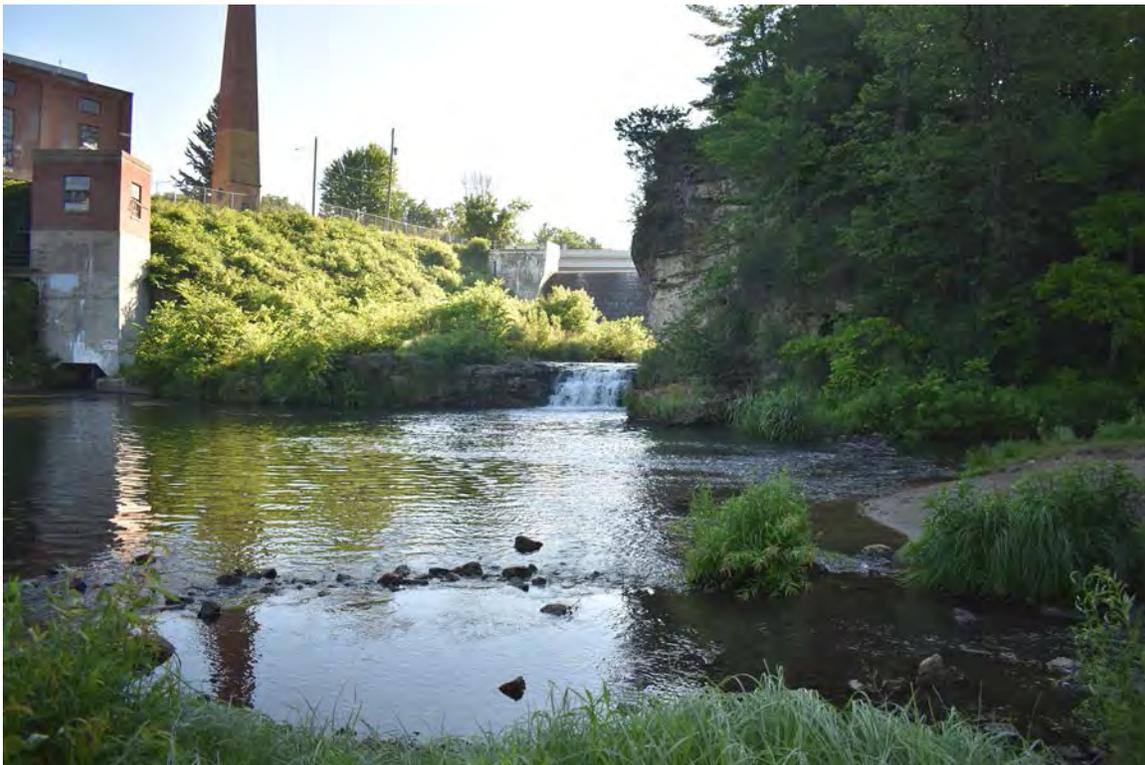
**Photograph 2. View of confluence of the Kinnickinnic River and South Fork Kinnickinnic River, with Junction Falls Dam in the background, facing north (June 29, 2020).**

The trails within the survey area lead downhill from Glen Park to the river and floodplain below. A natural swimming hole exists at the confluence of the South Fork Kinnickinnic River and the main channel just below the dam and waterfalls. It should be noted that this is not formally designated as a swimming area by the City of River Falls. The paths lead to this swimming hole, as well as to the north shore of Lake Louise where people can observe wildlife, fish, or swim among other outdoor activities. Unofficial walking paths along the South Fork Kinnickinnic River lead upstream to small waterfalls and additional areas suitable for exploration. No other formal amenities (e.g., picnic tables, restrooms) exist in this area. The nearest restrooms can be found in Glen Park.

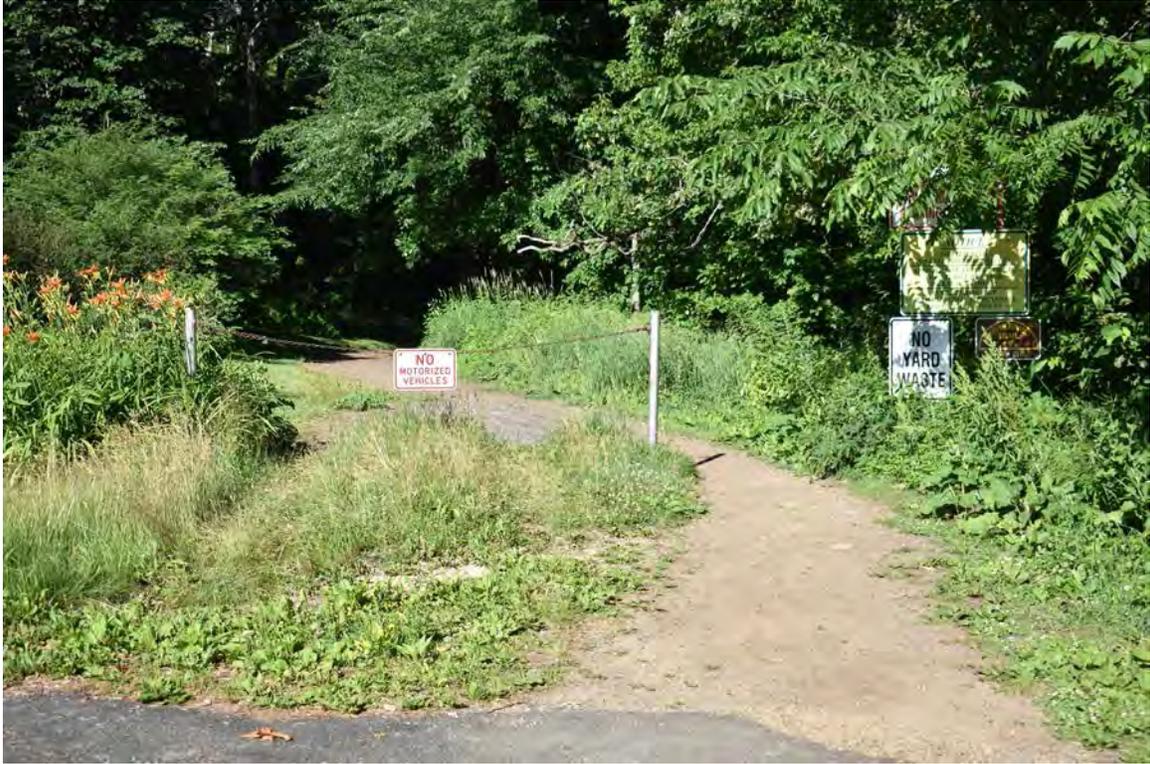
**Photograph 8. Entrance to trail leading to kayak launch, facing west (July 03, 2020).**

The southwestern corner of Glen Park is an area of maintained lawn which is used as a kayak staging area. Here, two picnic tables have been installed and signs provide information on parking regulations and use of the trail as a kayak put-in. The trail to the river is a gravel and dirt path with steps installed on the steeper portion going down to the river. No other amenities have been installed except for a bench located up on a bluff overlooking Powell Falls Dam in the southern portion of the Project Area. Vegetation has obscured most of the view of the dam. The closest restrooms and drinking water sources for kayakers are located in Glen Park, which is outside of the survey area. Some street parking is available near the kayak launch staging area, as well as the large parking lot located in Glen Park. There is also an approximately 200-foot stretch of curbside parking directly adjacent to the kayak staging area which is limited to a 15-minute loading zone. All of these parking areas are outside of the survey area but used by people recreating within the survey area.

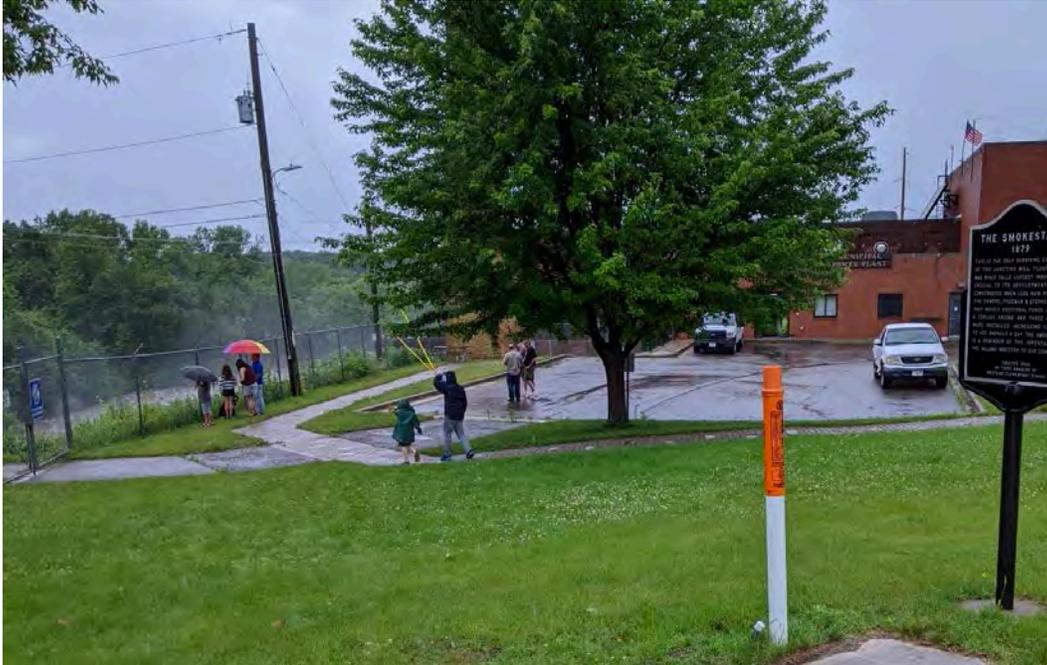
**Photograph 16. People viewing flooding at Junction Falls Dam, facing southwest (June 29, 2020).**

Two “Other” or custom categories were established for this survey area. “Berry-picking” was noted as a unique category as a family of three were observed specifically coming to the survey area to collect wild raspberries (confirmed by pers. comm.). “Looking at Dam/Flooding” was an event-specific category that was created after more than 7 inches of rainfall were received in River Falls over the course of one day. The day after the rain event, flood conditions were present along the river and impoundments, and many people came specifically to Junction Falls Dam to view the extent of the flooding (Photograph 16). This category was defined as the number of people that came and viewed the dam from an outlook between the dam and the municipal power plant (see the far southwestern corner of the survey area on Figure 5). Though an event such as this is infrequent, it is notable as an attraction that draws people to the survey area.

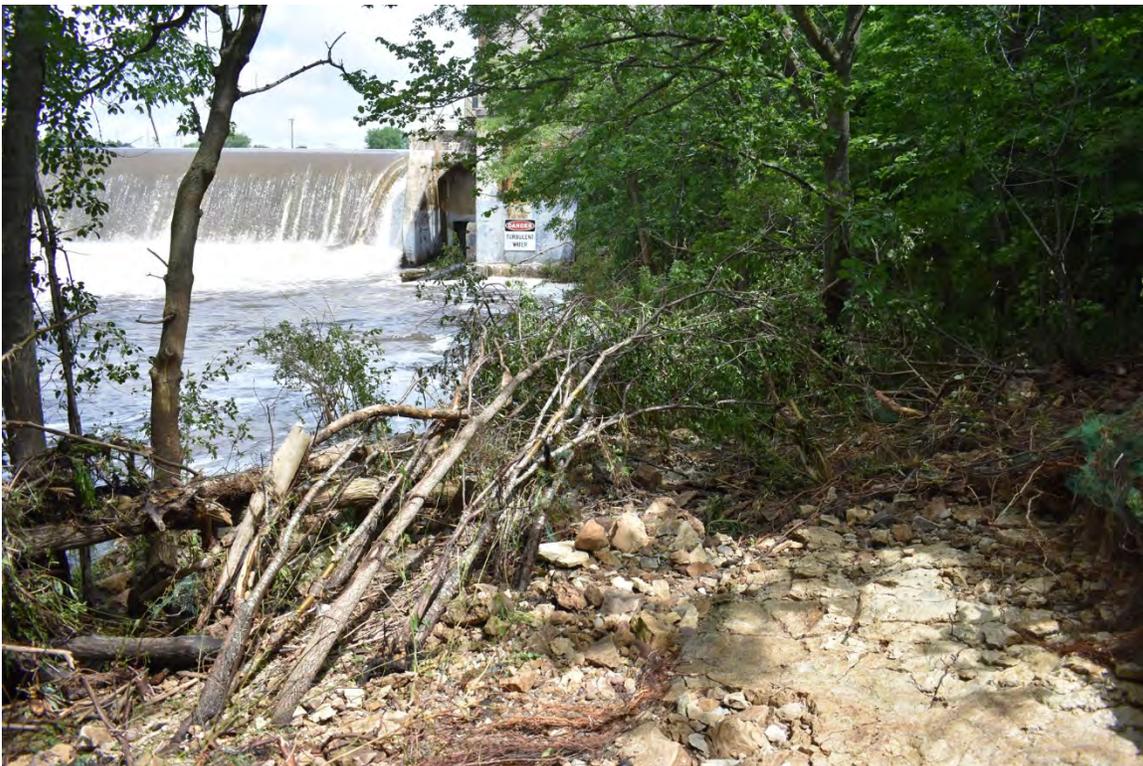
**Photograph 17. Flood damage including debris pile-up and a washed-out trail at Powell Falls, facing north (July 1, 2020).**

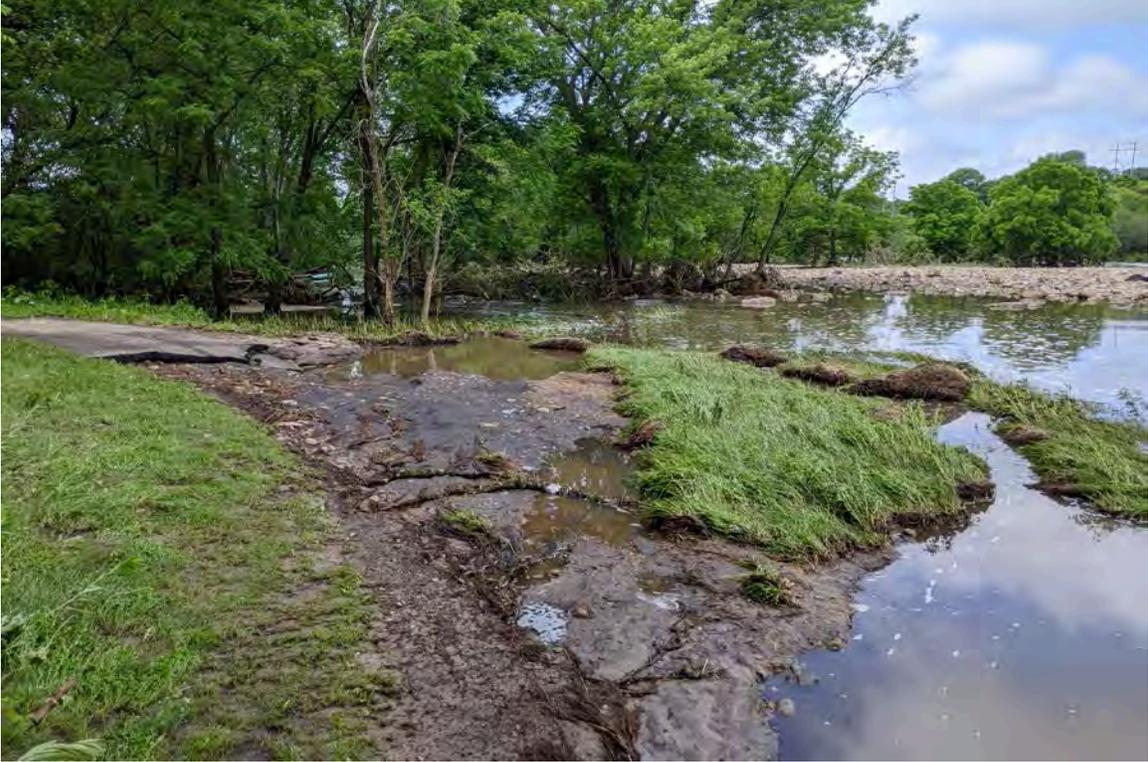
**Photograph 18. Part of the paved path at Glen Park Trails destroyed by flooding, facing southwest (July 1, 2020).**

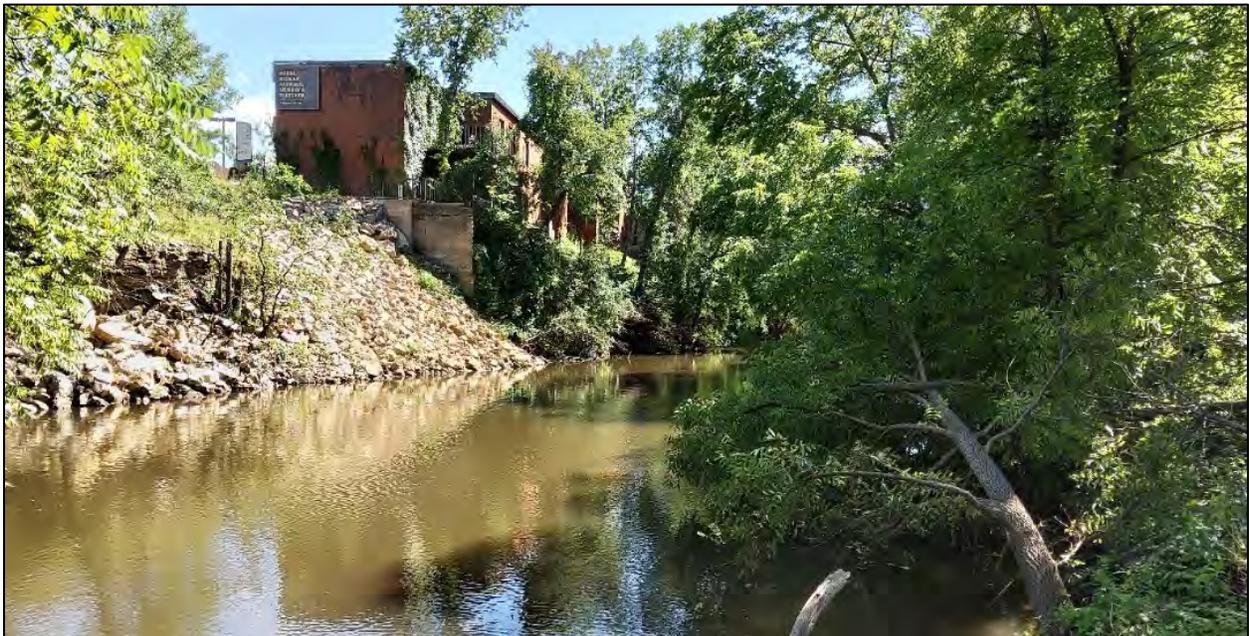
**Photo 2: General character of northern reach of Junction Falls APE. View to southeast.**

The July 2020 survey<sup>2</sup> examined the shoreline and noted that short reaches of the impoundment bank had been stabilized with riprap, landscaping, and by other means. However, much of the shoreline is stable and well vegetated with areas protected by natural slow water environments, which allow emergent and submergent vegetation to buffer the shoreline.

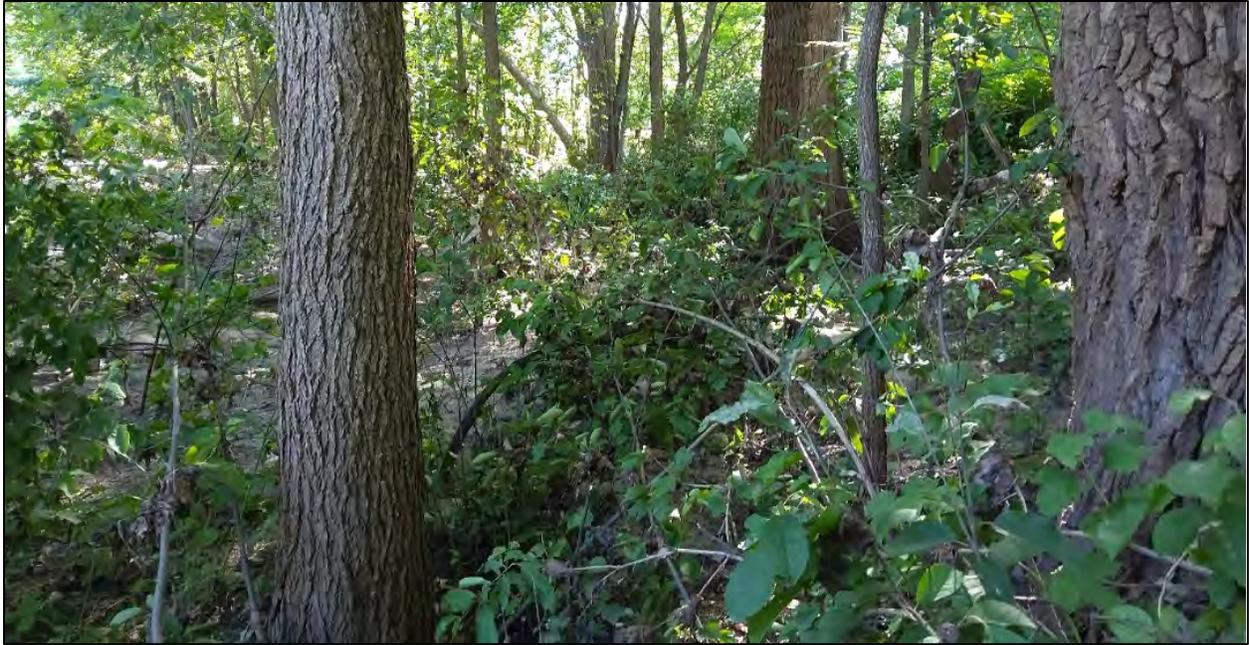
**Photo 3: Typical sloped shoreline down to vegetated gravel bar. View to southeast.**

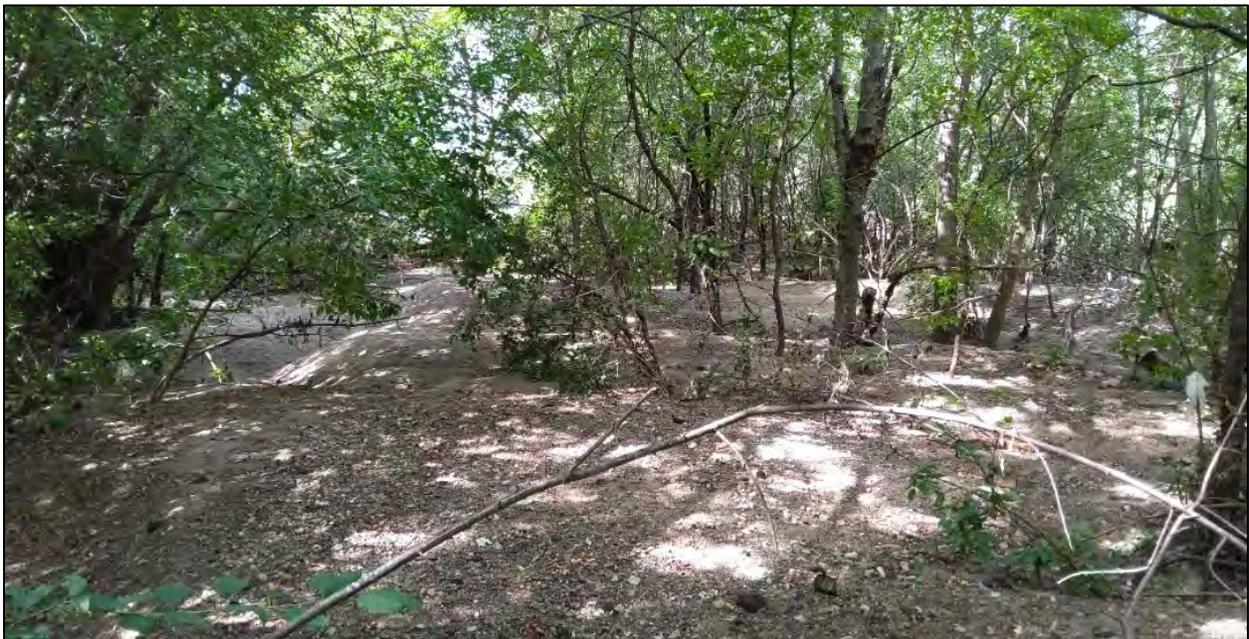
**Photo 4: Gravel bar along the midsection of Lake George. View to south.**

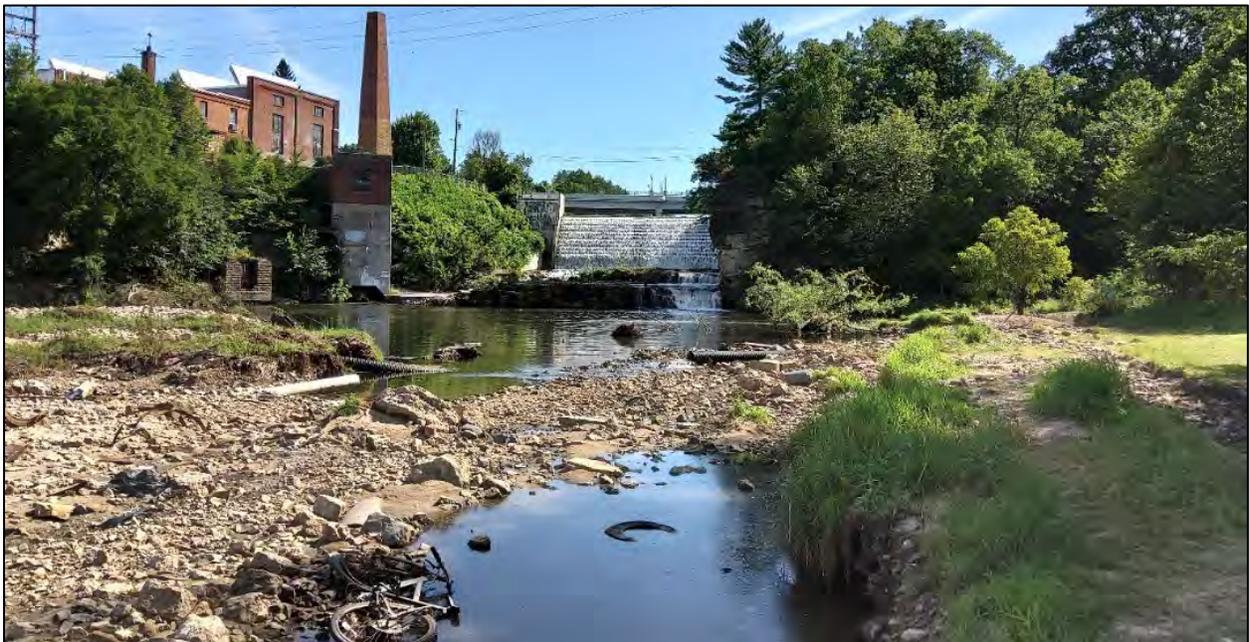
**Photo 6: Junction Falls Dam. View to northeast.**

In 1867 the first dam was built at Junction Falls and consisted of a rock filled timber dam used to generate power for a flour mill that was directly adjacent to the dam (City of River Falls 2018). In 1897 (Pierce County Historical Association 2020) the mill burned down, reportedly by arson fire to collect on the insurance. All that remains of the original 1867 mill is the smokestack (Pierce County Historical Society 2020, River Falls Journal 2018). In 1900, residents came together to create the River Falls Municipal Utilities and bought the Junction Falls Dam. During that same year, the Municipal Power Plant was built and provided the community with electricity and electric lighting (River Falls Municipal Utilities 2020). In 1920, the City of River Falls replaced the rock-filled timber dam with a concrete gravity dam. In 1923 a diesel generator was added but was removed sometime before 2020 (Pierce County Historical Association 2020). In 1948, a new powerhouse was built and during the early 1960s, the existing steel penstock was encased in concrete. Repairs and improvements have been made to the structures, but the penstock enclosed in concrete in the early 1960s and the powerhouse built in 1948 are still in use (River Falls Municipal Utilities 2020).

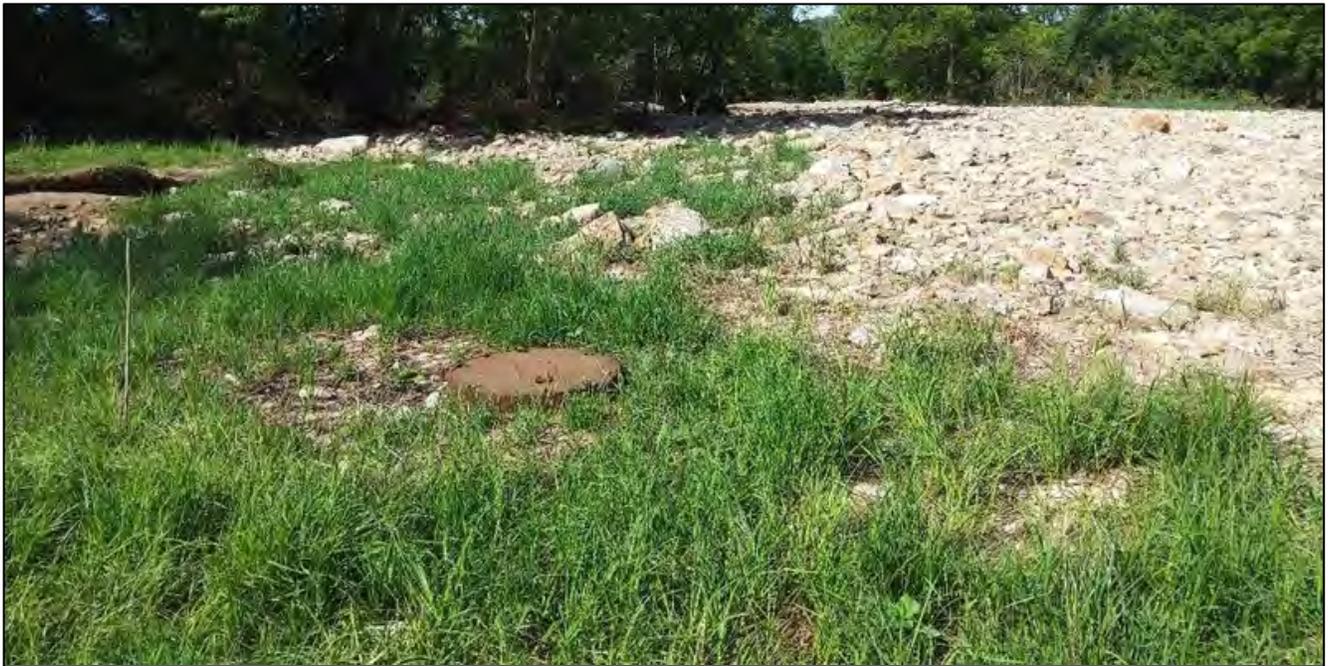
**Photo 3: A view of gravel bar and the sewer utility line within the northeastern quadrant. View to west.**

(10YR 5/3) sand (0-5 cm) over a B-horizon of black (10YR 2/1) sandy loam (5-30 cm). The water table was encountered at about 30 cm. The area had large gravel bars and showed disturbance caused by sewer construction as evidenced by a manhole in one of the gravel bars (Photo 3).

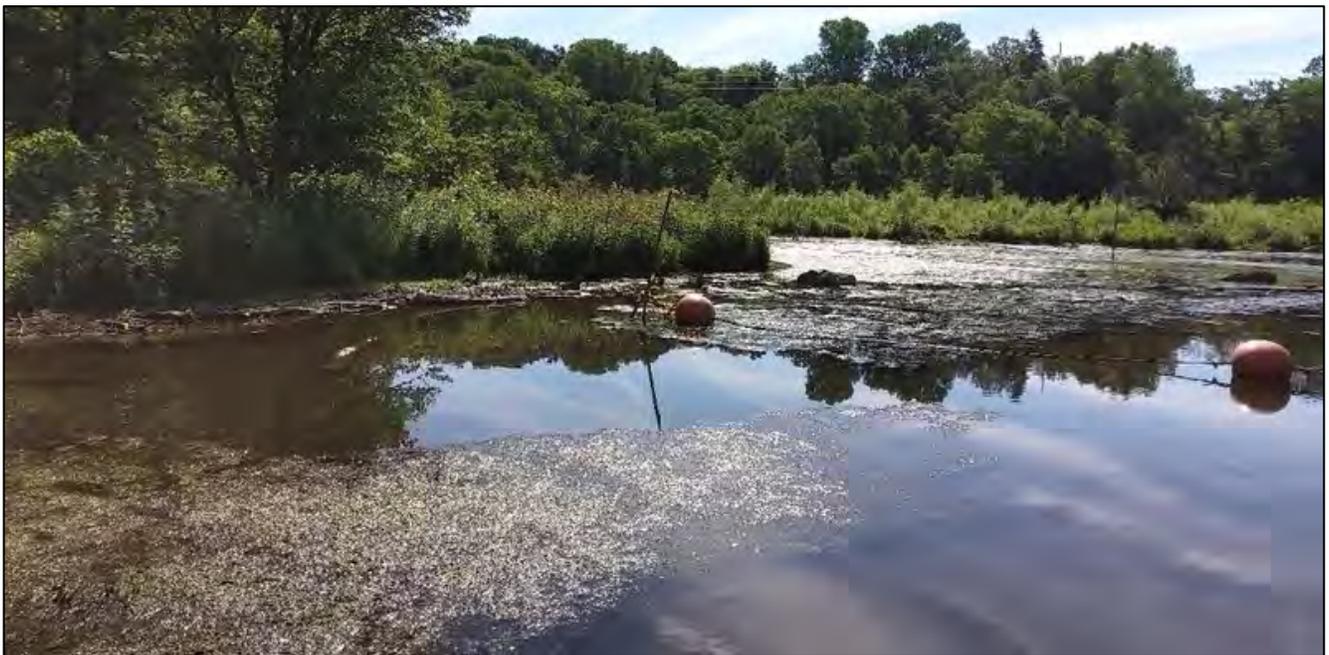
**Photo 4: Overview of stable shoreline in the southeastern quadrant. View to southwest.**

The July 2020 survey<sup>3</sup> examined the shoreline and noted that the northwestern shoreline of Lake Louise is stable and well vegetated with areas protected by natural slow water environments, which allow emergent and submergent vegetation to buffer the shoreline. Shovel tests were dug where it was possible to do so, but large areas of standing water and marsh were encountered. Soil profiles in shovel tests generally showed an A-Horizon of black (10YR 2/1) sandy clay loam (0-15 cm) over a B-Horizon of dark gray (10YR 4/1) sandy clay loam.

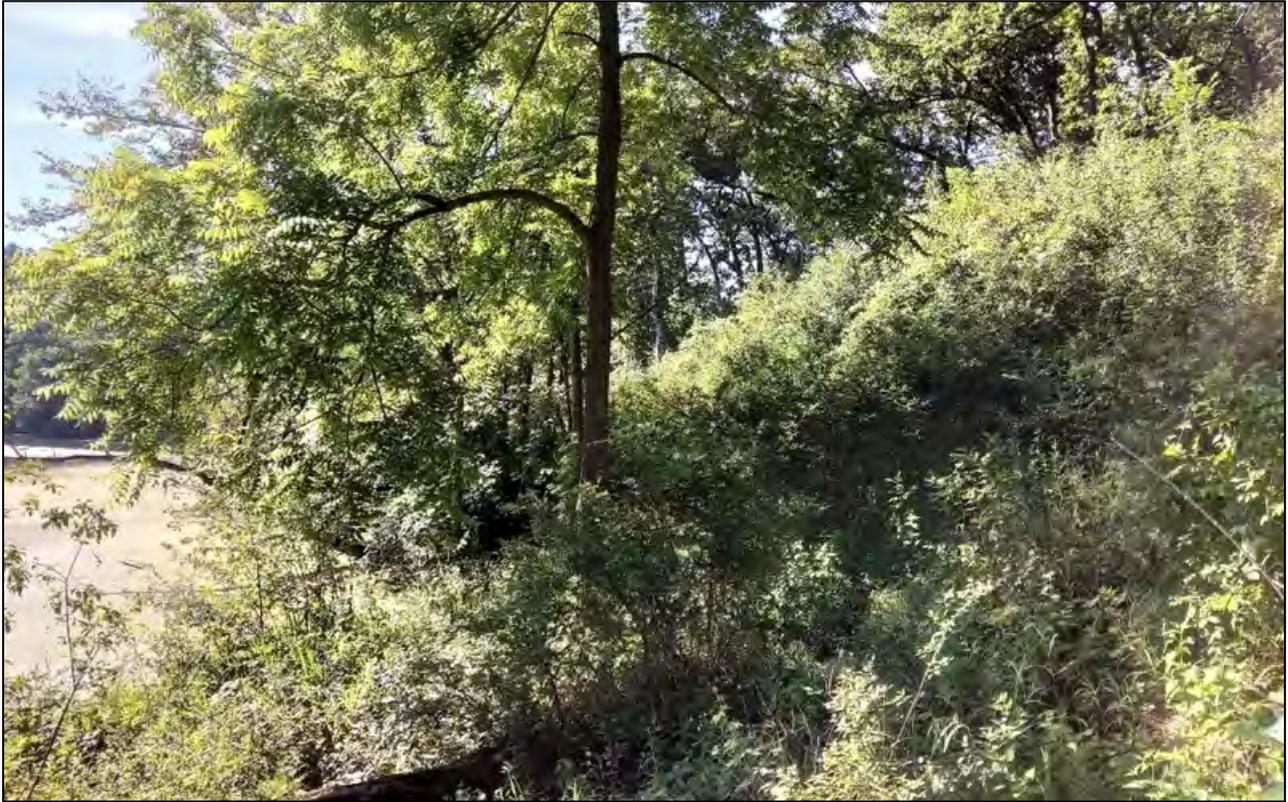
**Photo 5: View of slope of shoreline in the southwestern quadrant. View to south.**

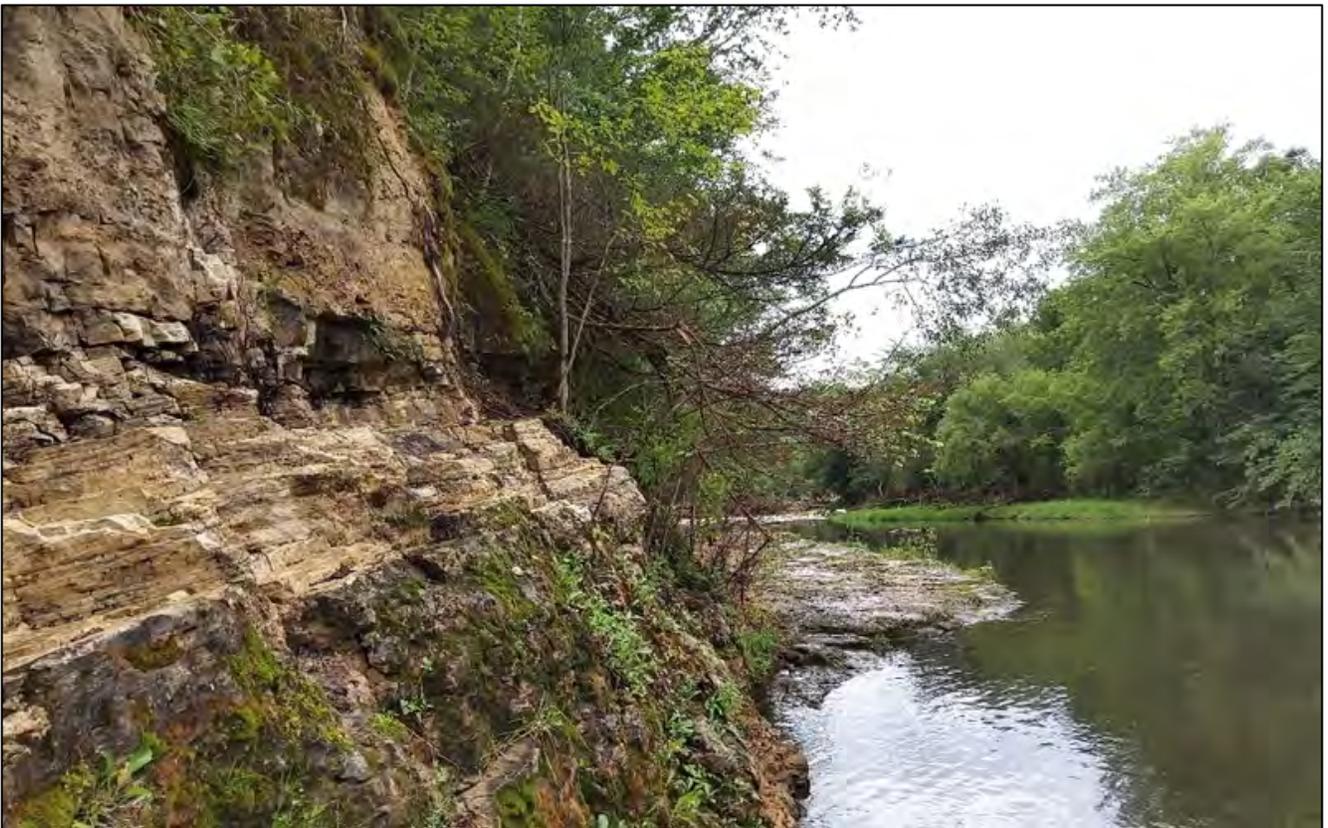
**Photo 8: Bank below Powell Falls Dam. View to southwest.**

About three acres of land below the dam were surveyed for the proposed dam removal with the Kinnickinnic River bisecting the three acres. Surface collection (also referred to as pedestrian survey), of the bluff tops and along the river edge noted that most of the area was steeply sloped (~80 percent). Shovel tests were dug where possible, even in areas with up to 40 percent slopes and dry soils. Shovel test profiles showed an A-Horizon of very dark brown (10YR 2/2) loam (0-30cm) over a B-Horizon of dark grayish brown (10YR 4/2) sandy loam. A single shovel test near the canoe launch and pedestrian trail on the south side of the river showed mixed, disturbed soils related to recreational use and landscaping.
