POWELL FALLS DAM REMOVAL SEDIMENT STUDY EVALUATION

**RIVER FALLS HYDROELECTRIC PROJECT
FERC No. 10489**

Kinnickinnic River Sediment Analysis for Proposed Powell Falls Dam Removal

Powell Falls Decommissioning Plan

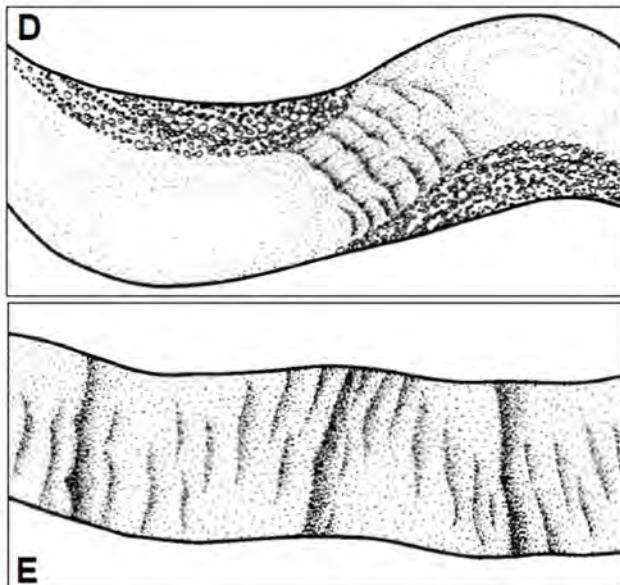
Figure 2: An idealized diagram of a pool-riffle (D) and dune-ripple (E) channel from Montgomery and Buffington, 1997

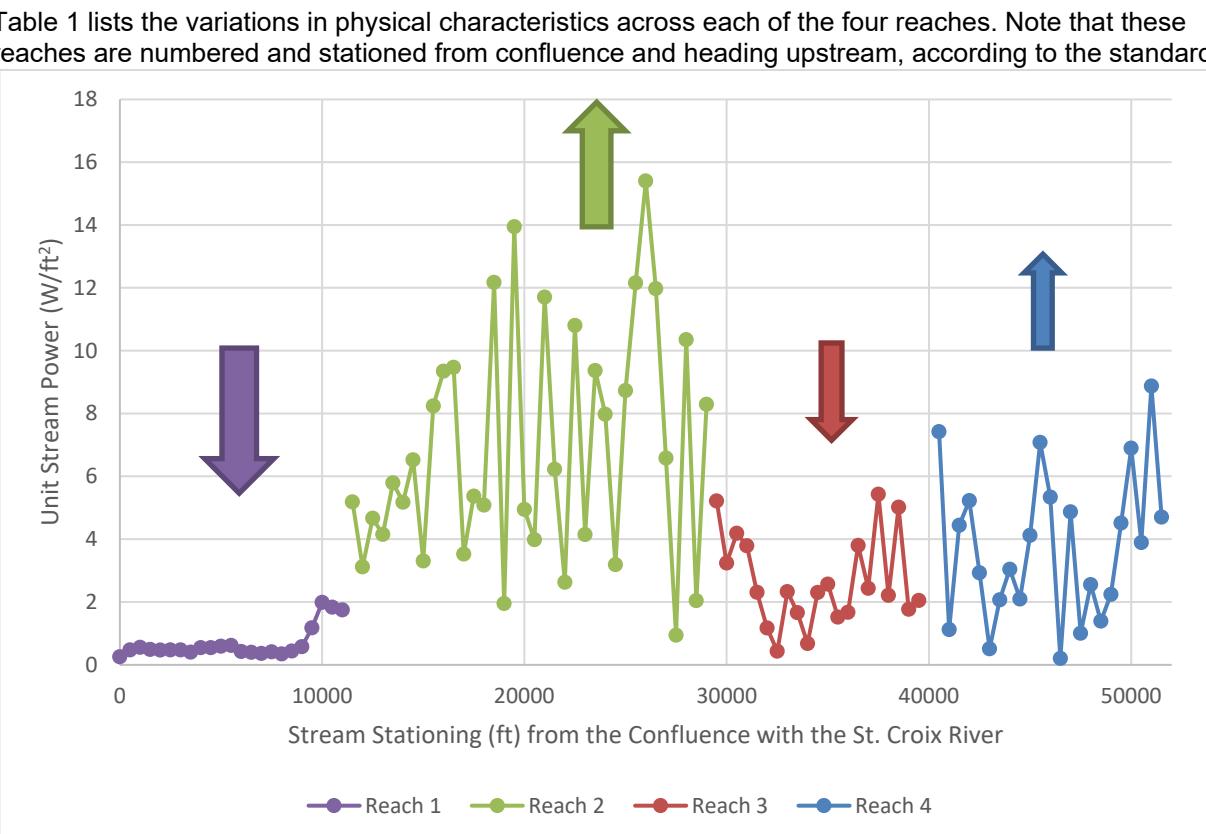
Figure 4: A plot of unit stream power along the study reach of the Kinnickinnic River. The different colors represent the reach breaks within the study reach. The arrows indicate relative change and magnitude compared to adjacent reaches.

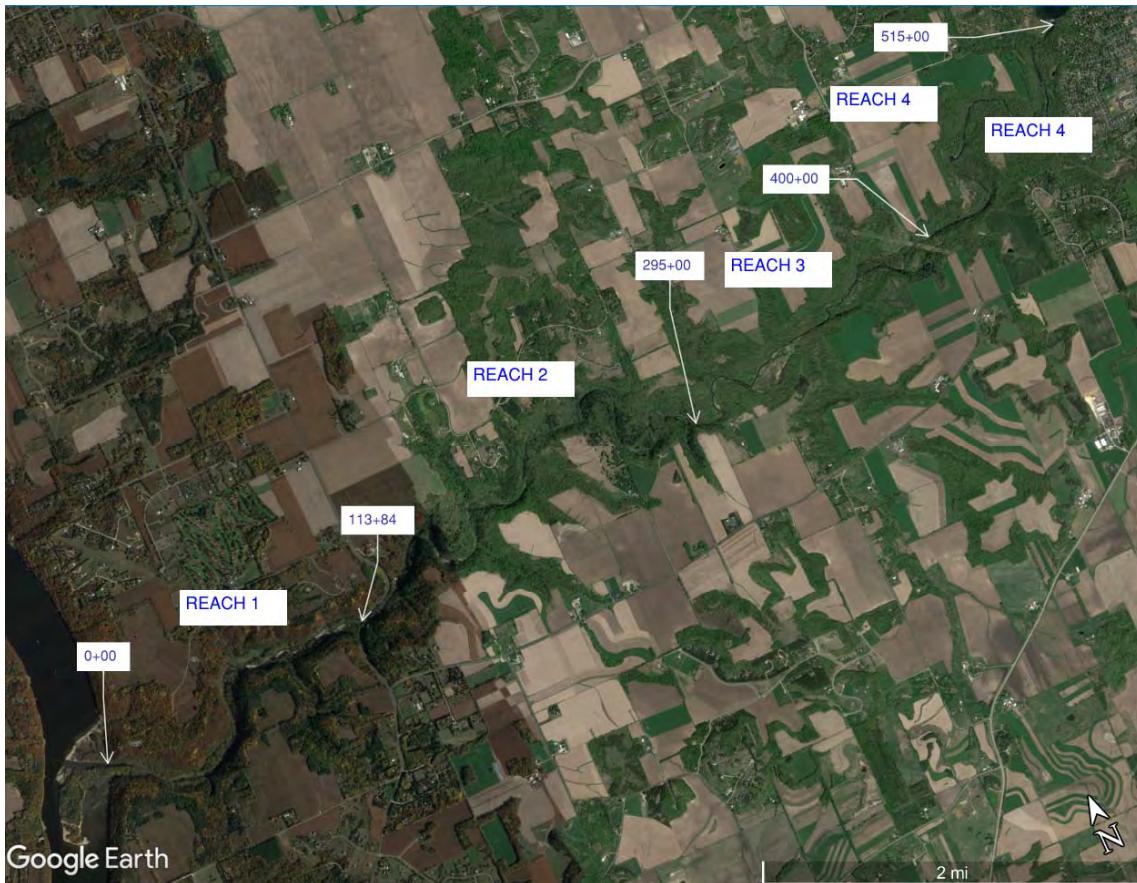
Table 1: Reach characteristics for the four reaches delineated along the Kinnickinnic River downstream of the Powell Falls Dam. Figure below table shows reach locations on a Google Earth Pro aerial photograph.

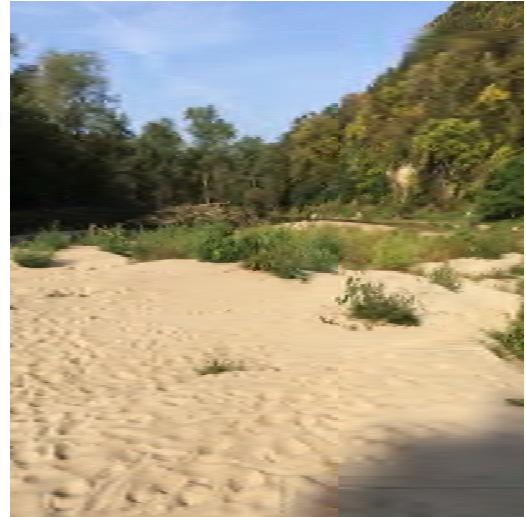
Figure 5: A sand deposit (~2,600 CY) in the shadow of a log jam deposited during the large 2020 flood.

The recent 2020 flood event has resulted in large amounts of deposition 200 feet past the mouth of the Kinnickinnic River into the St. Croix River, including sand and large wood. The dune-ripple portions of the Kinnickinnic River channel did not appear impacted by flood flows, with minimal log jams and very little scour or channel variations. This reach of the Kinnickinnic River stores significant amounts of sand transported from upstream. Above 60+00, sand has been deposited in at least six areas in velocity shadows and eddies during the flood (Figure 5). The channel was also realigned and diverted back into a cutoff channel following the event.

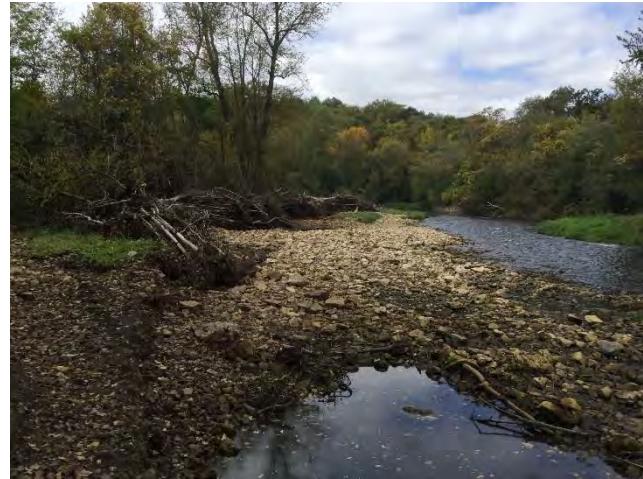
Figure 6: A photo taken looking downstream at the first meander bend where sands and fines have been removed and logs have been wrapped on trees.

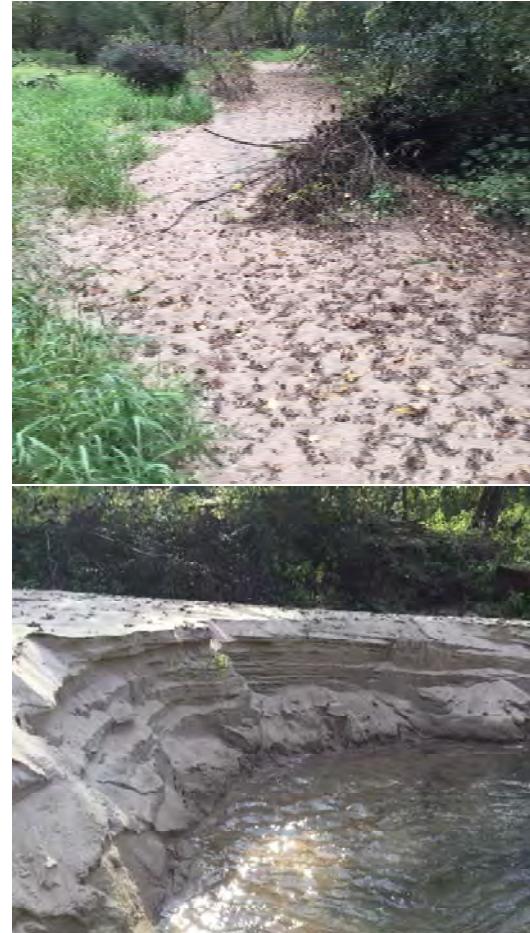
Figure 9: Sand deposited on overbanks and vertically in eddies.

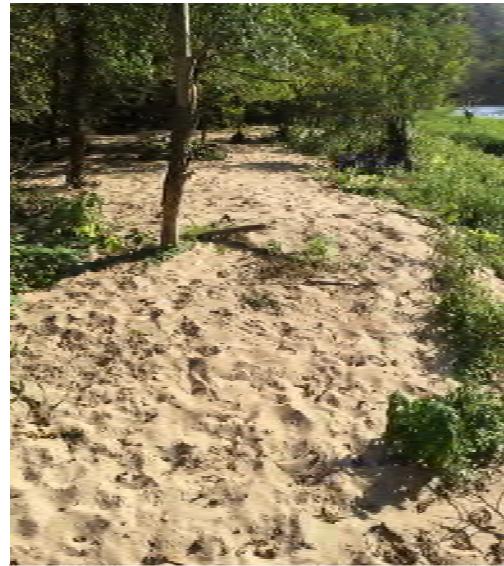
Figure 10: A typical sand bar deposit with dimensions approximately 80 ft x 30 ft x 7 ft (622 CY).

This estimate was confirmed by observations of many depositional bars during the field investigation. Based on the field investigation, these bars typically occur every 1,500 linear feet within Reach 1, 2, and 3 equating to approximately 23 bars. The maximum yearly volume release in the proposed conditions, 5,000 CY, is equivalent to approximately six depositional bars observed within bankfull channel.

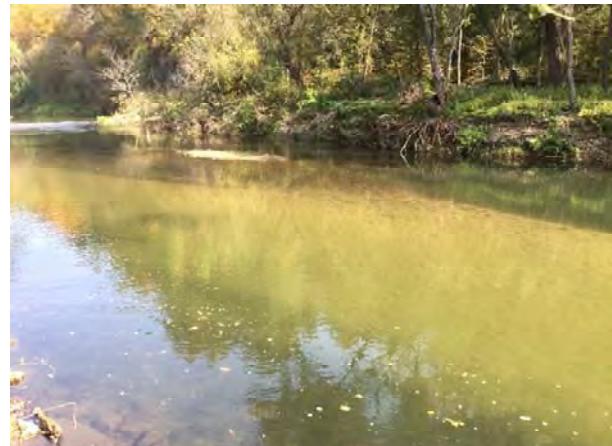
Figure 11: A pool filling with sand during low flow periods.

Normally, as described previously, pools will fill during low-flow periods and scour during high-flow periods. With an increased in sediment influx, these pools are likely to fill further than normal which will cause a decrease roughness and create a more uniform flow-depth and bed-gradient (Wohl, 2014). This will increase the ability of the stream to transport sediment during moderate- and low-flow periods while reducing channel heterogeneity and, potentially habitat. While the higher stream power makes this reach relatively less sensitive, it is also home to many high-functioning pool habitats and channel heterogeneity that may be at increased risk.

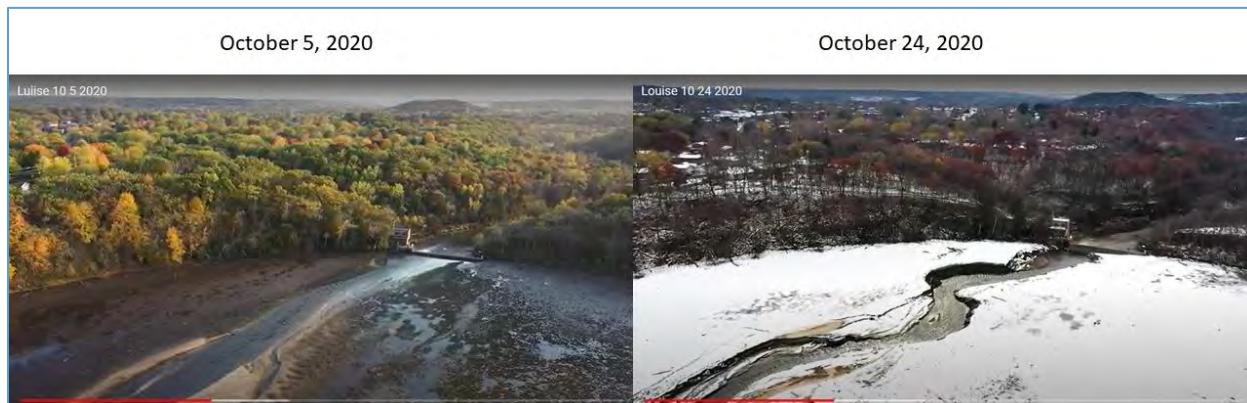
Figure 1. Aerial images of the Kinnickinnic River channel formation in the bed of Lake Louise during the Powell Falls Dam drawdown event of October 2020.

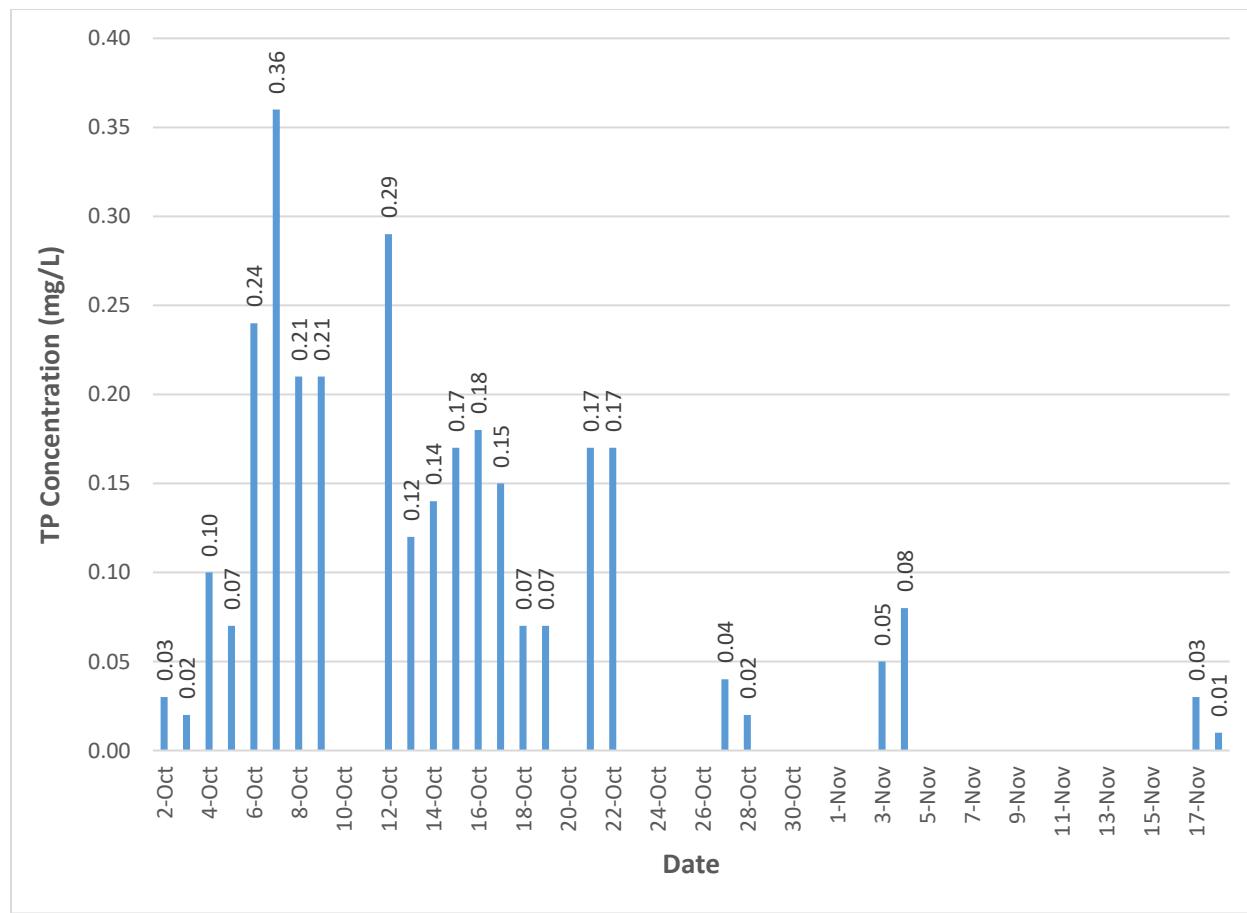
Figure 2. Total Phosphorus (TP) Concentrations (mg/L) in the Kinnickinnic River downstream of Powell Falls Dam

Note: State of Wisconsin total phosphorus water quality standard for streams is 0.075 mg/L (WDNR 2017).

Dam removal activities can impact water quality conditions by increasing suspended solids and releasing contaminants that were previously stored in the impoundment sediment. Given this concern, RFMU collected two parameters, total phosphorus concentration and total suspended solids, during the Lake Louise drawdown initiated on October 2, 2020 to monitor water quality impacts (results are depicted in Figure 2). Total phosphorus concentration was above the state of Wisconsin standard 13 of the 24 sampling dates. The highest value, 0.36 mg/L, occurred on

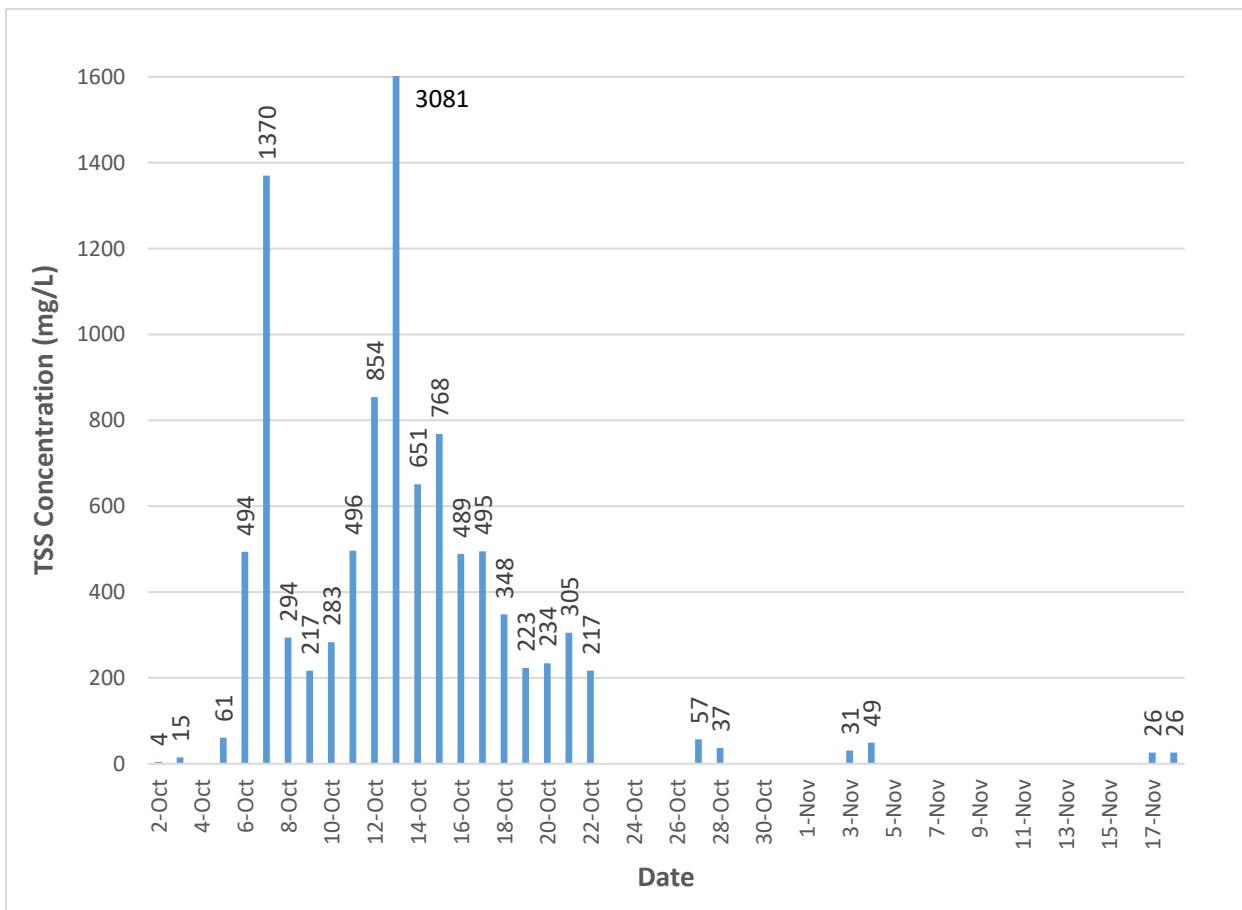
Figure 3. Total Suspended Solids (TSS) (mg/L) in the Kinnickinnic River downstream of Powell Falls Dam

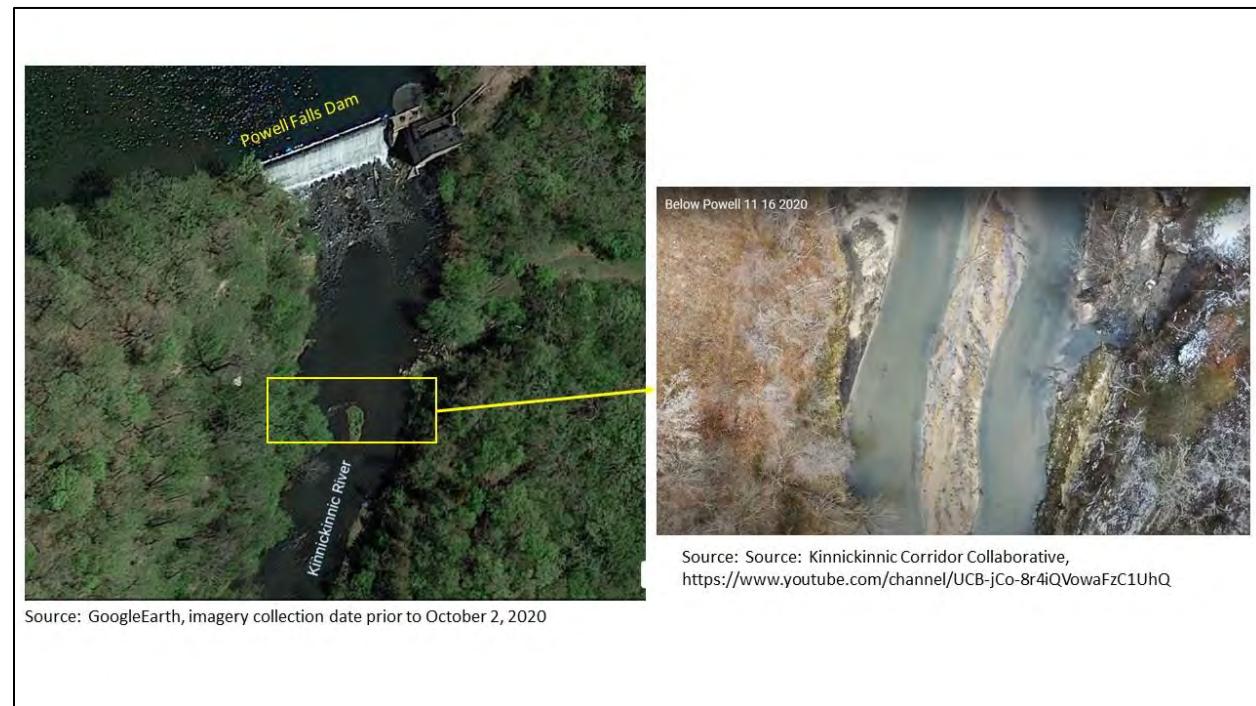
Figure 4. Aerial images of the Kinnickinnic River 200 feet downstream of Powell Falls Dam before and after the drawdown event of October 2020.

These observations demonstrate that the fine sediments released upstream will eventually settle in pool habitats of the Kinnickinnic River. The sediment accumulation in pools will influence the life stage specific behavior of Brown and Brook Trout that use this habitat. Decreased pool depth, i. e., raised channel bed elevation, can lead to decreased use of this habitat type as a holding location for resting or foraging for juveniles and adults. Daily peak water temperatures may increase in shallower pools because of the decrease in water volume, which could deter use by juveniles and adults. Short-term negative impacts to the life stages of Brown and Brook Trout due to increased sedimentation in pool habitats needs to be compared to the long-term advantages of dam removal.

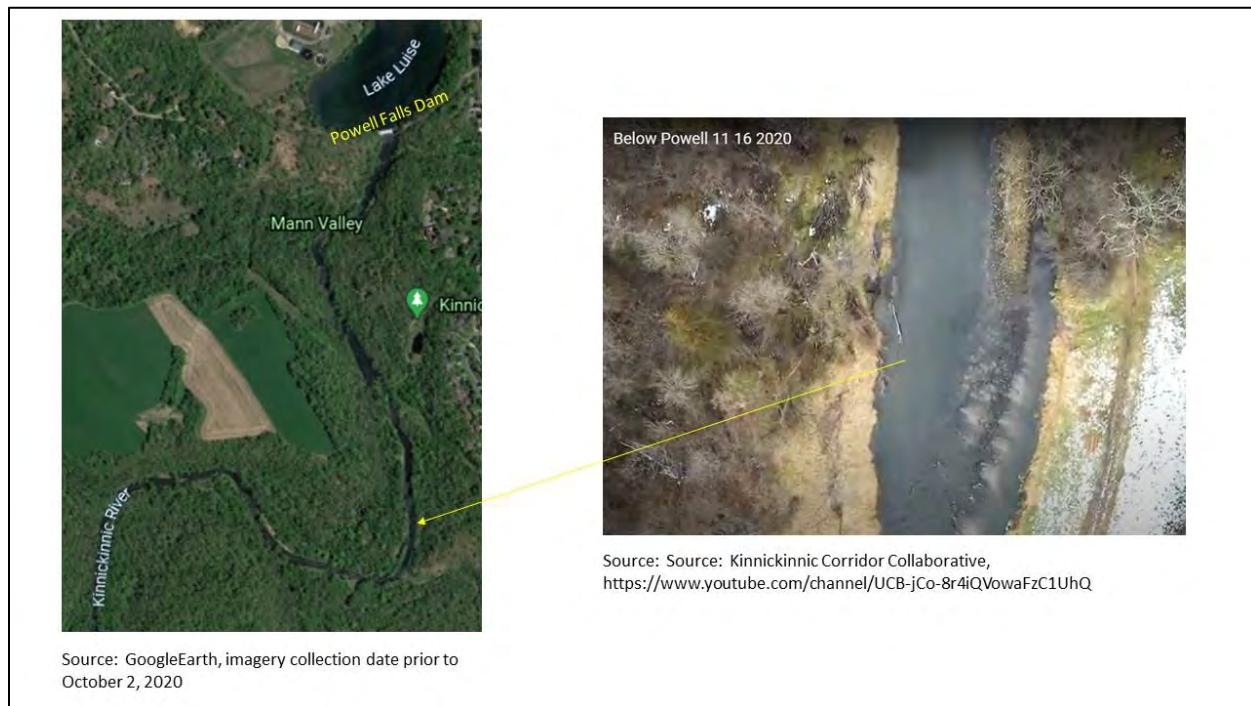
Figure 5. Aerial images of the Kinnickinnic River 3,000 feet downstream of Powell Falls Dam before and after the drawdown event of October 2020.

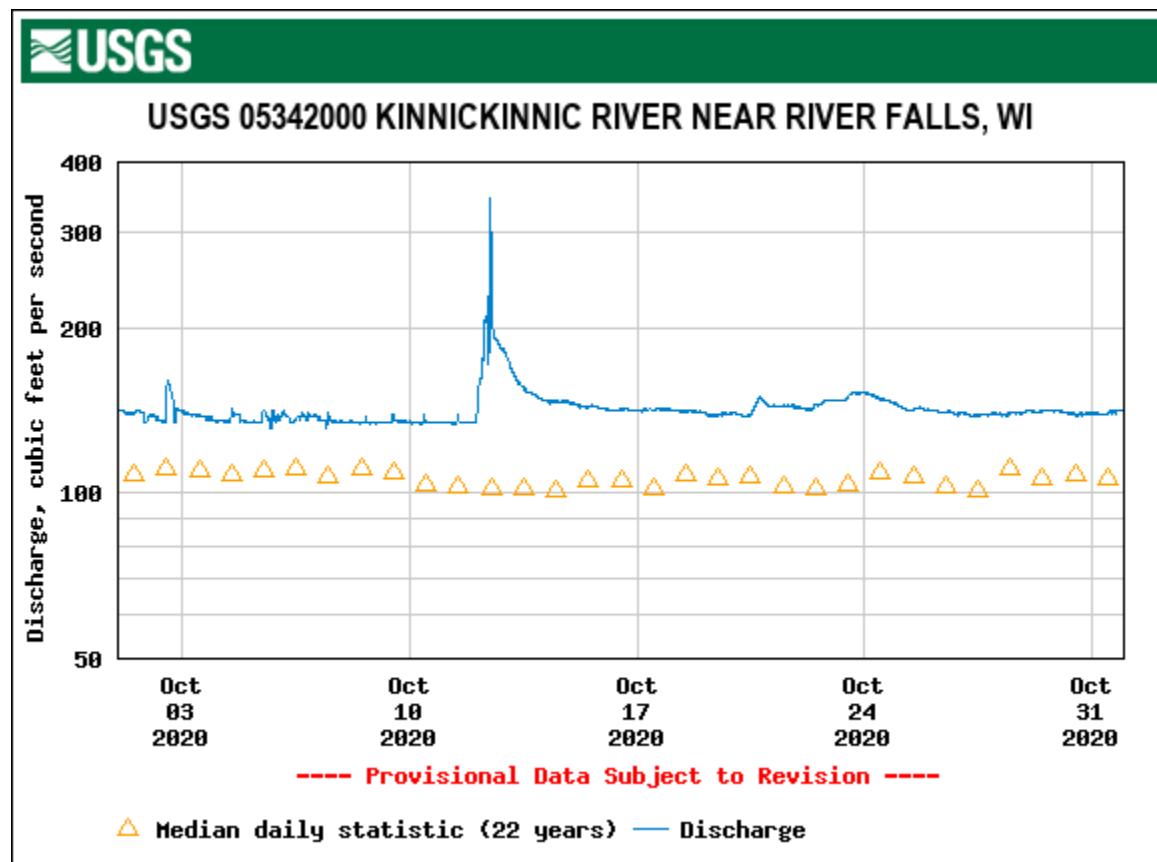
Figure 6. Kinnickinnic River discharge during the month of October 2020.

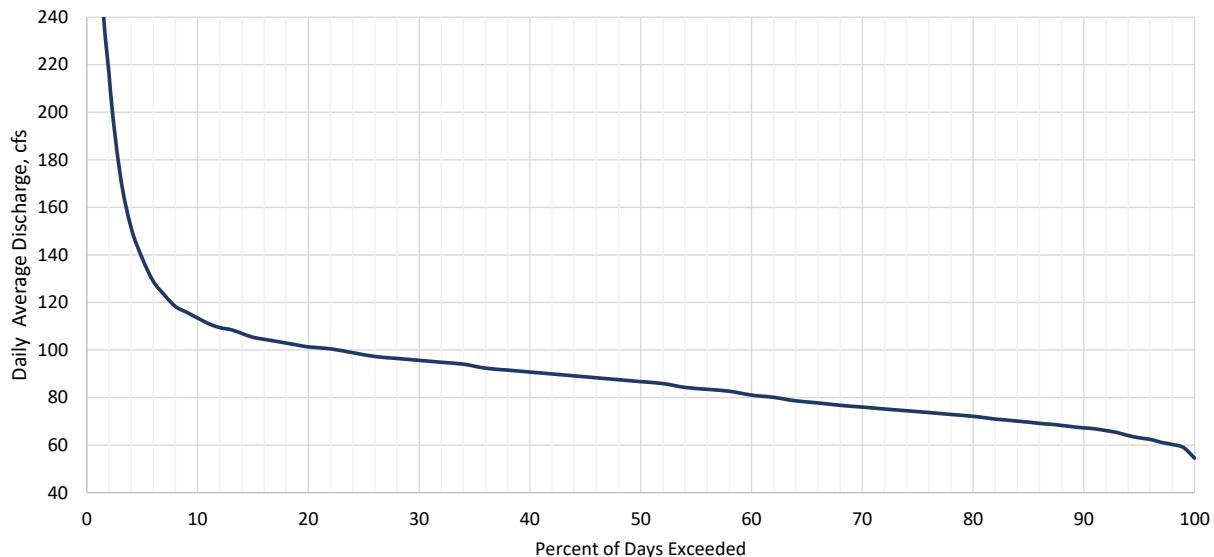
One definition of base flow is average daily flowrate for which half the records exceed and half the records are less than this value. Based on the USGS gage records for the Kinnickinnic River and adjusted for drainage area and flowrate ratios, the annual flow duration curve at Powell Falls was computed as shown in Figure 2 and the baseflow computed as 86 cfs.

Figure 2. Flowrate-duration curve for Powell Falls Dam

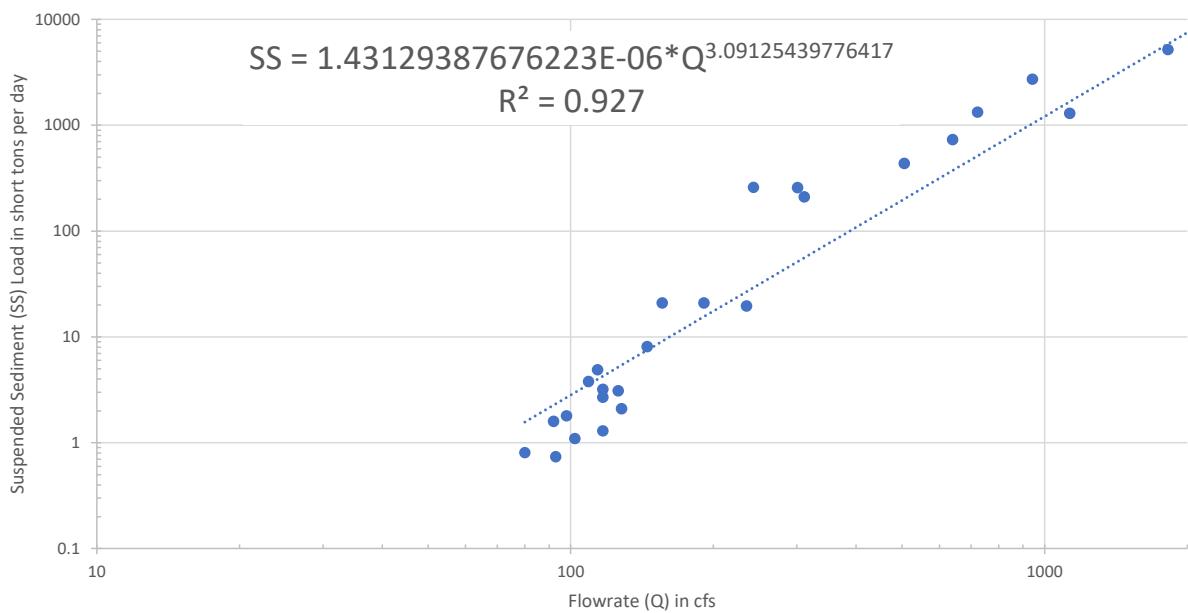
Figure 4. Correlation of suspended sediment load with flowrate

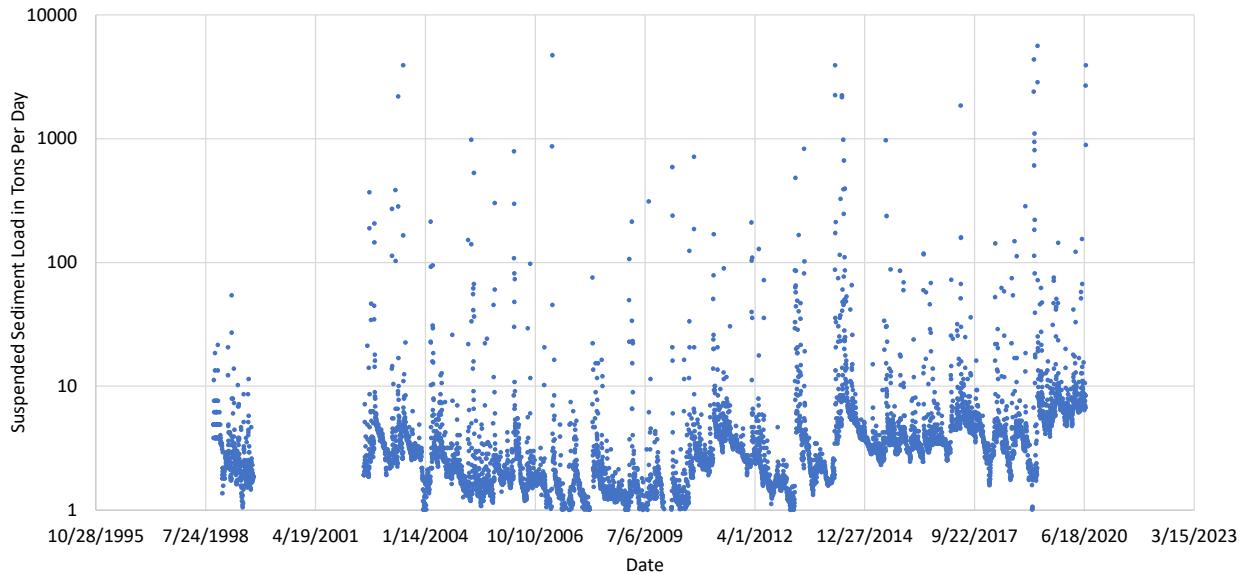
Figure 5. Variability in daily suspended sediment load for the Kinnickinnic River

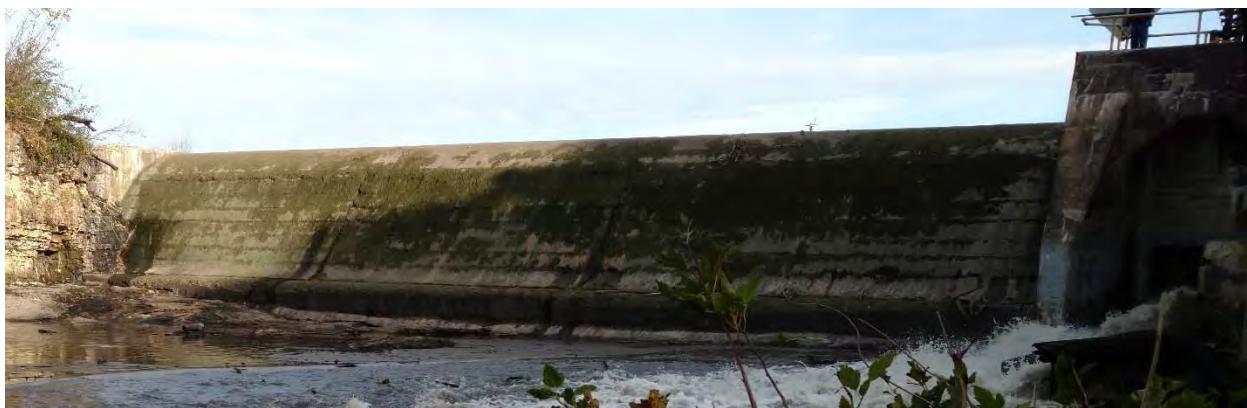
Figure 6. Right abutment bedrock (left side of figure) and main spillway (right side of figure)

Photographs shown in Figures 6 to 12 show various features discussed in the Decommissioning Plan. In Figure 6, note the variable bedrock height along the downstream end, or “toe” of the spillway. Note that “left” and “right” when referring to dam structures typically take the perspective of a viewer facing downstream.

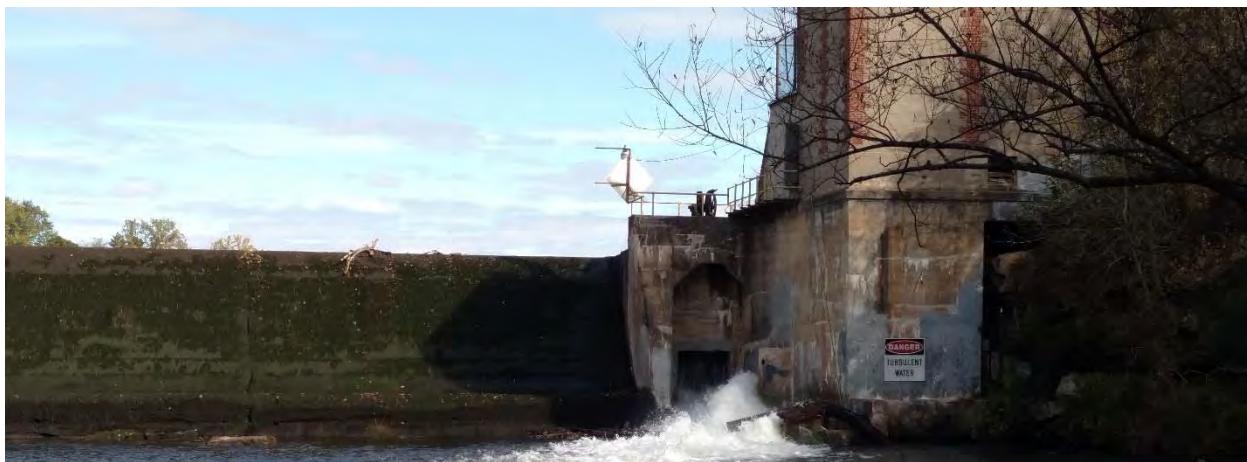
Figure 7. Left abutment (far right side of figure), powerhouse draft tube discharge (lower right, under the sign), powerhouse generating bay (upper right, above sign), and sluice or “waste” gate (lower center).

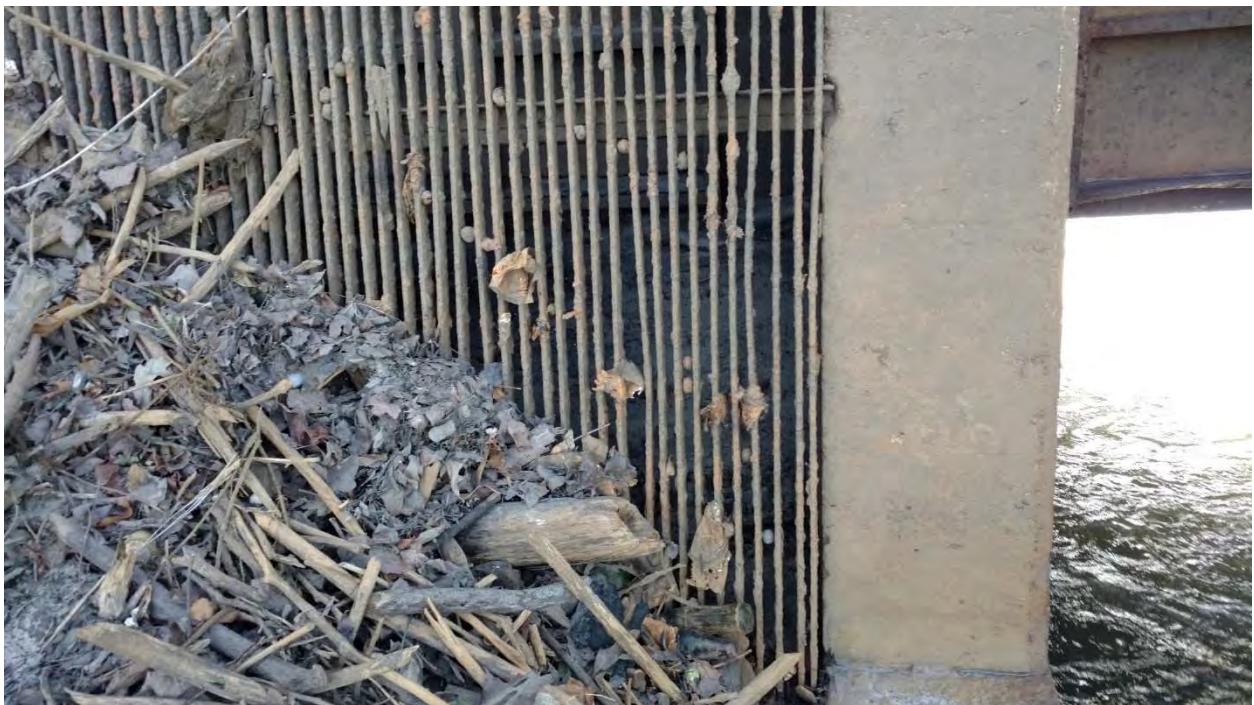
Figure 12. Sluice gate (looking from upstream side)

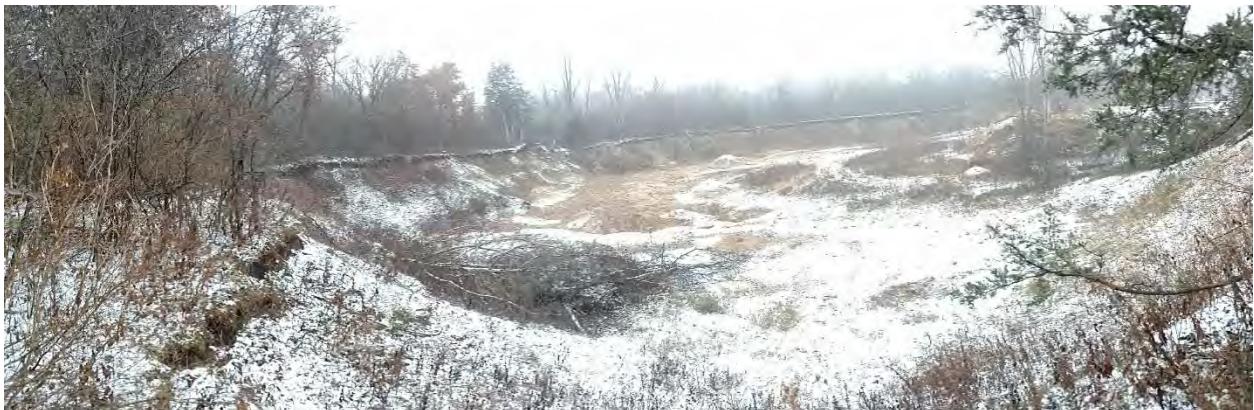
Figure 14. Proposed disposal site for concrete and sediments

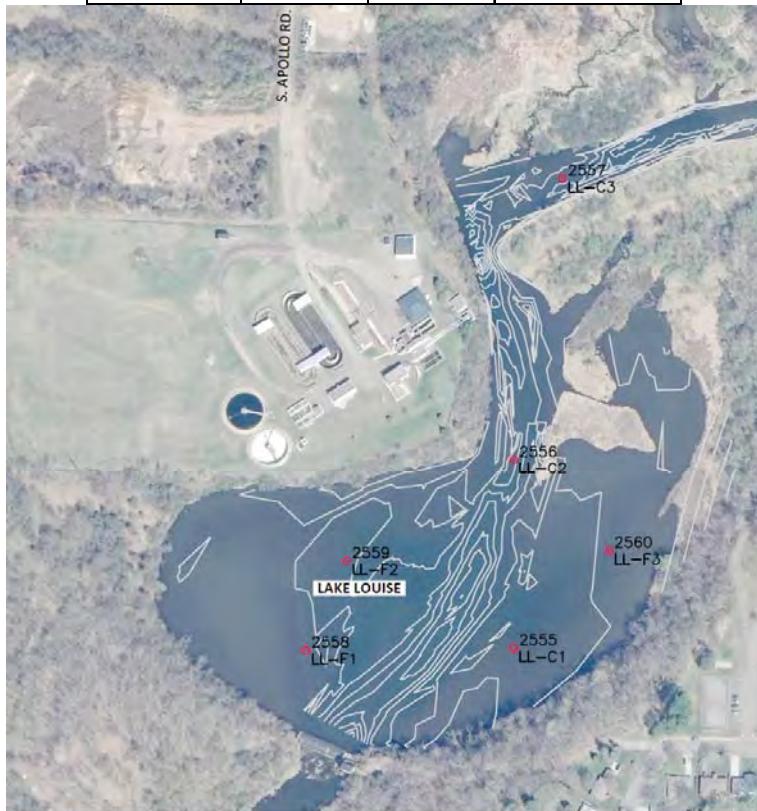
Core (2016)	k (ft/min)	Distance (ft)	Days to Dewater
LL-C1	5E-04	100	131
LL-C2	1E-01	10	0.05
LL-C3	5E-02	5	0.1
LL-F1	2E-03	200	81
LL-F2	1E-02	290	15
LL-F3	5E-04	280	366

Table 4 (top) and Figure 13 (bottom). Dewatering Time Estimated for 6 Sediment Samples

It is important to note that access to the new shoreline will be very difficult once the impoundment is lowered and soft soils prevent heavy construction equipment access. Sediment must dewater for a sufficiently long period to allow pore water to drain and sediment particles to gain strength to support construction equipment. The time to dewater impounded sediment is related to the permeability coefficient and seepage path length. Permeability can be estimated from the Hazen (1930) empirical formula, path length can be estimated from sediment core locations and the proposed channel location separation, and grain size is provided in Appendix C-2 of the Lake George and Lake Louise Sediment Assessment Report (2016). Based on these data, the time to dewater the impounded sediments in Lake Louise varies as shown in Table 4 (for locations shown in Figure 13).
