POWELL FALLS DAM REMOVAL SEDIMENT STUDY EVALUATION

**RIVER FALLS HYDROELECTRIC PROJECT
FERC No. 10489**

Kinnickinnic River Sediment Analysis for Proposed Powell Falls Dam Removal

Powell Falls Decommissioning Plan

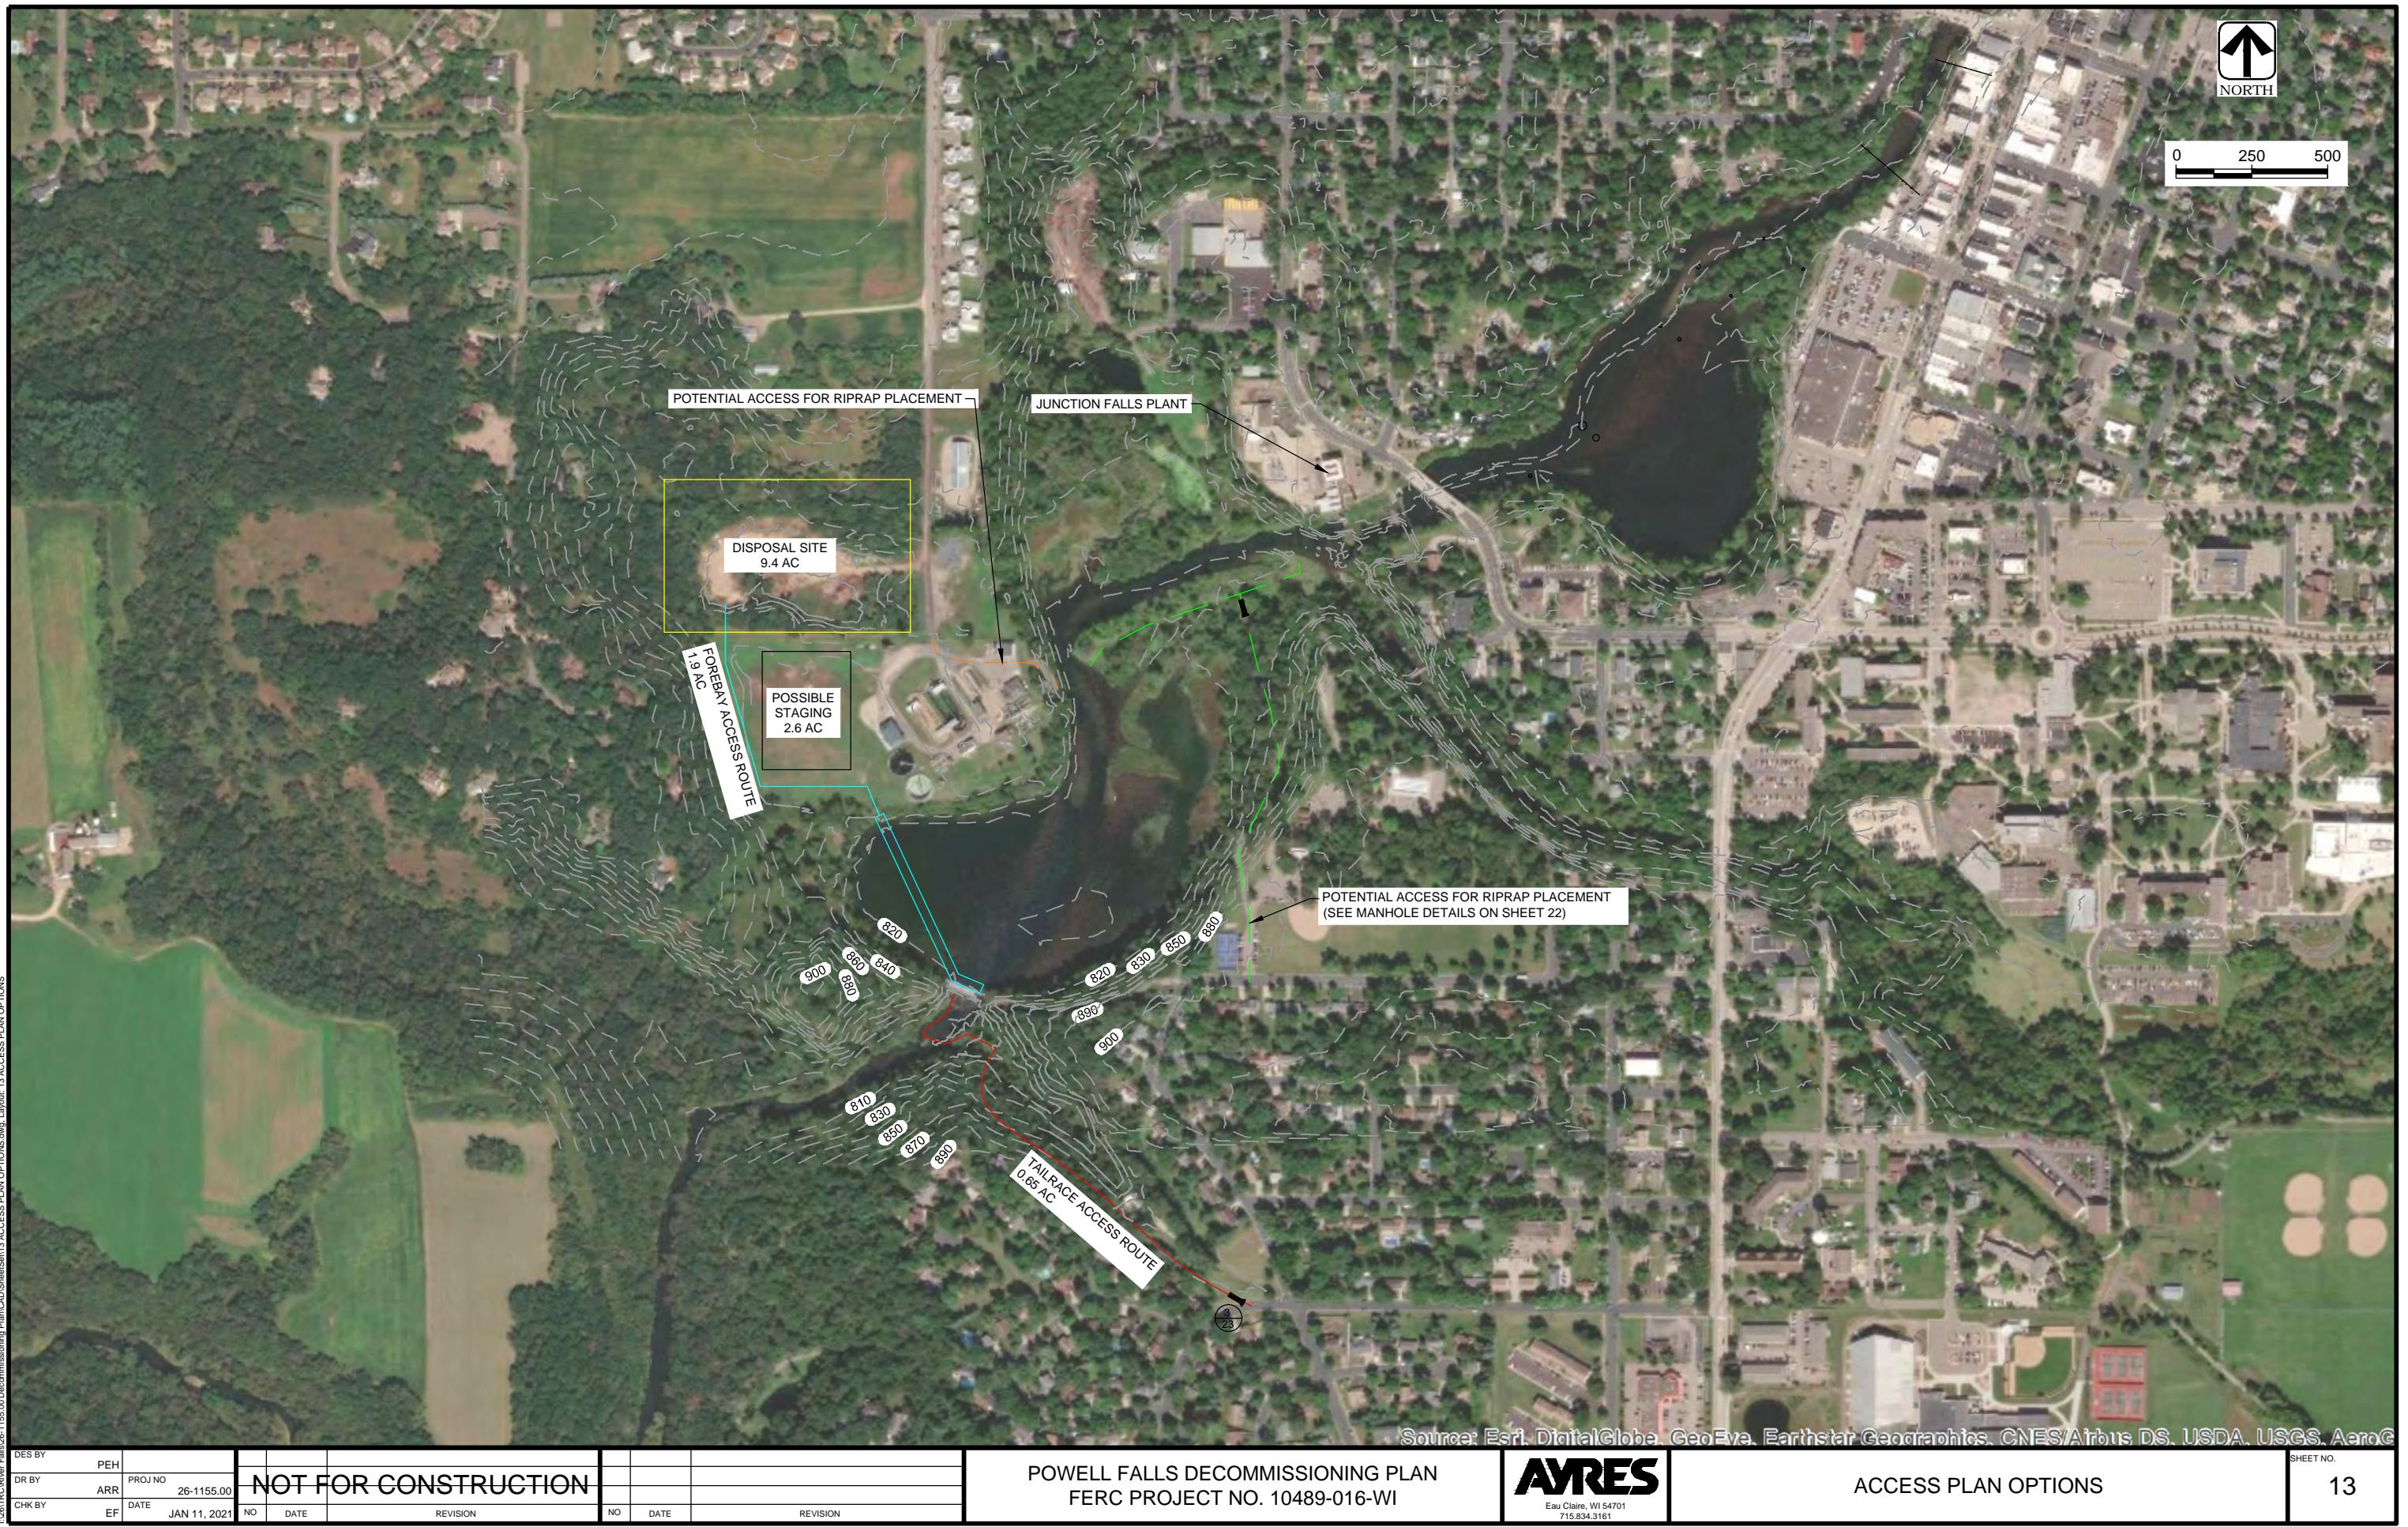
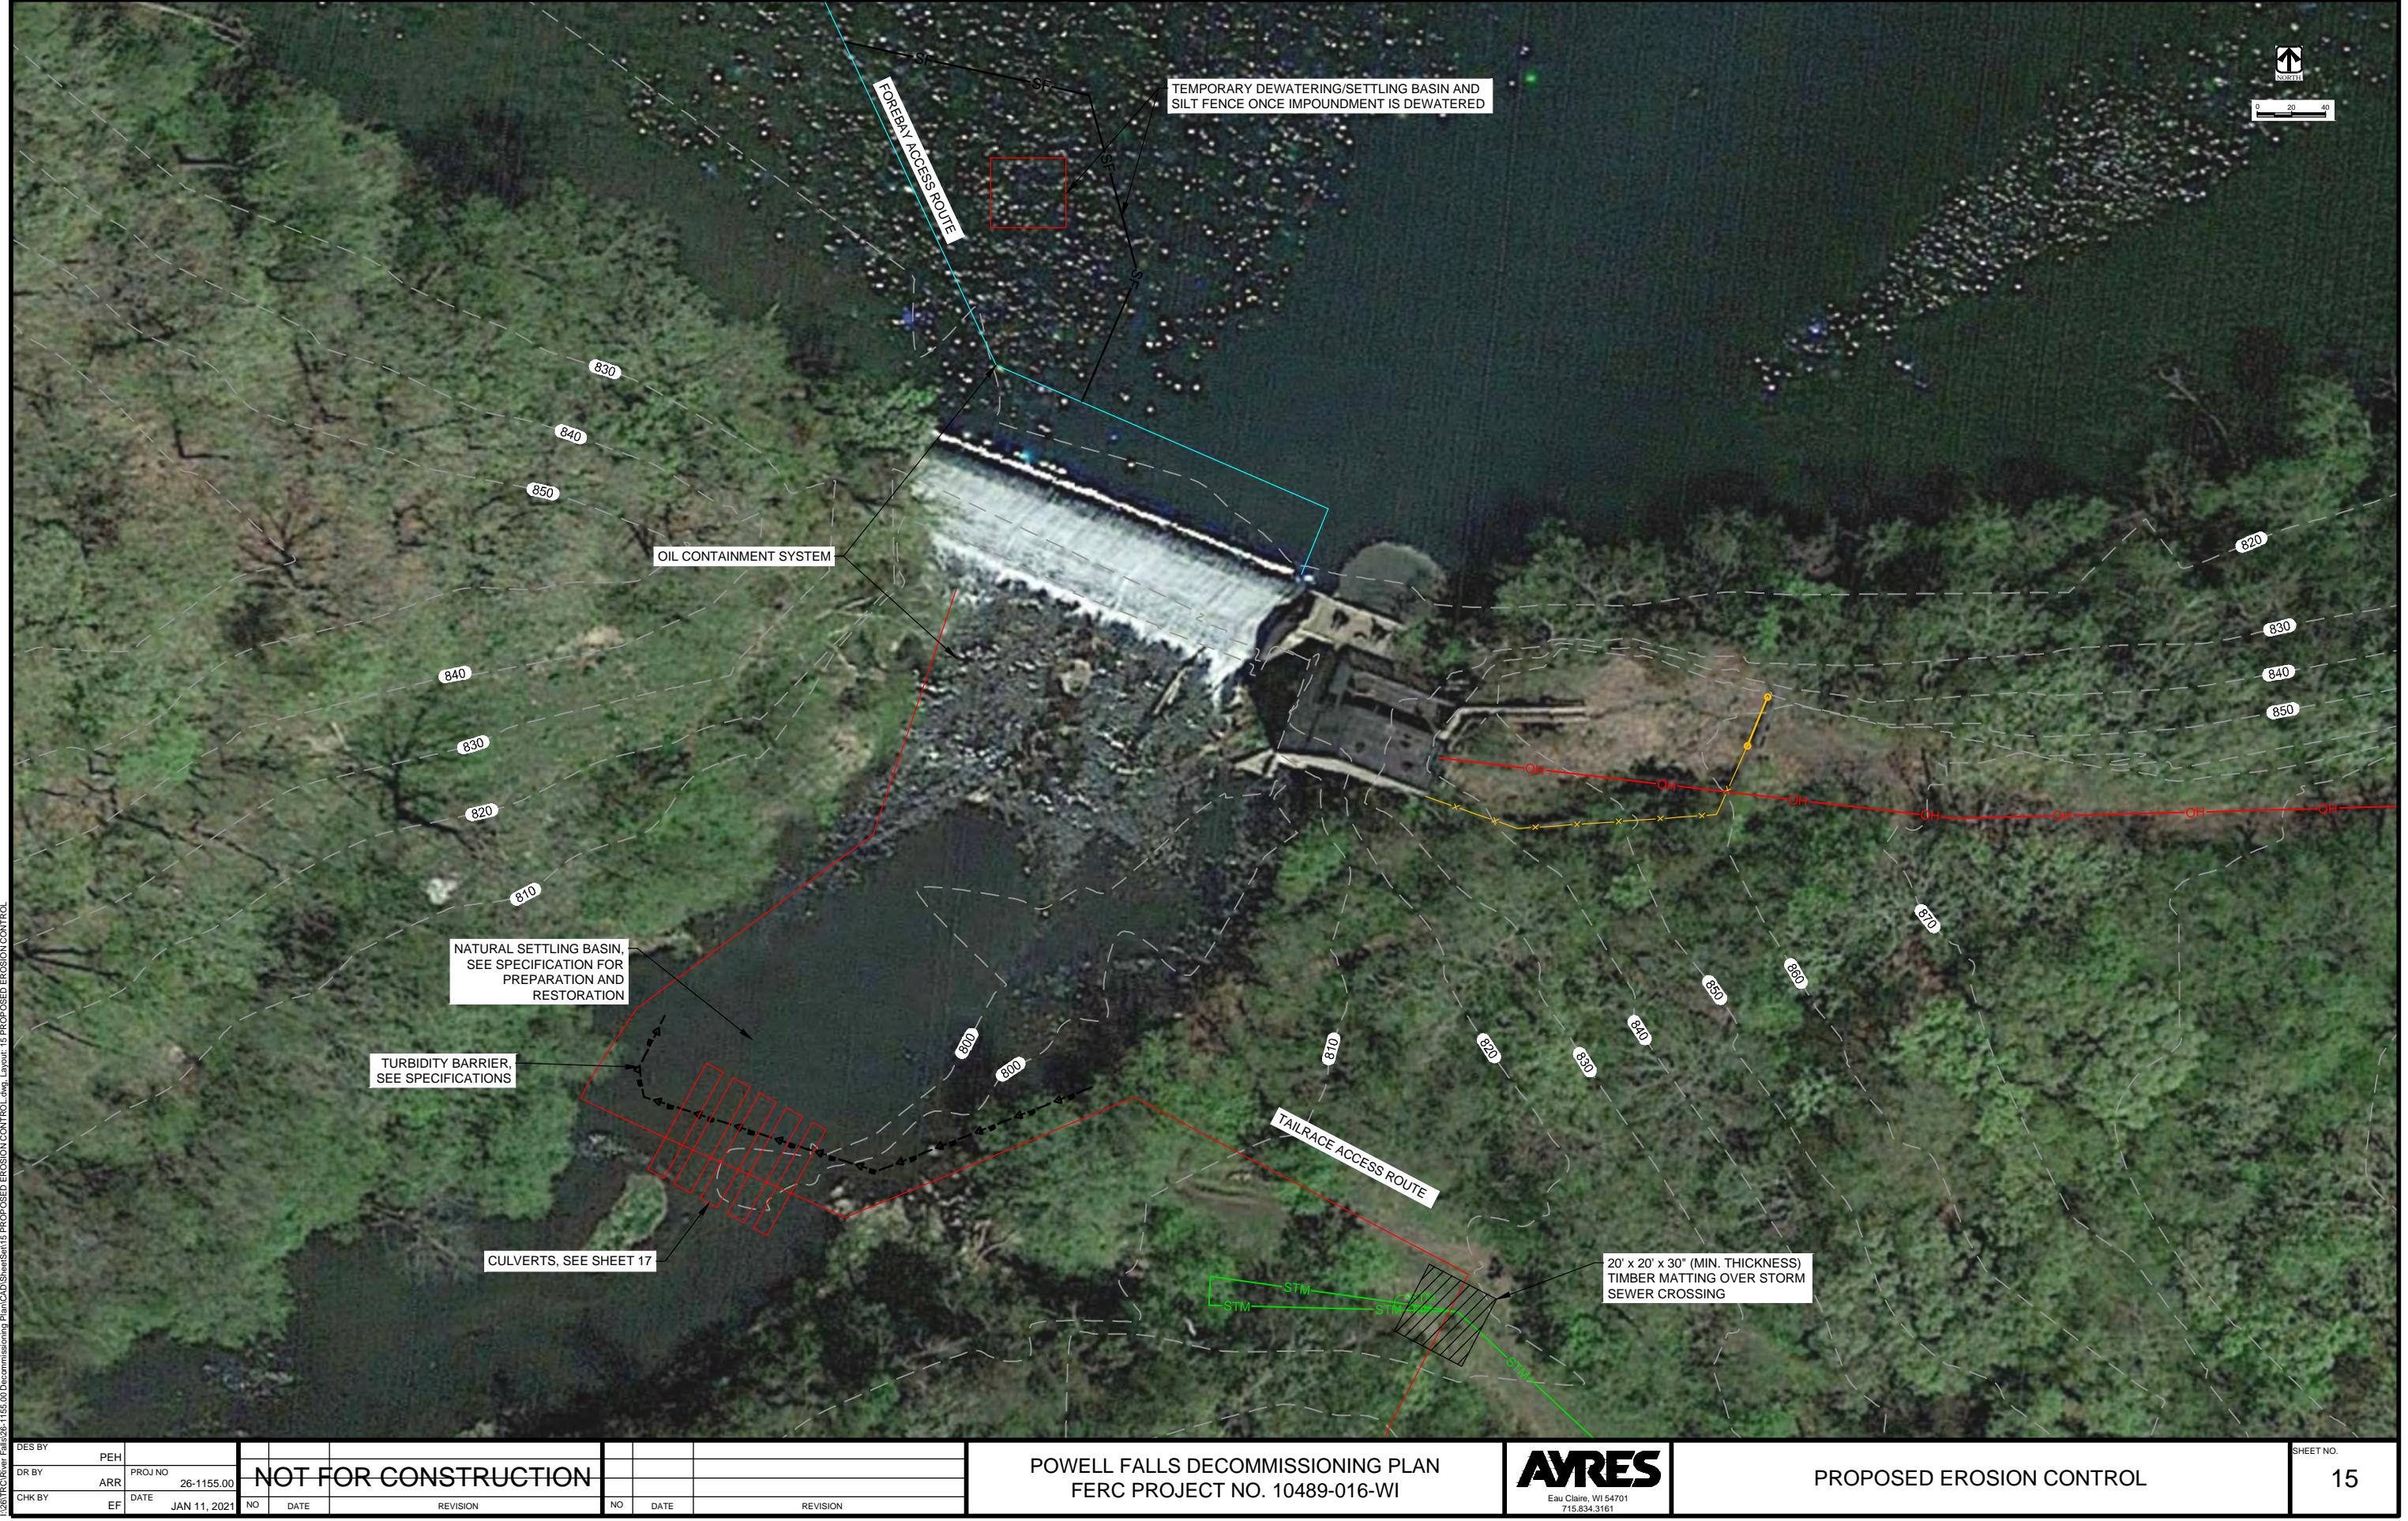
SHEET NO.
12

PROFILE THROUGH THALWEG

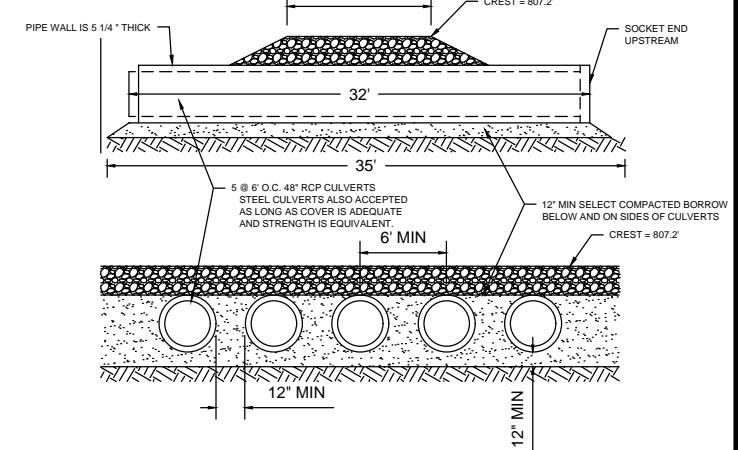
ROCK CAUSEWAY DETAIL
N.T.S.

5 @ 48" DIA. RCP CULVERTS (SEE DETAIL)

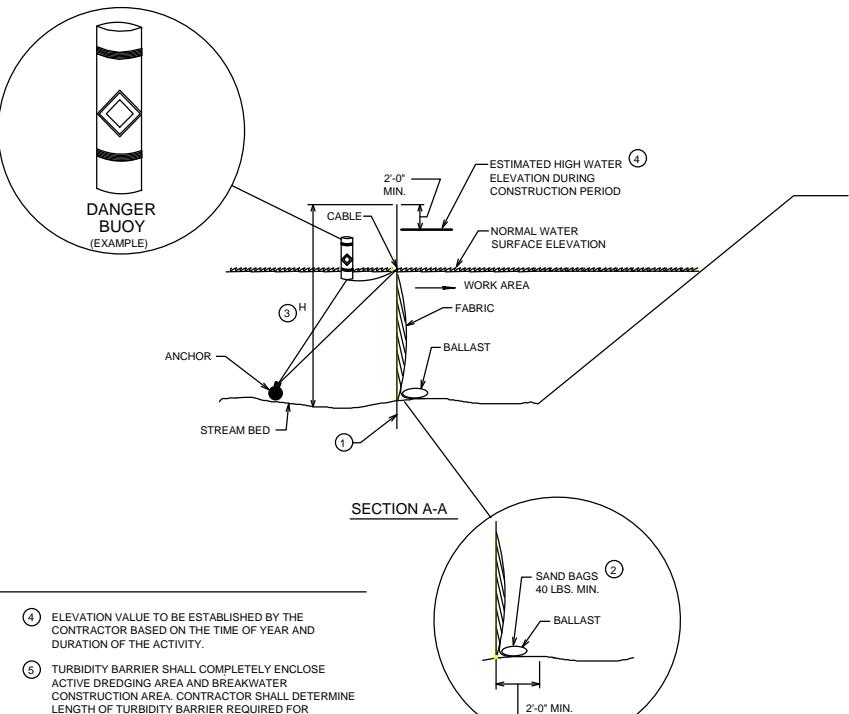
1 TURBIDITY BARRIER DETAIL
N.T.S. 0156203

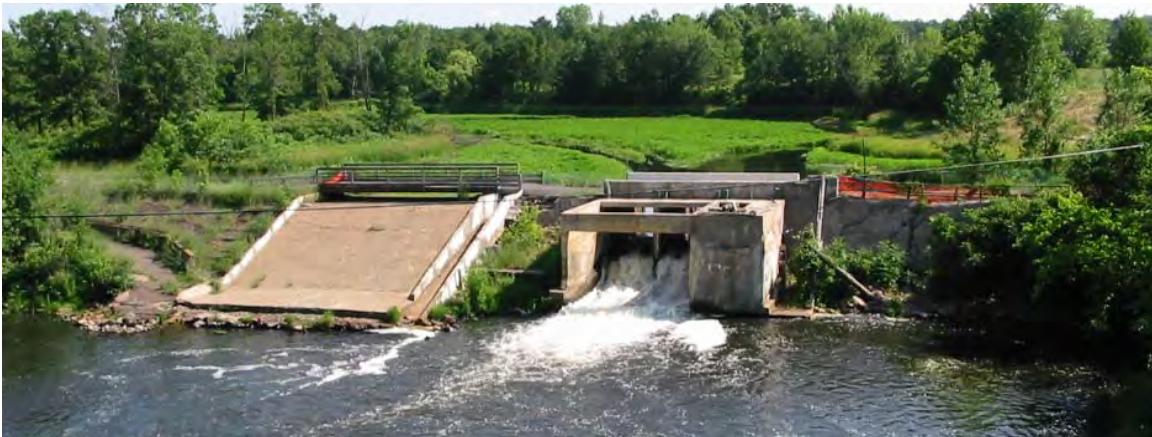
Figure 3. Woodley Dam in 2007 (powerhouse removed in 2003 and reservoir drawn down in 2001).

Citing excessive repair expenses, the grist mill building (last producing hydroelectric power in 1994 but never licensed under FERC jurisdiction) was removed in 2003 with little opposition (Figure 3), but the County's subsequent application for dam removal in 2003 was met with opposition.

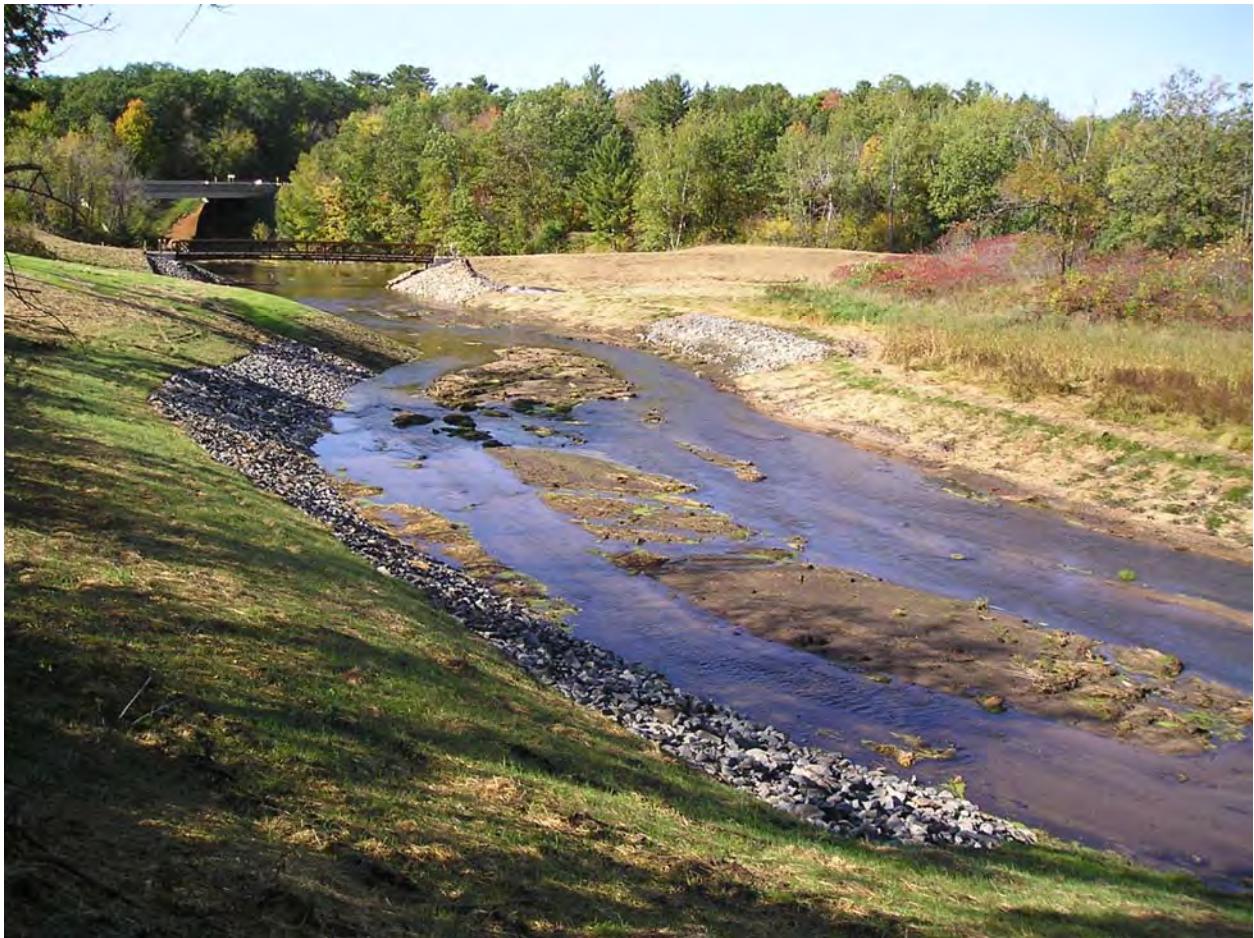
Figure 4. Woodley Dam in fall of same year as removal, note active sediment transport (bedload)

Figure 5 shows the site, two years after removal. The revised design (outer bend riprap and re-grading) successfully stabilized lateral bank stability, and the former scour hole below the dam had refilled with silt without leading to upstream migrating headcuts. The disposal site was stable and well vegetated.

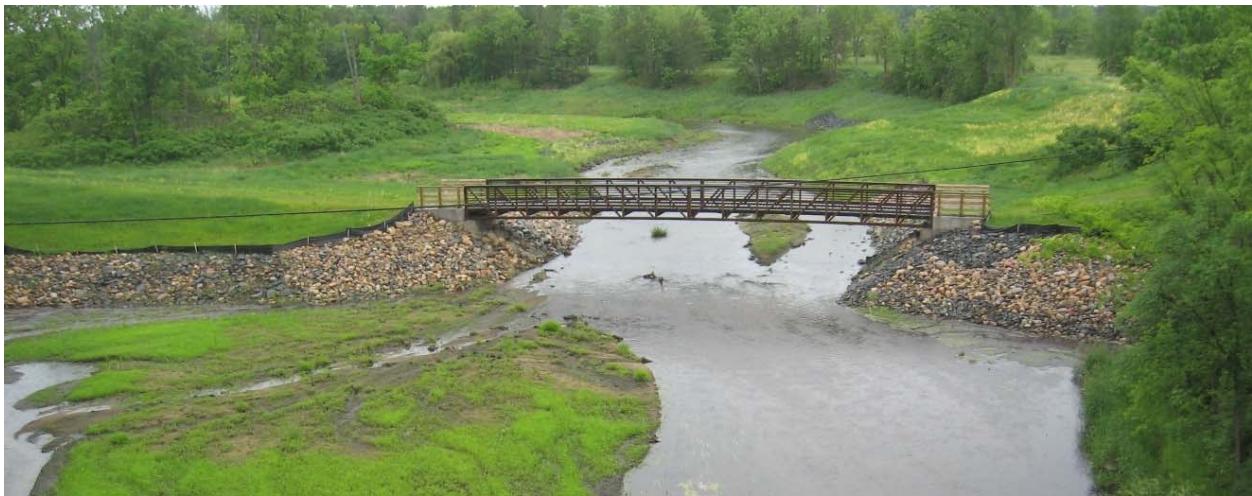
Figure 5. Woodley Dam two years post-removal (same view as Figure 3), note little sediment transport

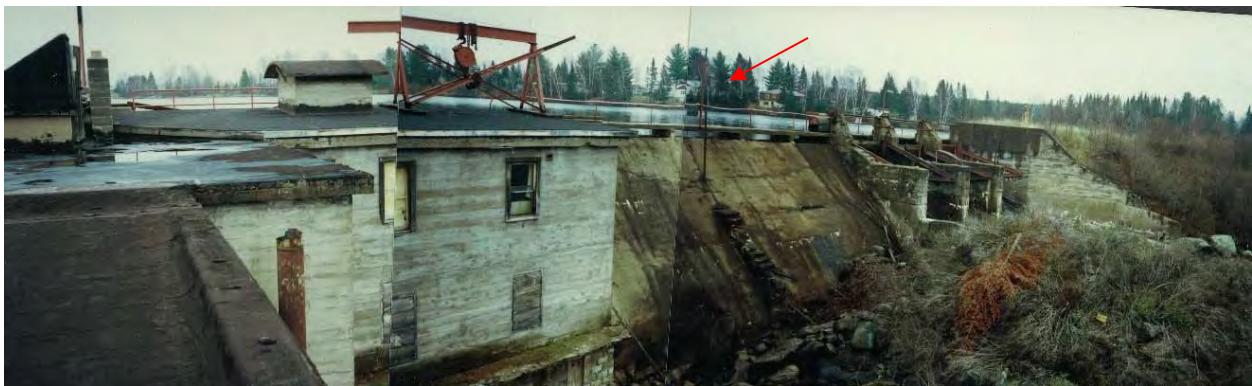
Figure 6. Grimh Dam in 1990, Pre-Removal

Figures 6 and 10 show, respectively, the before and after removal photographs (note the same house under the red arrow, though 15 years later).

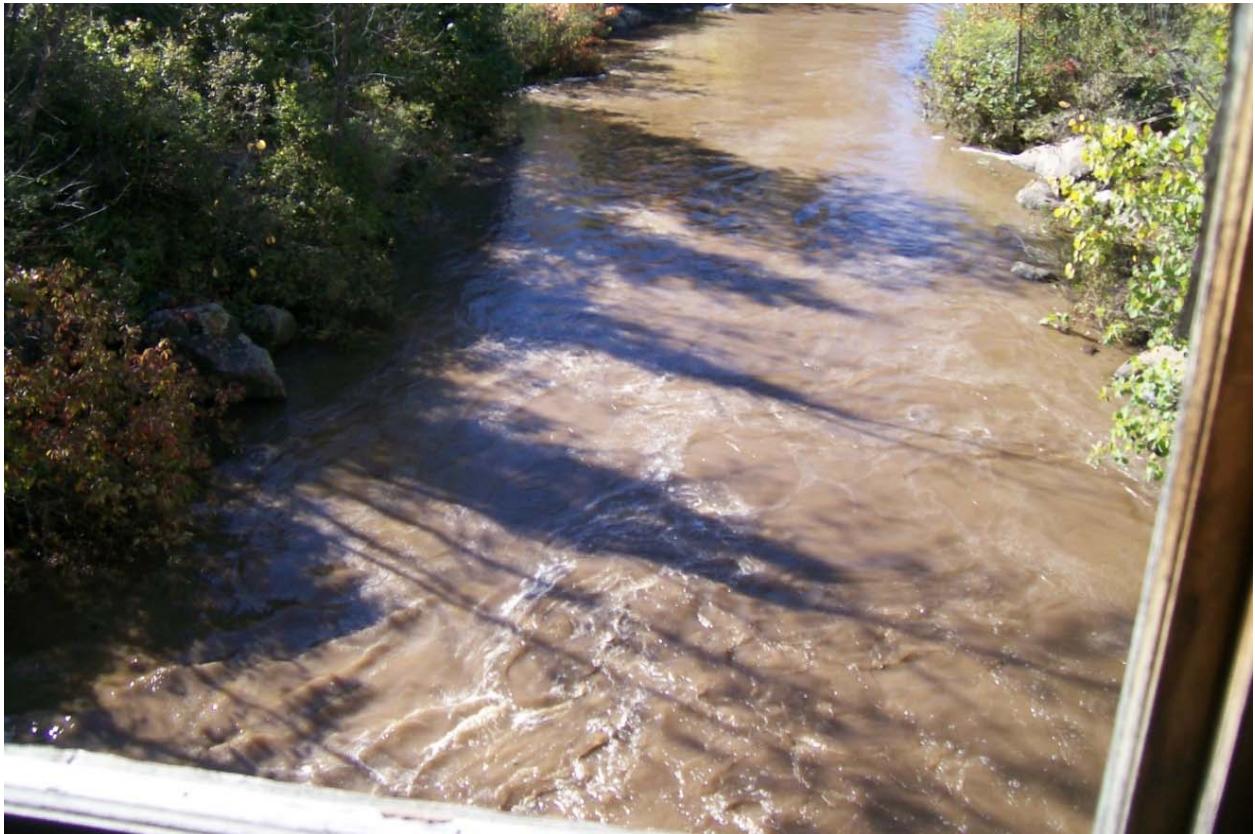
Even after a decade of the lake drawn down halfway and a slow methodical drawdown and removal sequencing plan, sediment management was a significant challenge when compounded with high water events. For dam safety reasons, the WDNR permit restricted any work done onsite during high water, and this permit condition was implemented twice. Grimh Dam’s cofferdam overtopped as four inches of rainfall fell in seven hours on September 25, 2010. An unknown quantity of sediment (possibly 5,000 to 10,000 cubic yards) was released during this single event to the Couderay and Chippewa Rivers. Consultation with DNR dam safety and permitting staff was frequent, and all parties agreed that dam safety was the highest priority throughout the flood. Turbidity was high for three days (Figure 7), but then the river returned to normal color. Since the lake had refilled during the flood, the WDNR and Ayres waited for the lake to return to a drawn down condition for inspections of the remnant site. Within two weeks, Ayres’ inspections of the rivers below the removal site found no evidence of new sandbars, no change in bedforms, and little evidence that a large volume of silt had been released. However, the reservoir clearly showed signs that up to three feet of channel bed incision had occurred during this single event. The contractor was allowed to resume work once the high water period had passed.

Figure 7. Couderay River below Grimh Dam during September 2010 flood event

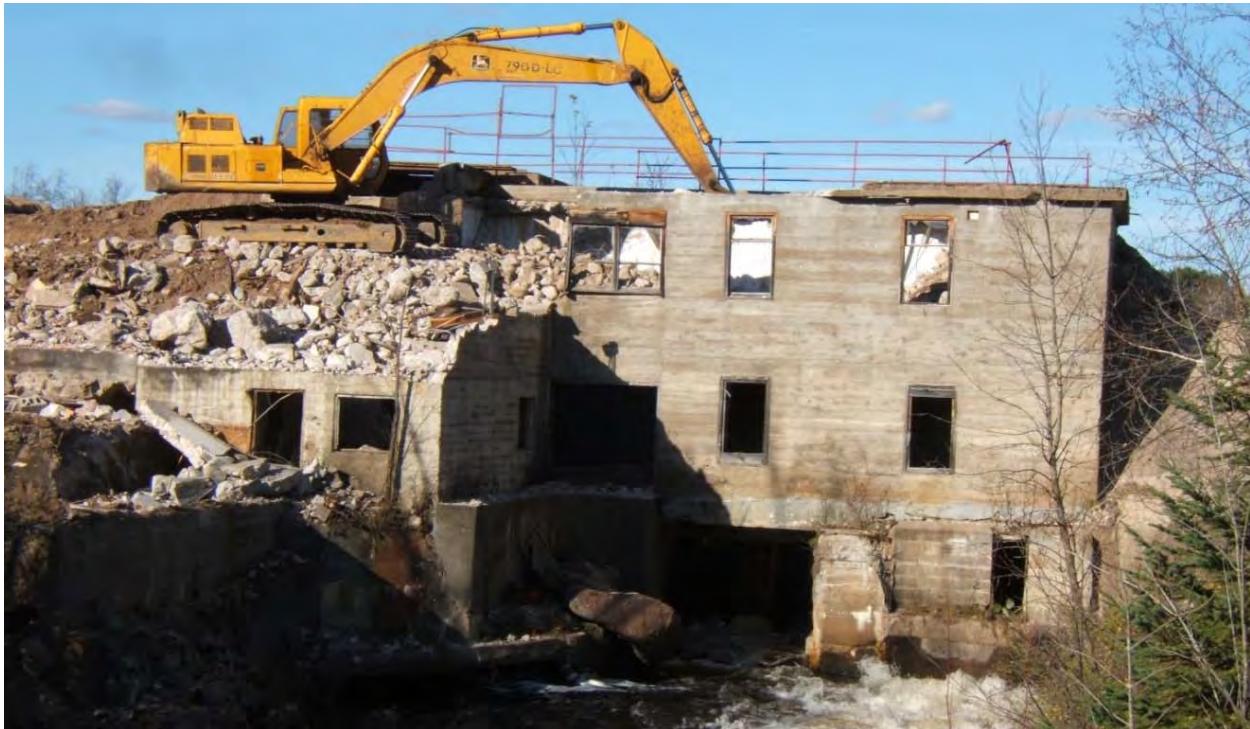
Figure 8 shows how difficult construction access was, because protected wetlands downstream of the dam and fifteen feet of muck upstream of the dam limited contractor access to slowly working from dam ends toward the dam's middle.

Figure 8. Difficult site access at Grimh Dam, looking upstream at powerhouse

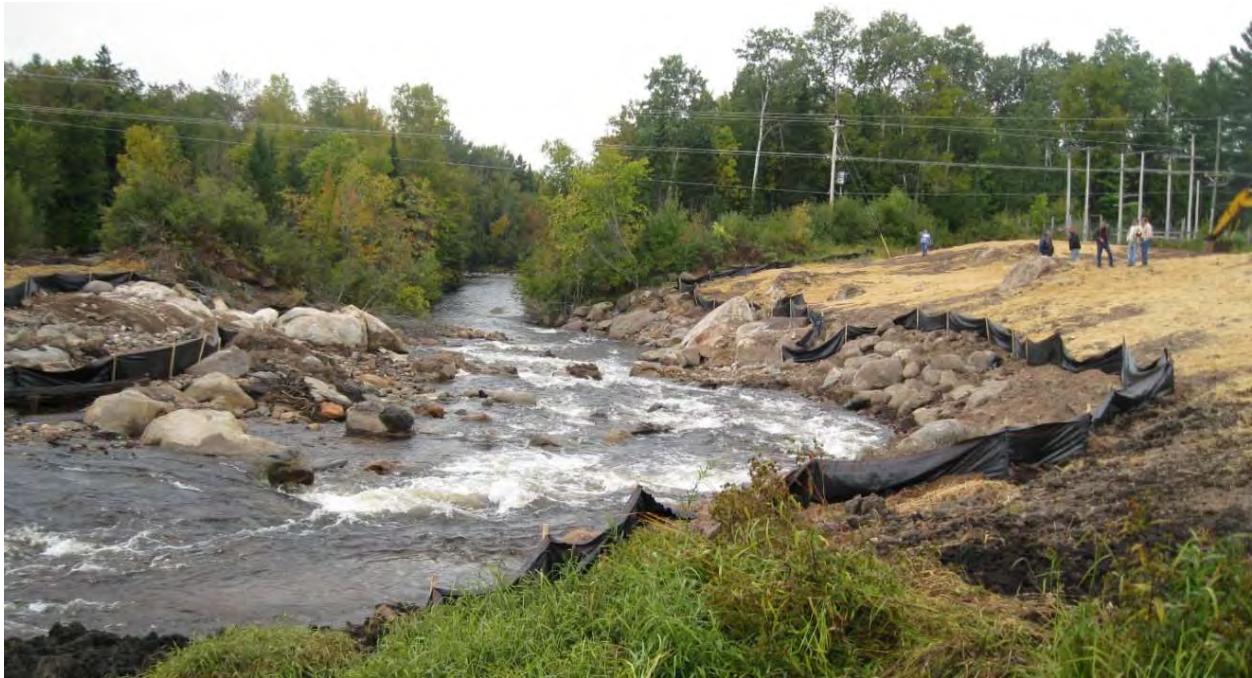
Figure 9 shows the site, looking downstream at the previous powerhouse location during the substantial completion inspection. This project was a highly collaborative project and also highly regulated with frequent DNR visits to the site. Figure 9 shows 4 DNR staff onsite during substantial completion and in the two years after completion many DNR upper management staff visited the site to see the results.

Figure 9. Complete removal of powerhouse by end of 2011, looking downstream at powerhouse site.

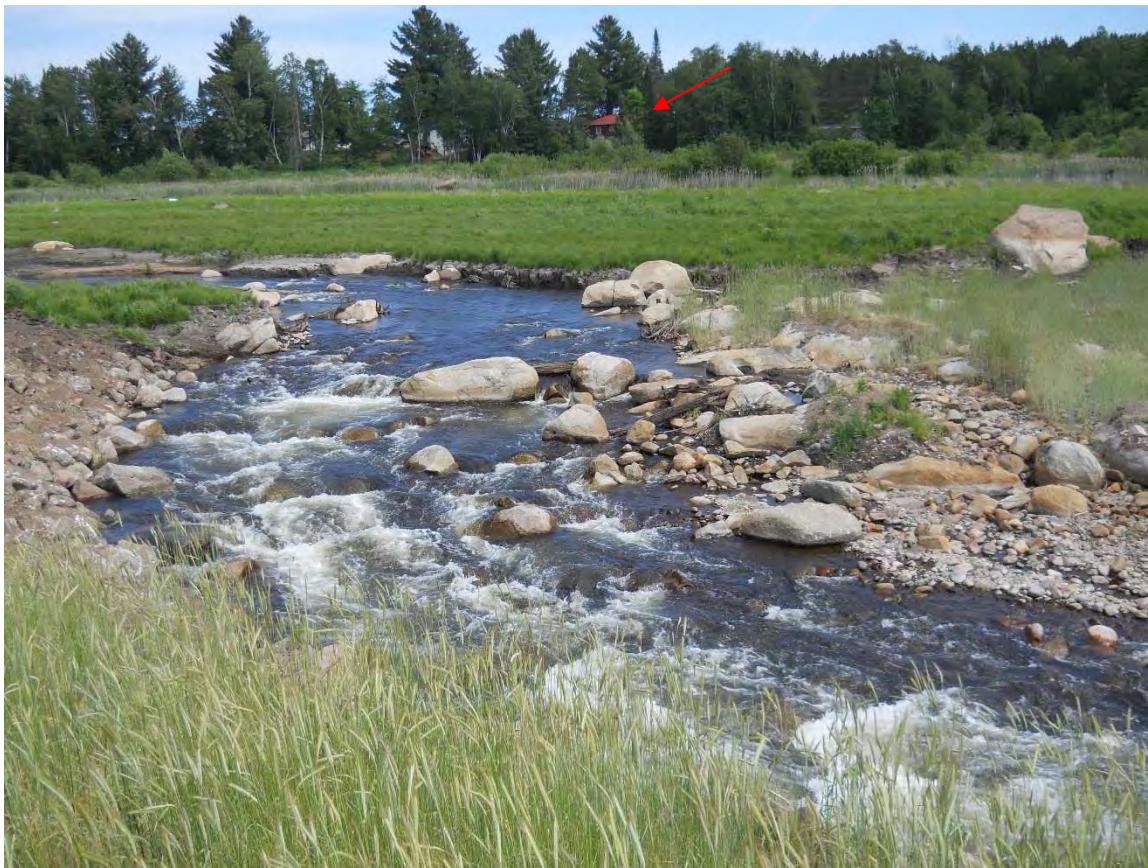
Figure 10. Grimh Dam site three years post-removal

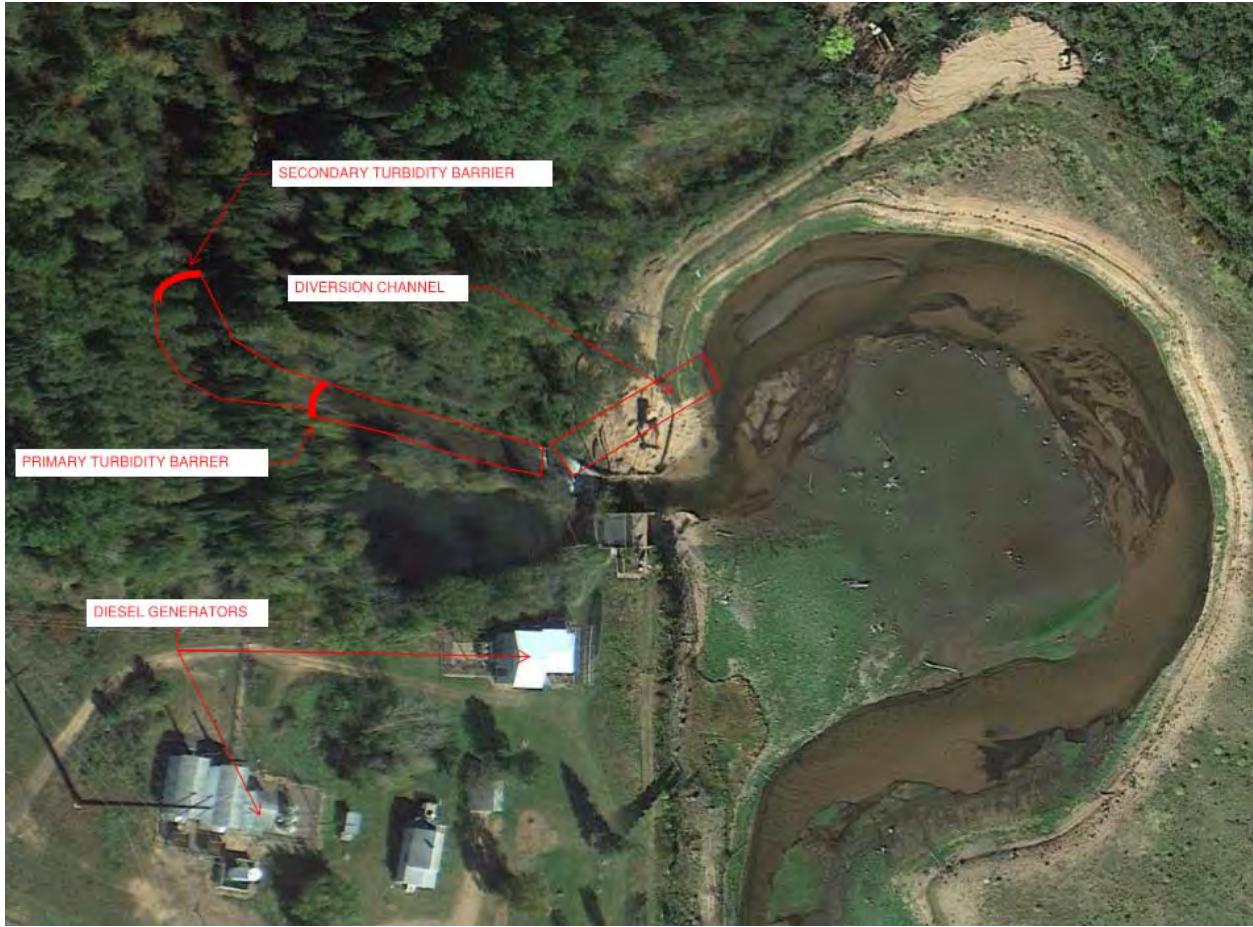
Figure 12. Gordon Dam removals' double turbidity containment system and diversion channel (image courtesy of and used under license of Google Earth Pro, 2020)

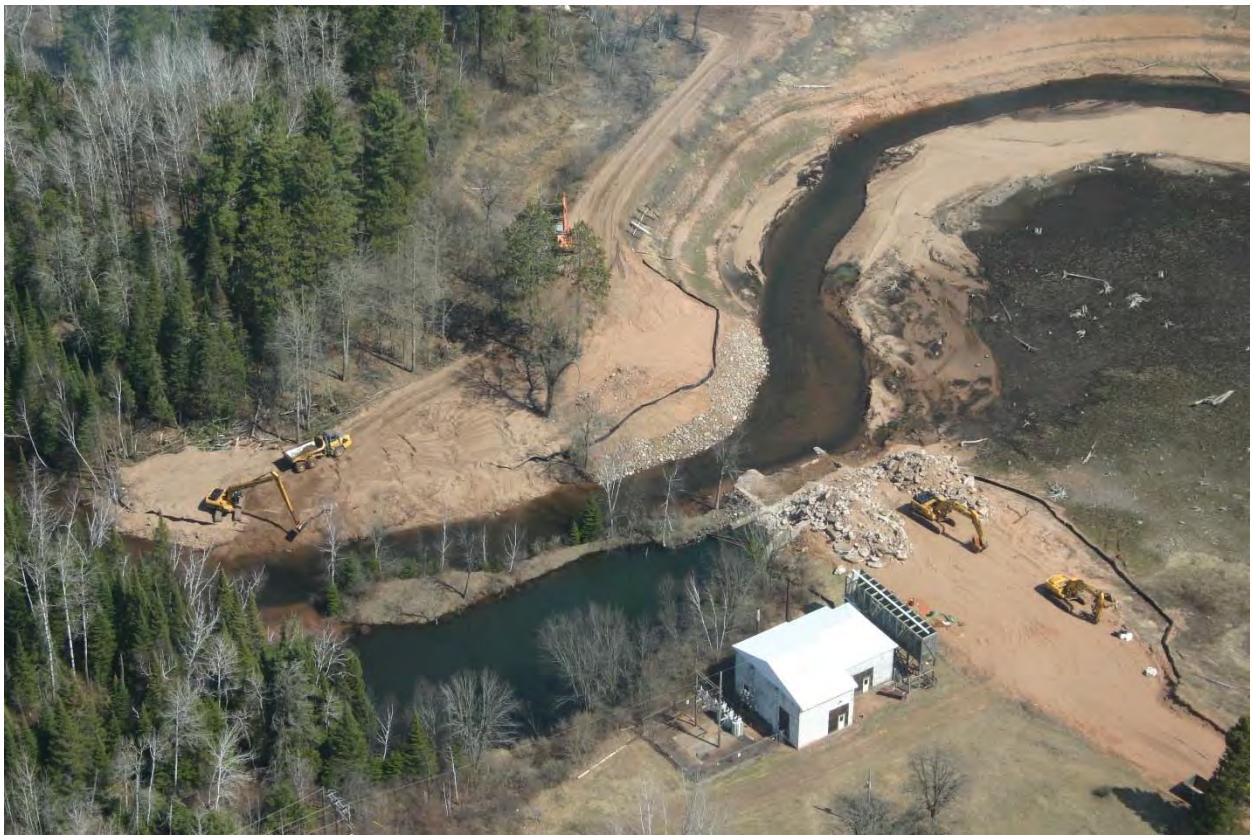
Figure 13 shows the second-year removal (powerhouse foundation still shown), and this view shows the channel is carrying a significant bedload of sand nearly ten months after the full drawdown was completed.

Figure 13. Gordon Dam during second year of removal (image courtesy of Frank Dallam, DNR)

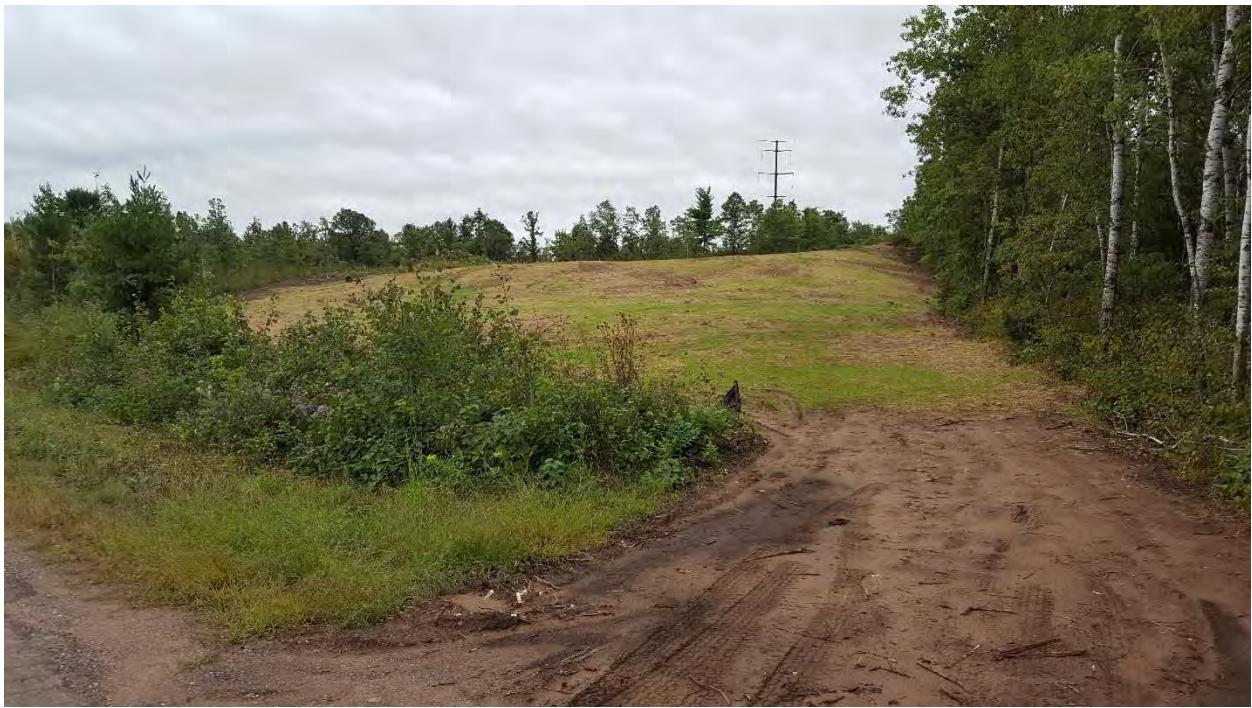
To remove the 13,500 cubic yards of embankment fill and clean concrete chunks, Ayres requested and received permits to store the removed materials onsite. Figure 14 shows the berm built into the hillside, capped with topsoil and seeded. The relatively silt-less sands collected by the turbidity barriers were donated to the local township's borrow pit for possible reclamation as future road sand.

Figure 14. Gordon Dam's onsite permanent stockpile for removal materials

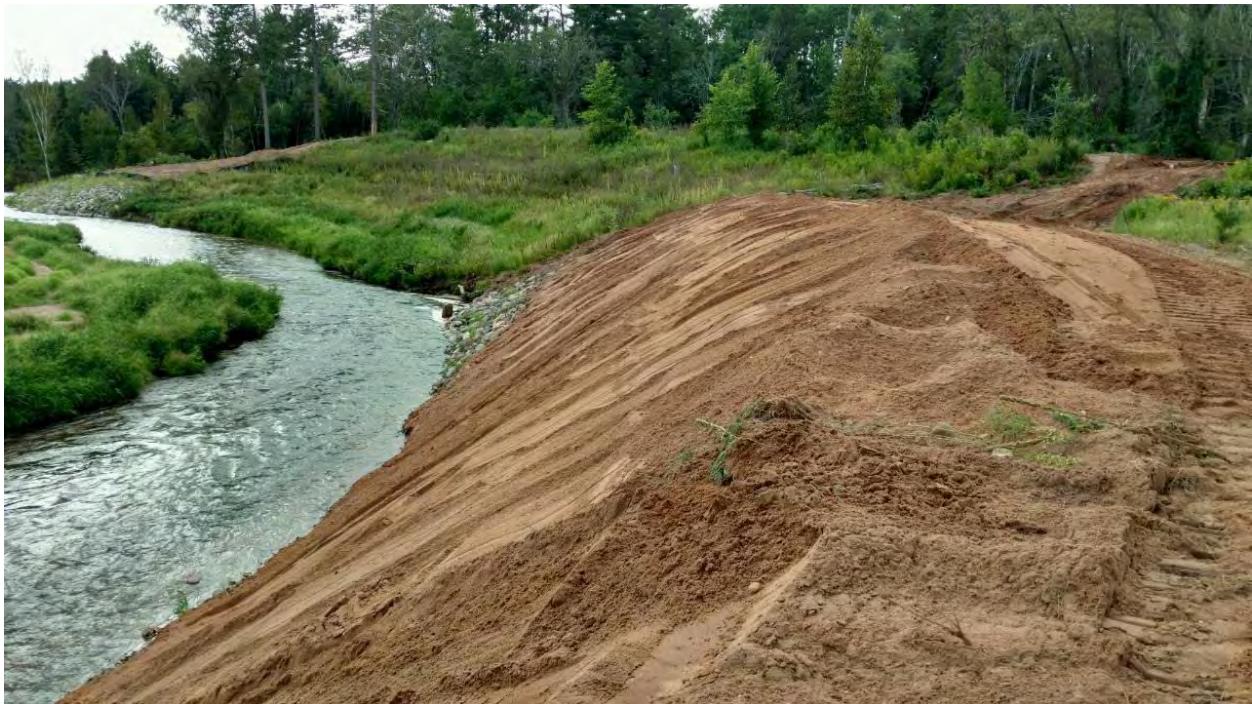
Figure 15 shows bank restoration efforts at two cut banks within the former flowage. The contractor used riprap and filter sand along the toe and regraded slopes to 3H:1V (horizontal to vertical; the site's round glacial sands required flatter than normal grades for stability).

Figure 15. Bank restoration efforts at Gordon Dam

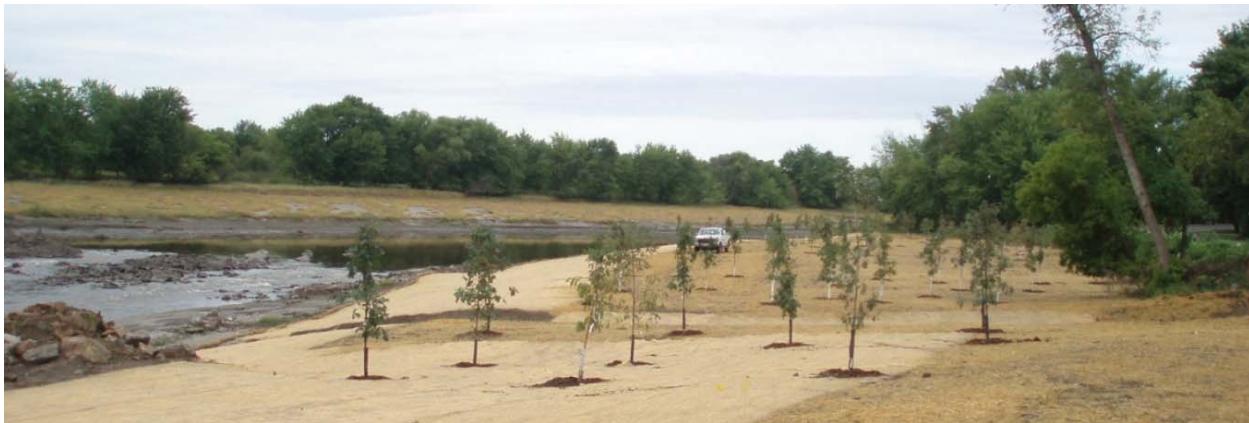
After expiration of the FERC license, the timeline of the Minnesota Falls Dam Removal project was typical. Plans²⁹ to remove the dam were submitted to regulating agencies in January 2010 and the dam was removed³⁰ in February 2013 (Figure 17). The construction was completed during low river flow conditions in mid-winter, and turbidity was monitored downstream of the worksite for most of the 62-day construction period. Construction was completed by equipment working in water to hydraulically hammer and demolish the structure in place. Once demolished, crews hauled sediment and clean concrete fragments to an onsite disposal location and other materials to approved landfill or recycling centers. The winter drawdown and dam removal efforts were successful at meeting the turbidity standards set by the state reviewers. Vegetation at the removal site was stabilized by September 2013, and the construction report (including post-construction monitoring provisions) was issued in December 2013.³¹
