January 7, 2021

Subject: Phase I Archaeological Survey at the Powell Falls Development, River Falls Hydroelectric Project (FERC #10489), Pierce County, Wisconsin
TRC Project No. 350165
WIARC No. 263

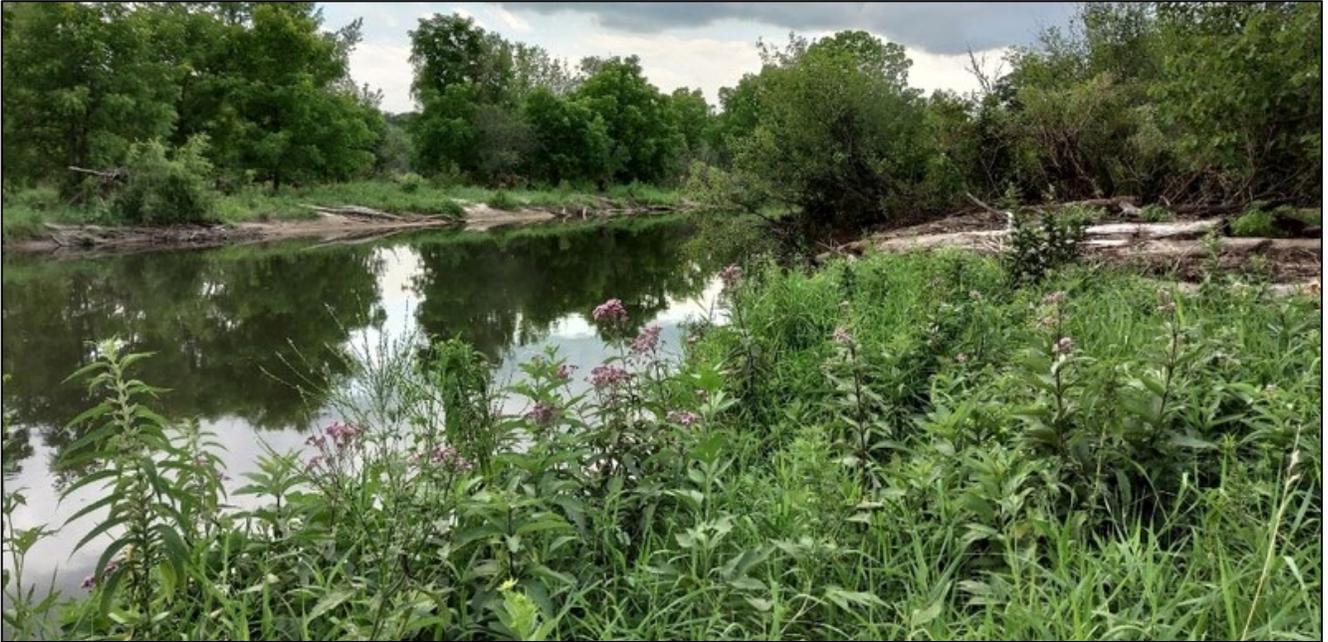
Photo 1: View of the shoreline of both the northwest and northeast quadrants. View to southwest.

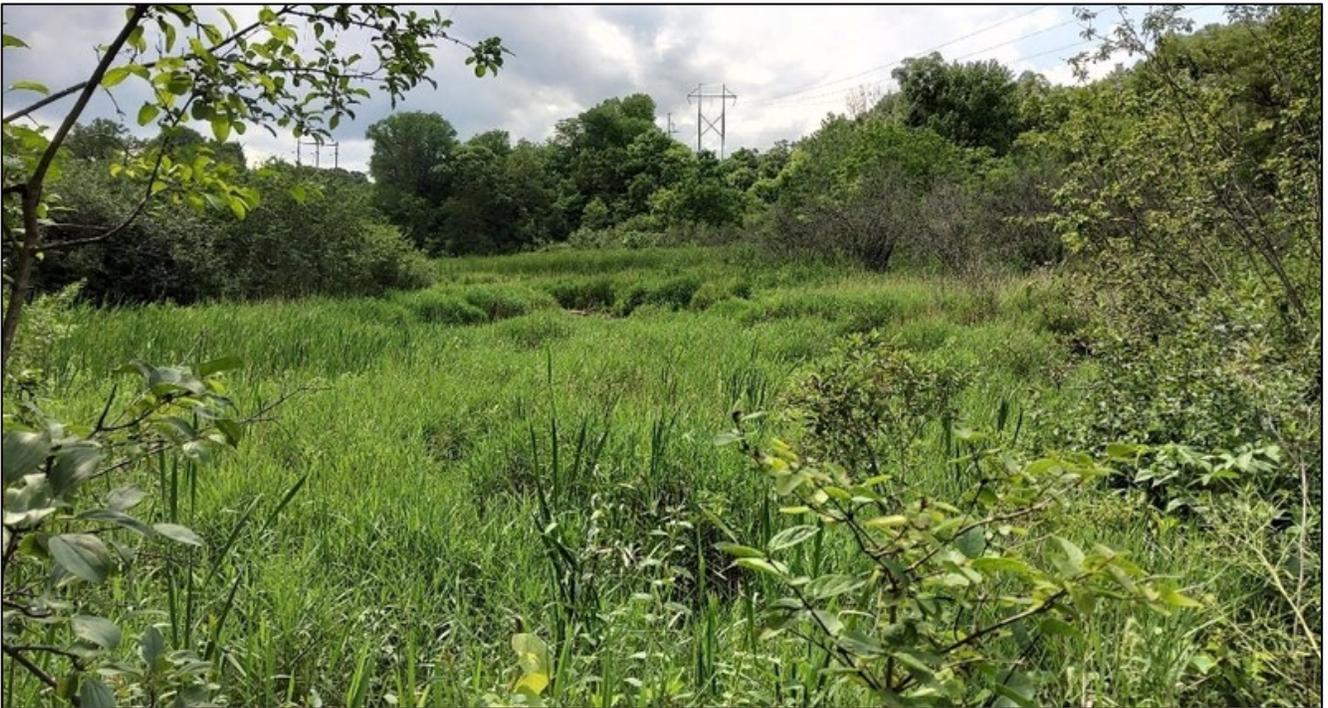
The July 2020 survey³ examined the shoreline and noted that the northwestern shoreline of Lake Louise is stable and well vegetated with areas protected by natural slow water environments, which allow emergent and submergent vegetation to buffer the shoreline. Shovel tests were dug where it was possible to do so, but large areas of standing water and marsh were encountered. Soil profiles in shovel tests generally showed an A-Horizon of black (10YR 2/1) sandy clay loam (0-15 cm) over a B-Horizon of dark gray (10YR 4/1) sandy clay loam.

Photo 2: View of the northwestern quadrant.. View to west – southwest.

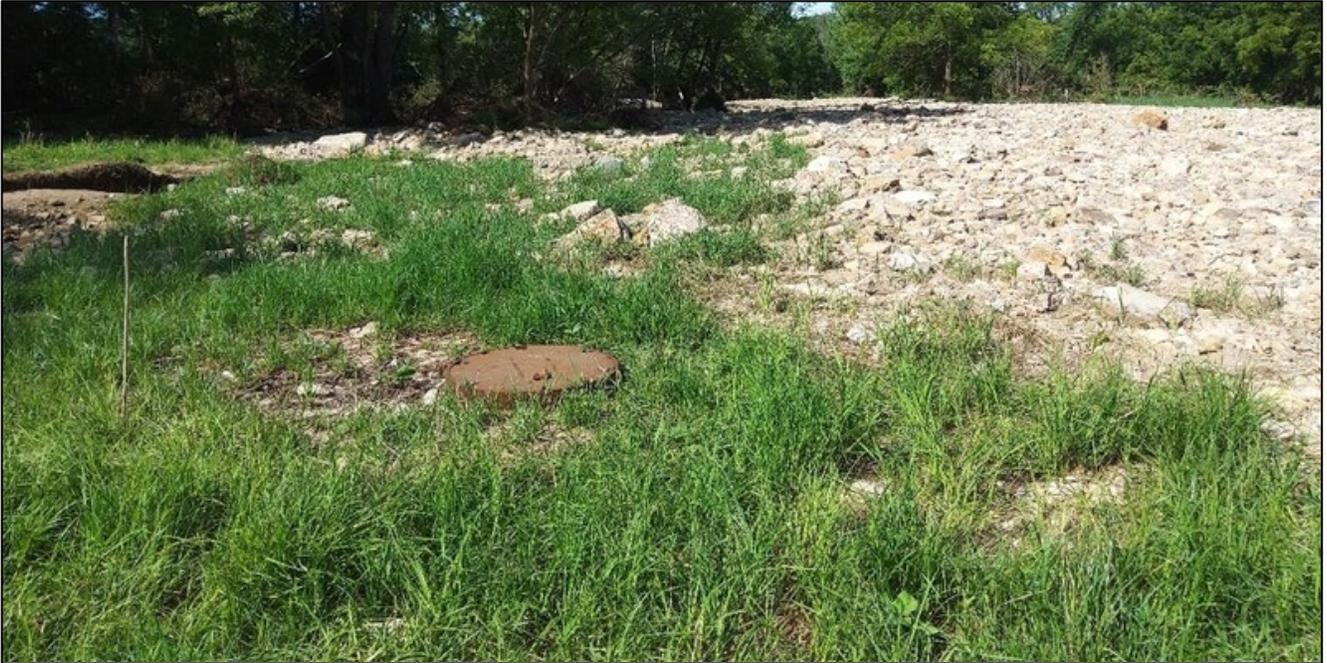
(10YR 5/3) sand (0-5 cm) over a B-horizon of black (10YR 2/1) sandy loam (5-30 cm). The water table was encountered at about 30 cm. The area had large gravel bars and showed disturbance caused by sewer construction as evidenced by a manhole in one of the gravel bars (Photo 3).

Photo 3: A view of gravel bar and the sewer utility line within the northeastern quadrant. View to west.

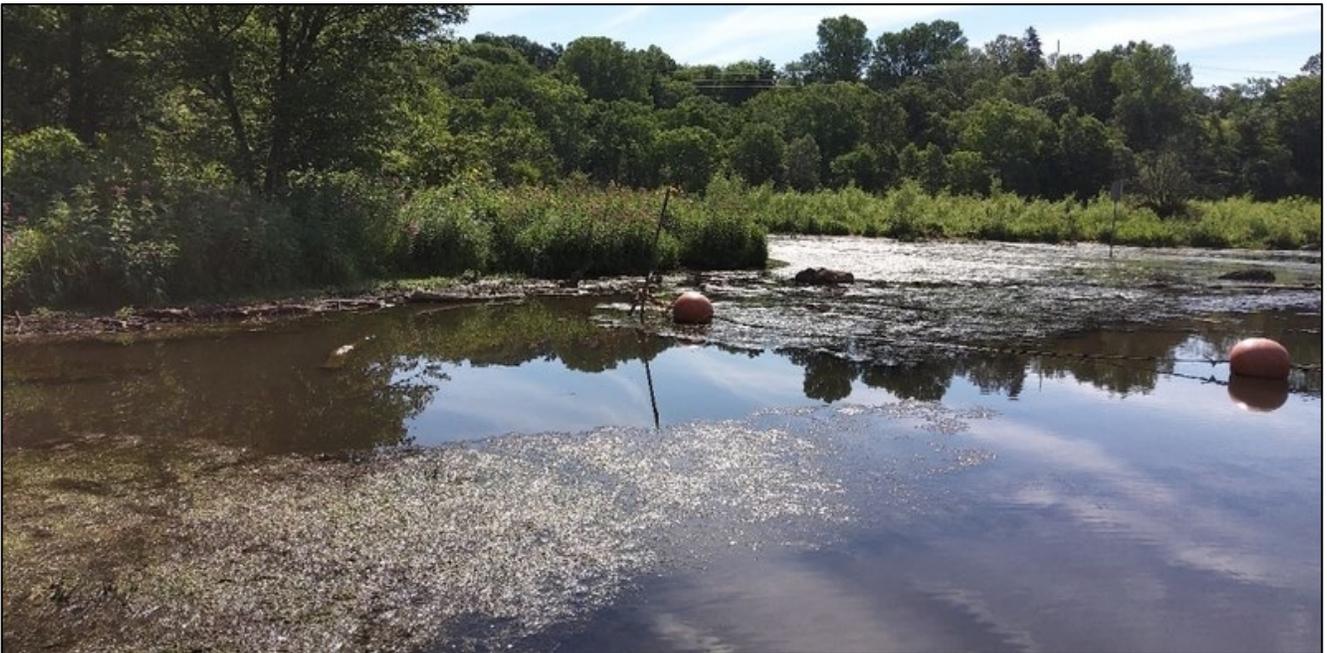
The southwestern and southeastern Lake Louise shoreline was steep but well vegetated. The shoreline sloped up from the water at about 70-80 degrees within the Powell Falls APE.

Photo 4: Overview of stable shoreline in the southeastern quadrant. View to southwest.

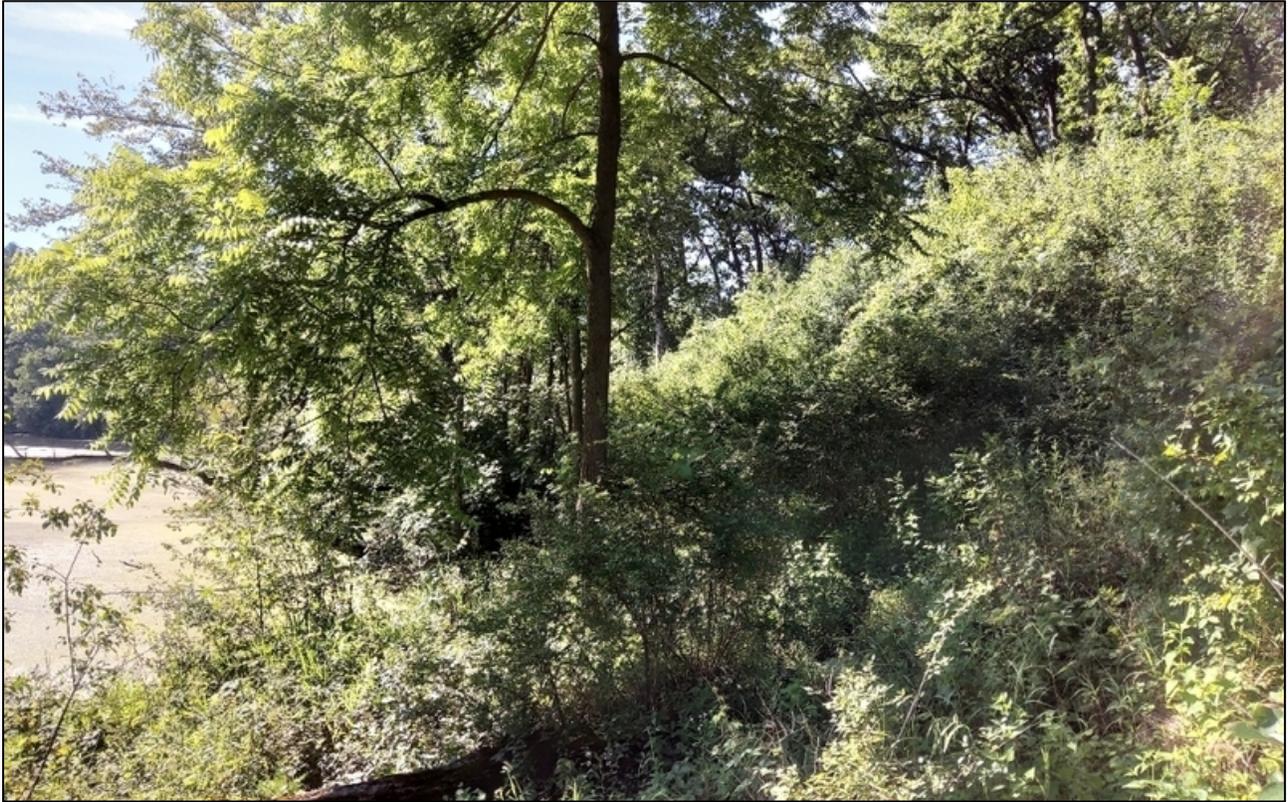
Photo 5: View of slope of shoreline in the southwestern quadrant. View to south.

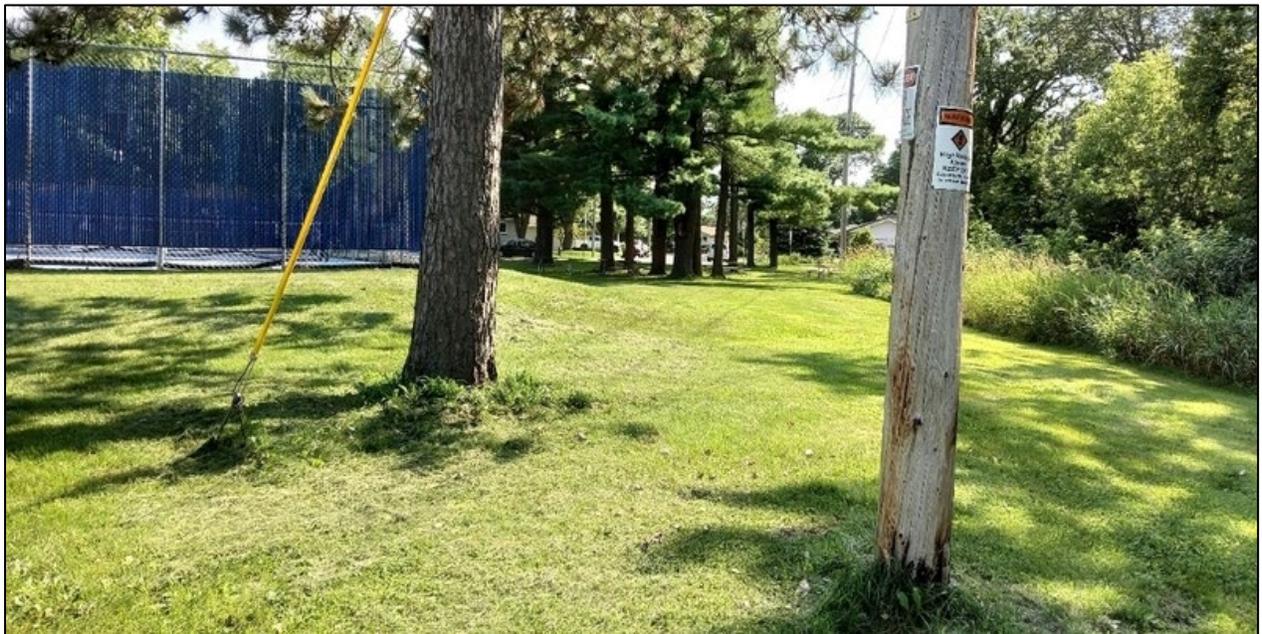
The Phase I survey continued along the existing transmission line south of the southern shoreline of the lake. Shovel tests in the western half of the corridor showed mixed soils and heavy disturbance related to earlier episodes of development and expansion at Glen Park. The eastern half of the corridor ran along a well vegetated valley wall that had a 60-70 percent slope which was not shovel tested.

Photo 6: Glen Park and recreational disturbance. View to southwest.

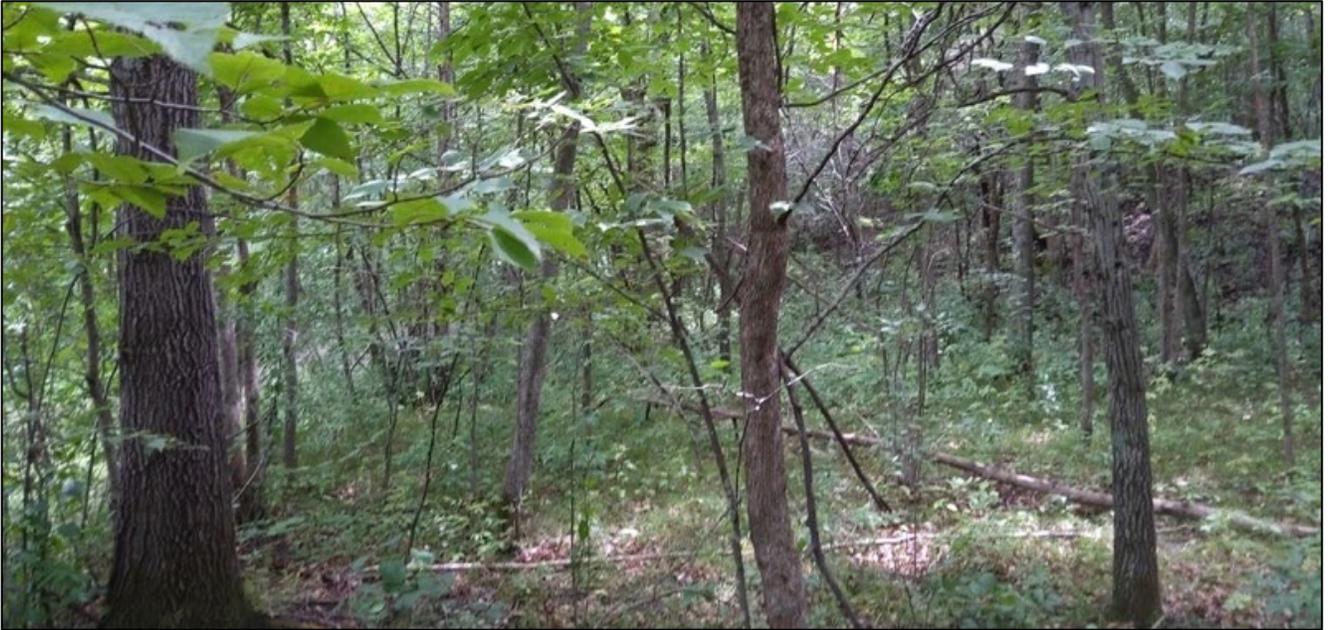
About three acres of land below the dam were surveyed for the proposed dam removal with the Kinnickinnic River bisecting the three acres. Surface collection (also referred to as pedestrian survey), of the bluff tops and along the river edge noted that most of the area was steeply sloped (~80 percent). Shovel tests were dug where possible, even in areas with up to 40 percent slopes and dry soils. Shovel test profiles showed an A-Horizon of very dark brown (10YR 2/2) loam (0-30cm) over a B-Horizon of dark grayish brown (10YR 4/2) sandy loam. A single shovel test near the canoe launch and pedestrian trail on the south side of the river showed mixed, disturbed soils related to recreational use and landscaping.

Photo 7: Wooded area below Powell Falls Dam. View to west.

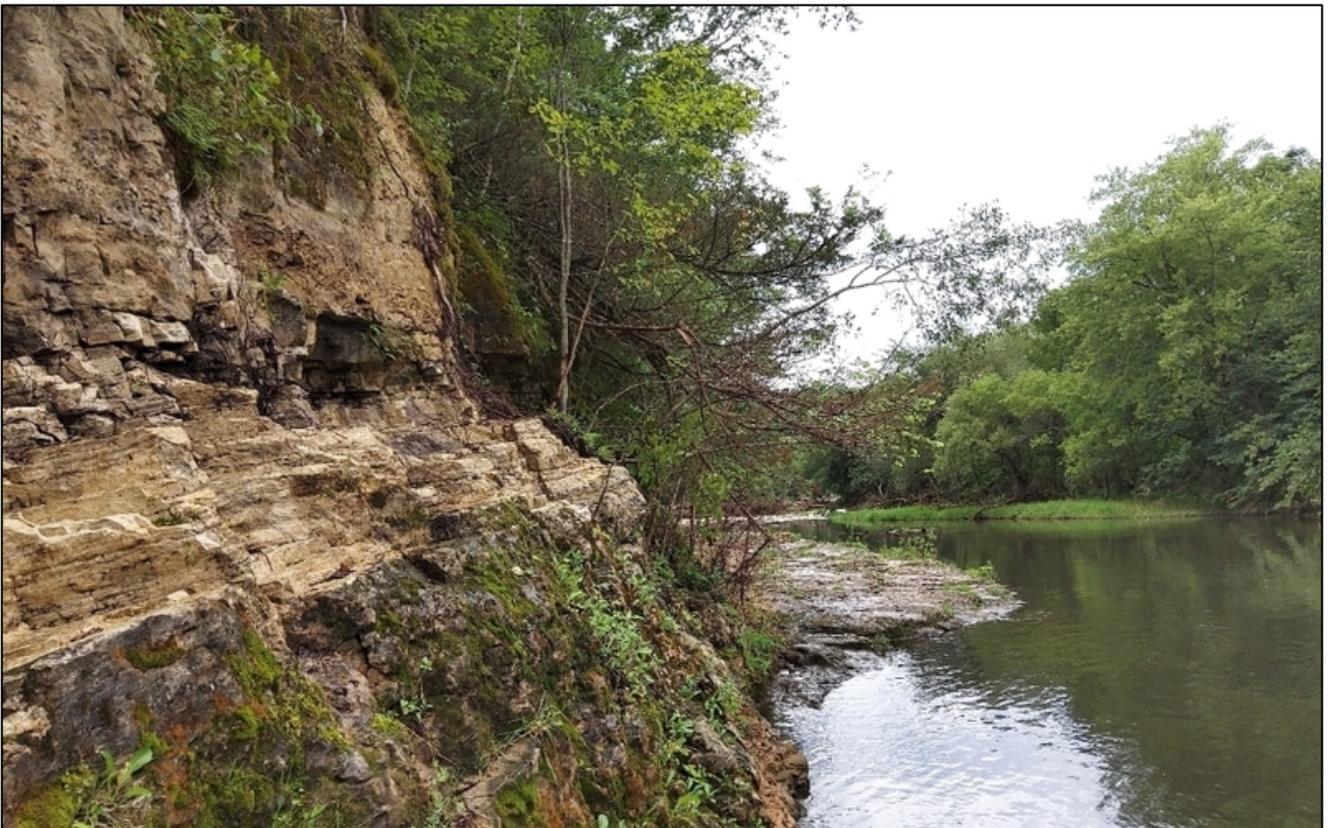
Photo 8: Bank below Powell Falls Dam. View to southwest.
