**Lake George Report
River Falls, Wisconsin
John A. Downing, June 2006**

Background and purpose: The purpose of this work was to map the bottom contours of Lake George, River Falls, Wisconsin, and to map the thickness of flocculent sediments in this lake. This lake was created by a hydroelectric dam that backed up water over a set of old meanders in the Kinnickinnic River.

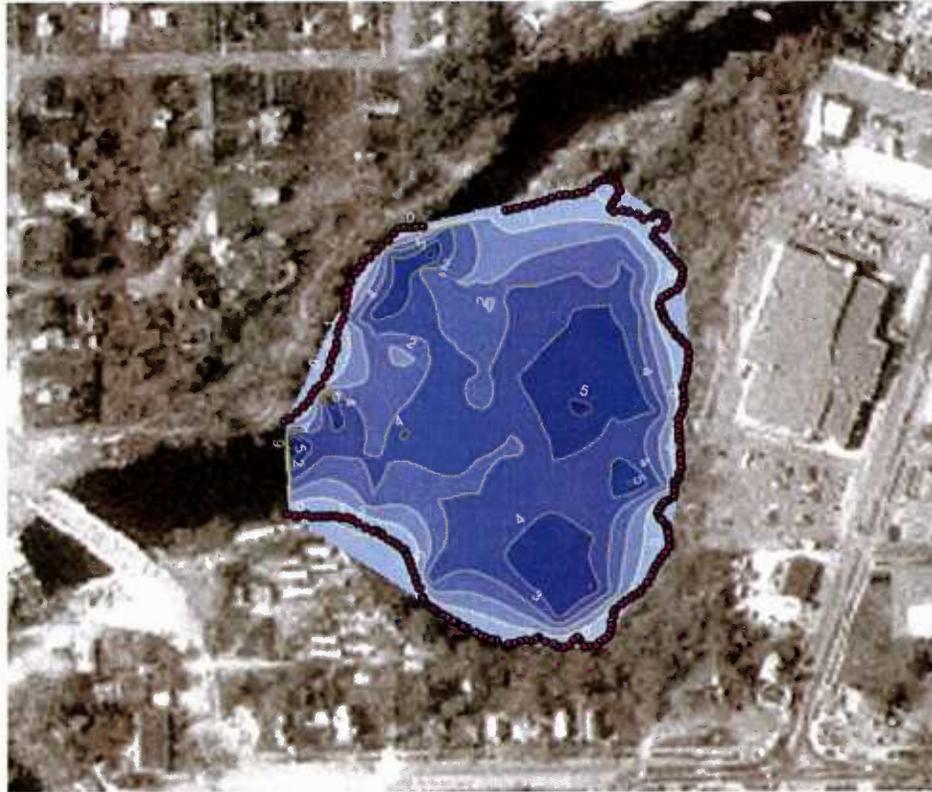
Figure 1. Bathymetric map showing depth in feet to the sediment surface of Lake George, Wisconsin. Depths were determined by sediment penetration measurements. Coverages were created using natural neighbor methods.

Rod soundings: Figures 1-3 and Figures 6 and 7. Show map coverages created from rod soundings. The salient features are a large shallow submerged point projecting in a southwesterly then southerly direction projecting from the point of land at the eastern shore of the entry point of the Kinnickinnic River, a meandering streambed near the western shore and a depression near the eastern shore of the lake (Figure 1). The origin of this depression can be seen in Figure 2 because the hard bottom bathymetry shows a drowned, meandered stream channel along the east bank of the lake. At some point in the past, the Kinnickinnic River meandered to the east of its current bed and carved a deep channel near the east shore of Lake George.

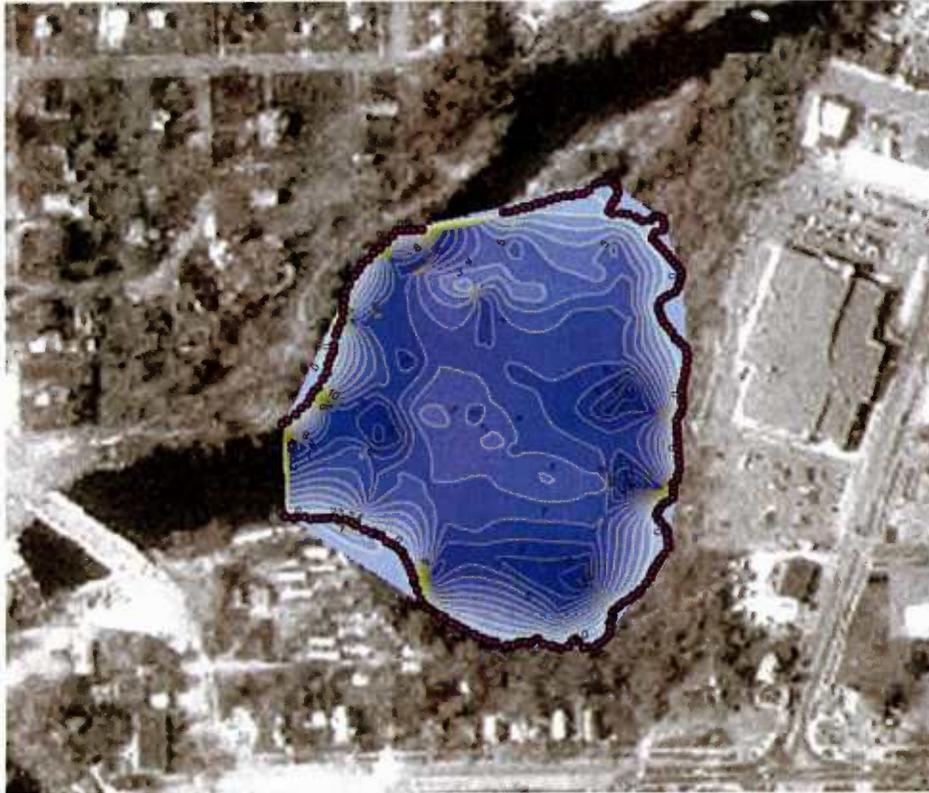
Figure 2. Bathymetric map showing depth of hard bottom in Lake George, Wisconsin. Depths were determined by sediment penetration measurements. Coverages were created using natural neighbor methods.

Elevation coverages: Figures 6 and 7 show the rod sounding coverages (Figures 1 and 2) calculated in elevation above mean sea level. These data were corrected using the lake level referenced to the top of the hydroelectric dam (865.5 feet above MSL). These coverages are identical to those in Figures 1 and 2 except for their units and differences in contour lines because they are drawn offset by 0.5 feet in depth (i.e., the first contour is drawn at the 0.5 foot level shown in Figures 1 and 2).

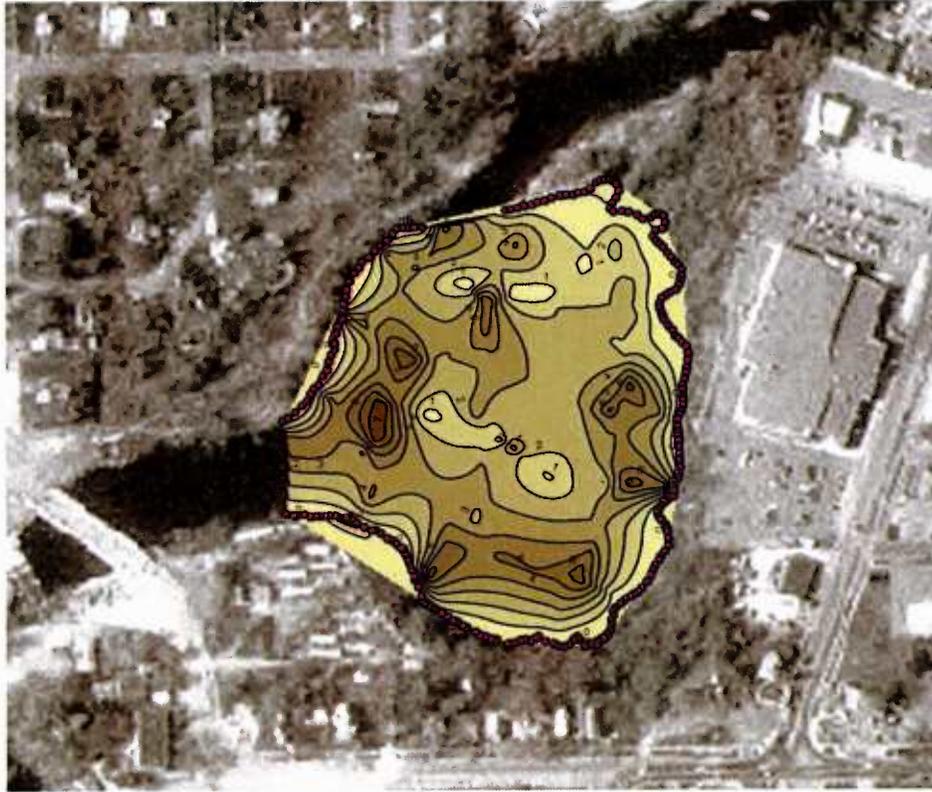
Table 3. Bathymetric map showing sediment thickness in Lake George, Wisconsin. Thicknesses were determined by difference between sediment surface measurements and depths to hard bottom using sediment penetration measurements (Figures 1 and 2). Coverages were created using natural neighbor methods.

Due to damming, sediment accumulation has been quite substantial in Lake George (Figure 3) with soft sediment depths of 6-8 feet quite common. Sediments have substantially filled both the current river channel near the western shore and the drowned river channel near the eastern shore (Figure 3).

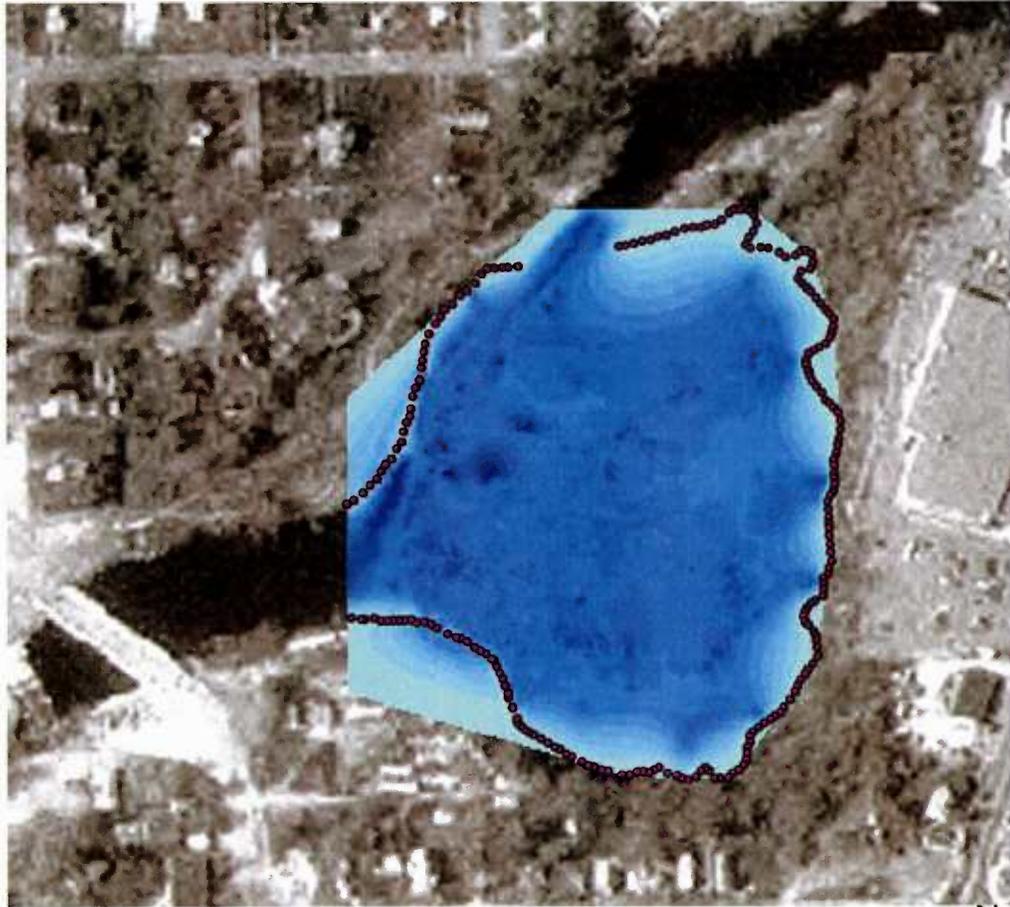
Figure 4. Bathymetric map showing depth in feet to the sediment surface of Lake George, Wisconsin, determined by bottom discriminating sonar. Coverage was created using natural neighbor methods.

Sonar soundings: Sonar readings indicate a similar bottom form but are less accurate than the rod soundings in the eastern part of the lake basin due to shallow depths and interference from macrophytes. Sonar soundings show the current river channel distinctly but lose resolution in the shallow parts of the lake basin (Figure 4). Contours of the sonar coverage are found in Figure 5.

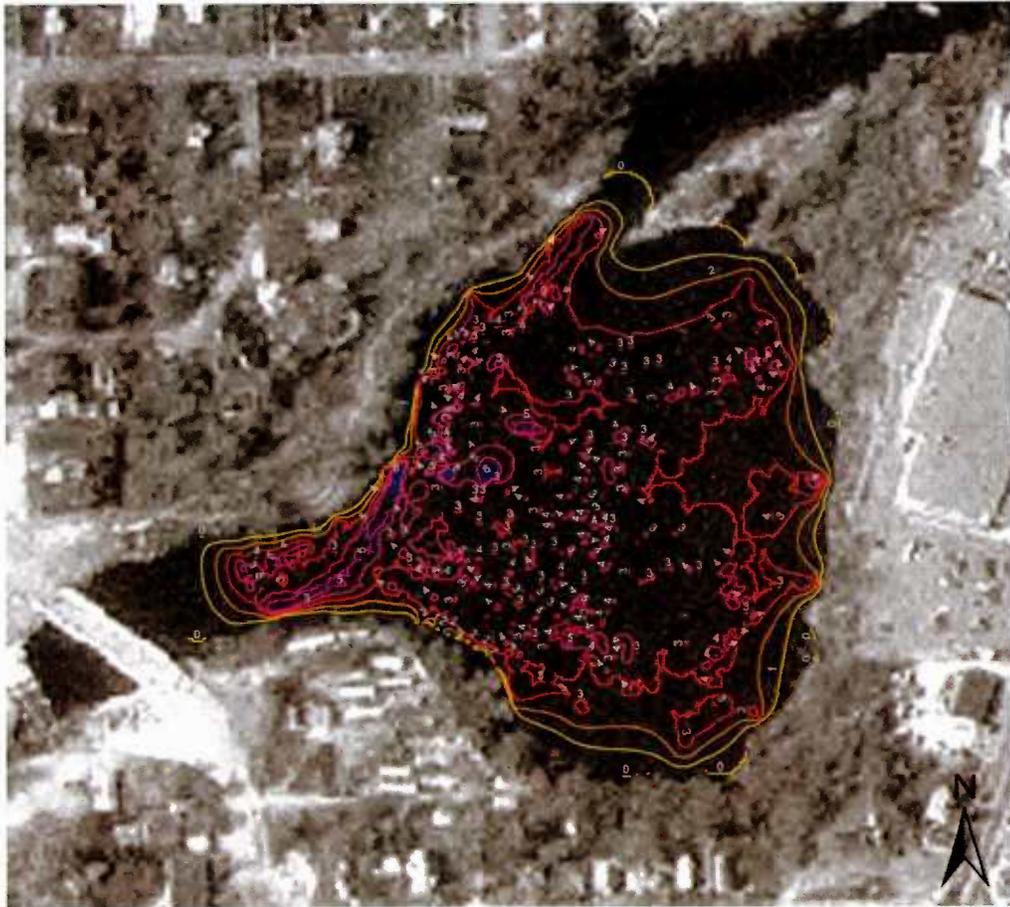
Figure 5. Bathymetric map showing contours of depth in feet to the sediment surface of Lake George, Wisconsin. Depths were determined by sonar. Coverage was created using natural neighbor methods. Sonar measurements were most accurate above 3.5 feet of depth.

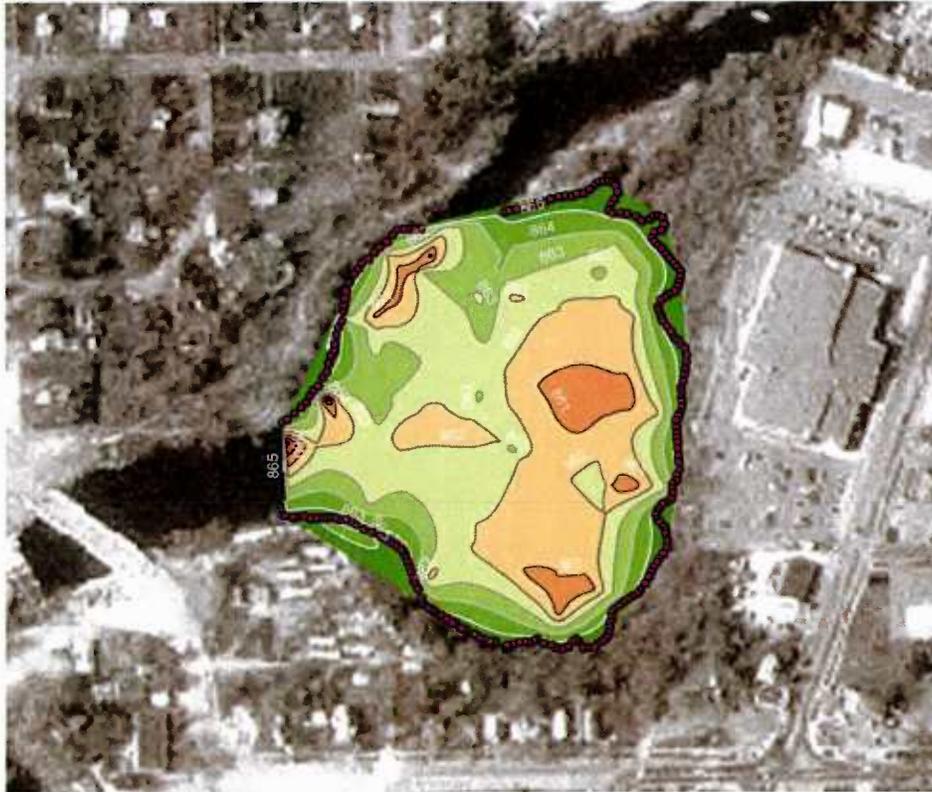
Figure 6. Bathymetric map showing elevation in feet above MSL of the sediment surface of Lake George, Wisconsin. Depths were determined by sediment penetration measurements. Coverages were created using natural neighbor methods.

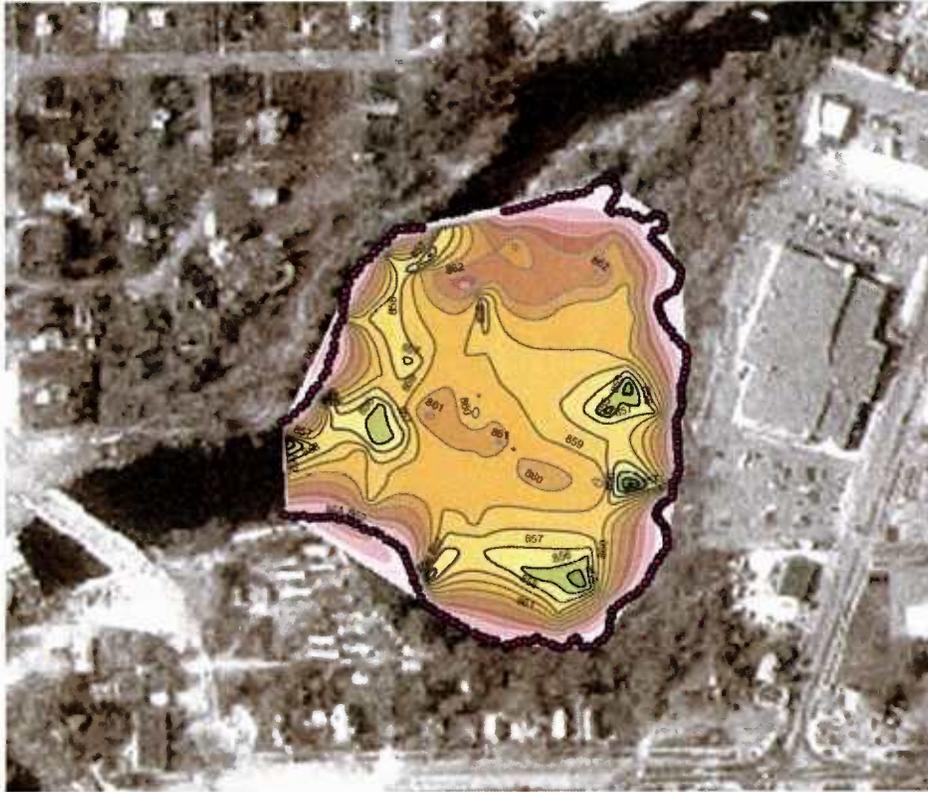
Figure 7. Bathymetric map showing elevation in feet above MSL of the hard bottom surface of Lake George, Wisconsin. Depths were determined by sediment penetration measurements. Coverages were created using natural neighbor methods.
