Inspection Report

**River Falls Hydroelectric Project
FERC Project No. P-10489**

**Junction Falls Dam
River Falls, Wisconsin**

December 2009

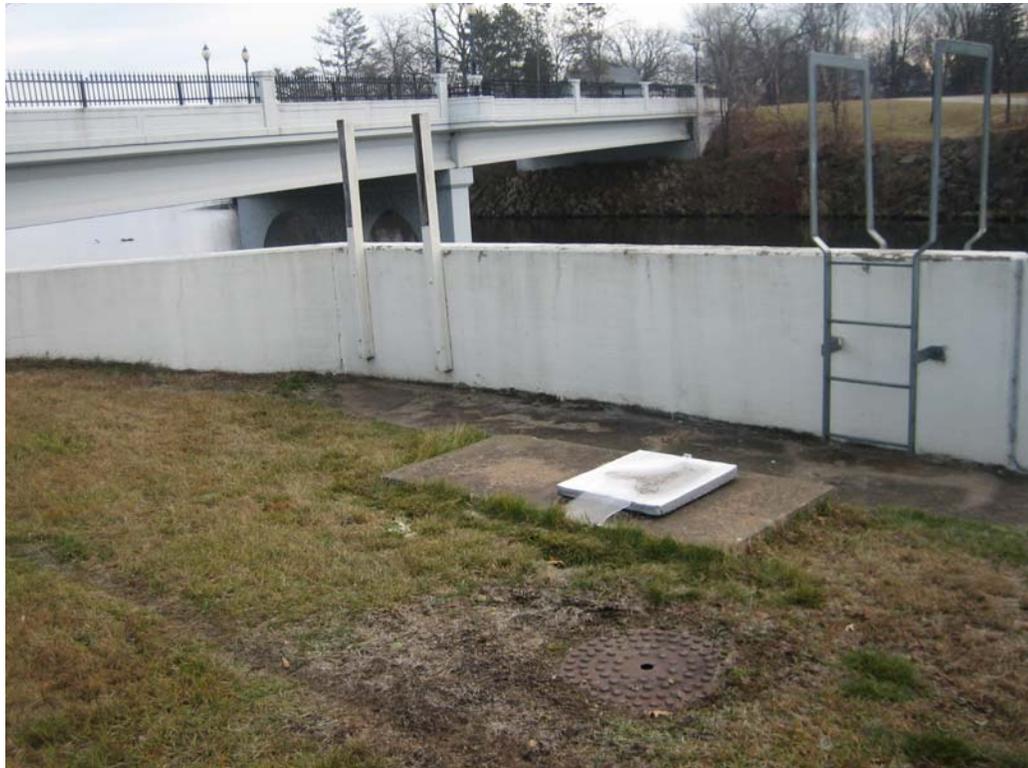
2. Upstream parapet wall

The parapet walls are in good condition with minor cracking (Photos 4, 7 and 8). The paint system has failed in many areas.

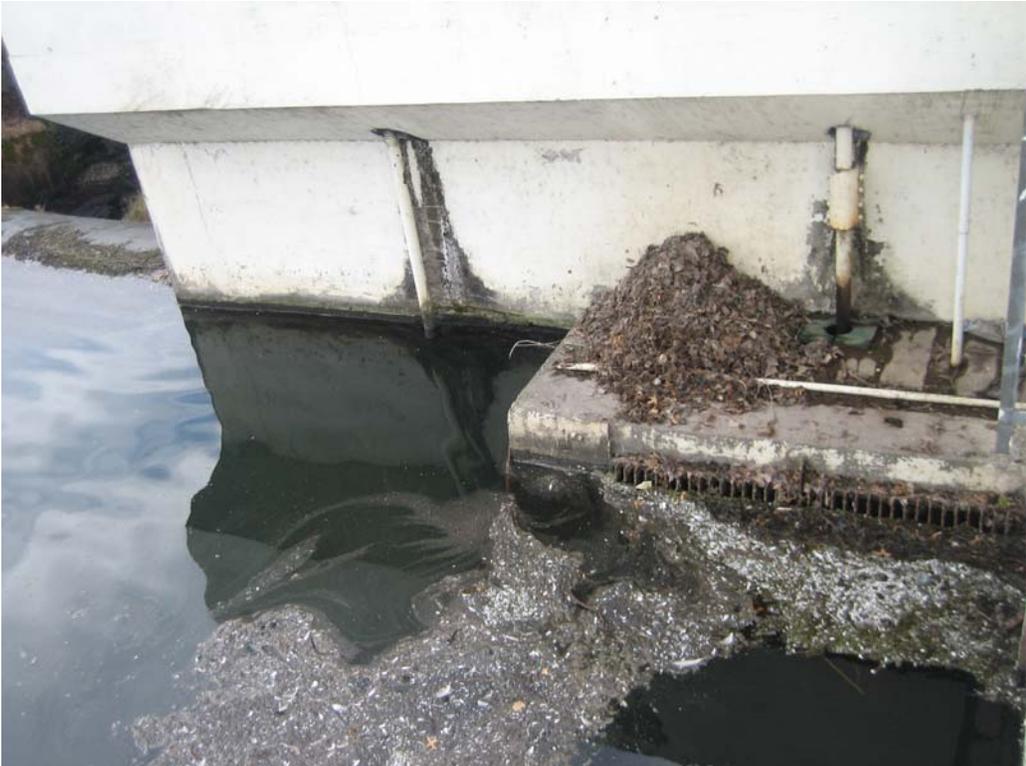
6. Intake

The headworks (Photos 1 to 8, 13, 14, and 17) are concrete structures containing the wasteway and penstock intake. Sluice gates are located in the structure for flow regulation. A steel trashrack is located upstream of the intake. A concrete operating deck supports the sluice gate operators. A concrete parapet wall is located on the upstream edge of the deck. A downstream concrete retaining wall is located on the right bank and extends to the rock face (Photo 13). The headworks appear to be founded on bedrock.

The brush and trees growing around the headworks should be removed within one year to facilitate inspection and to eliminate potential seepage paths and concrete damage due to the root systems

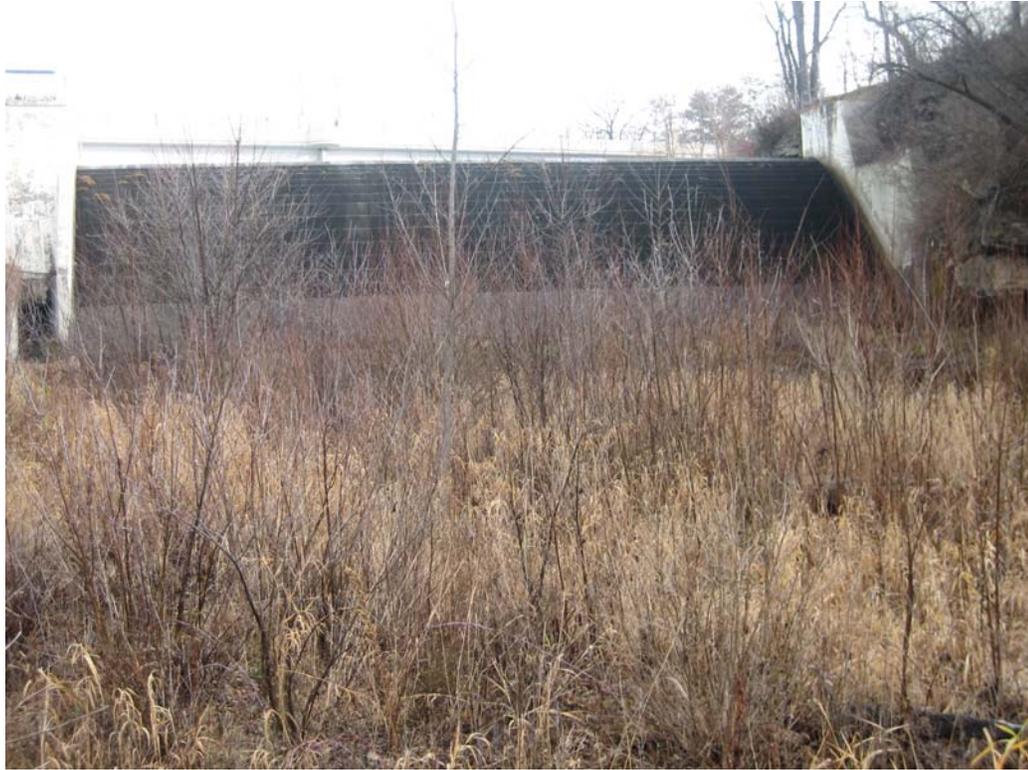
9. Downstream view of spillway

The spillway (Photos 9 to 11, and 16) consists of an uncontrolled stepped concrete gravity structure. The spillway appears to be founded on bedrock. The spillway is bookended by concrete abutments. A portion of the right abutment is part of the headworks.

The spillway is in good condition with minor deterioration and missing caulk at the vertical joints. Moss growth limited inspection of all joints. There were no visible signs of structure undermining. Minor flow was observed from the weep holes.

The missing caulk at the vertical joints should be repaired within two years.

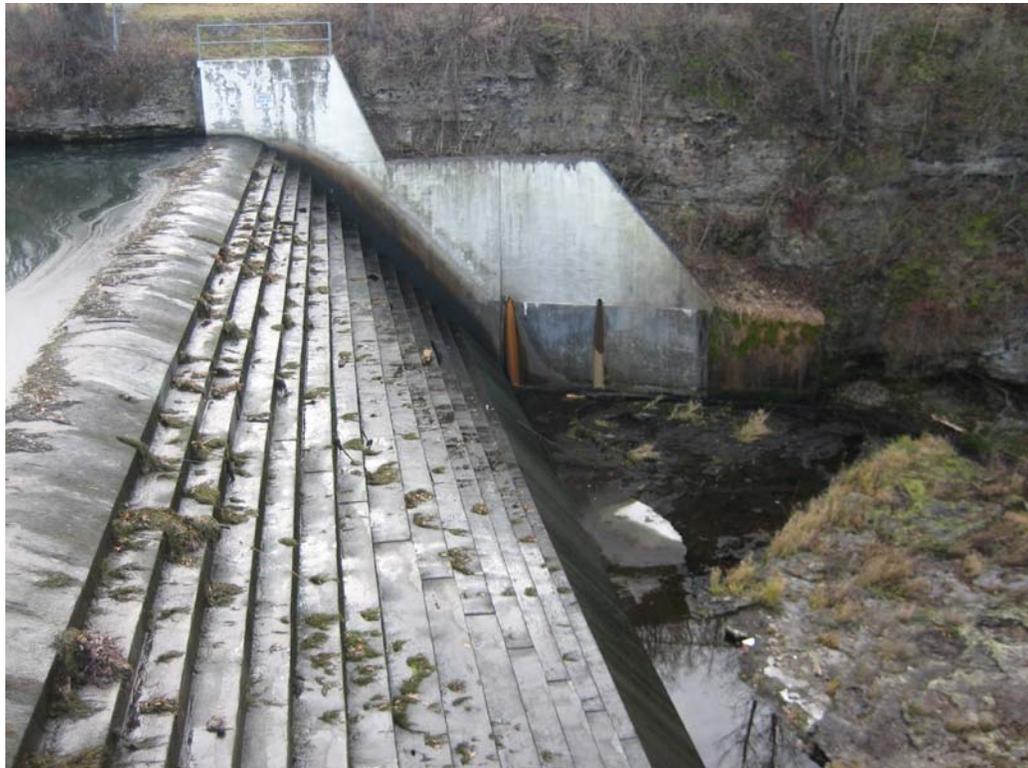
10. Spillway, left abutment and left retaining wall

The left concrete abutment and downstream concrete retaining wall are located to the left of the spillway (Photos 10 to 12). The left abutment and downstream retaining wall appear to be founded on bedrock.

The left abutment is in good condition. The downstream retaining wall is in good condition with minor cracking and efflorescence (Photos 11 and 12). The paint system has failed in many areas. All the weep holes were functioning at the time of the inspection. There is moss growth (Photo 12) on the downstream retaining wall due to seepage through the rock face and vegetation build up on the top of the wall.

The brush and trees growing around the left abutment and downstream retaining wall should be removed within one year to facilitate inspection and to eliminate potential seepage paths and concrete damage due to the root systems.
