TECHNICAL MEMORANDUM

To: Kinni Corridor Collaborative
From: Sean Morrison and Marty Melchior, Inter-Fluve
Date: December 18, 2020
Re: Drone based Drawdown Analysis

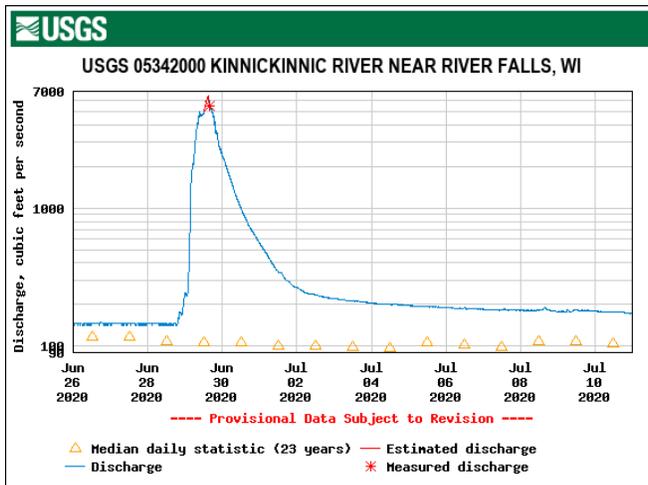
On June 28-29, 2020, a large rain event (6.75 inches in River Falls) caused flooding within the Kinnickinnic River Watershed and the surrounding areas. At USGS gage 05342000, located at the County Road F crossing in Pierce County, discharge peaked at 6,450 cfs at 2:45 pm. For

comparison, the 10-year recurrence interval flood at the Powell Falls Dam is 6,800 cfs (FEMA 2011). The June 28-29th flood event damaged the Powell Falls Dam and prompted the River Falls Municipal Utilities (RFMU) to lower the Powell Falls Dam impoundment (Lake Louise) to inspect the dam structure (Ayres 2020). The drawdown of the impoundment began October 2nd by opening the dam sluice gate. The drawdown was completed on October 15th, 2020

Figure 2: USGS gage data from the flood occurring on June 28-29, 2020.
